## Audio System Not Working After Completing S/B 20-047?

Just wrapped up the repair procedure in S/B 20-047, *Noncompliance Recall: Gauge Control Module Software Update*, and now the audio system **won't** turn on? We've gotten several reports from dealers of this happening.

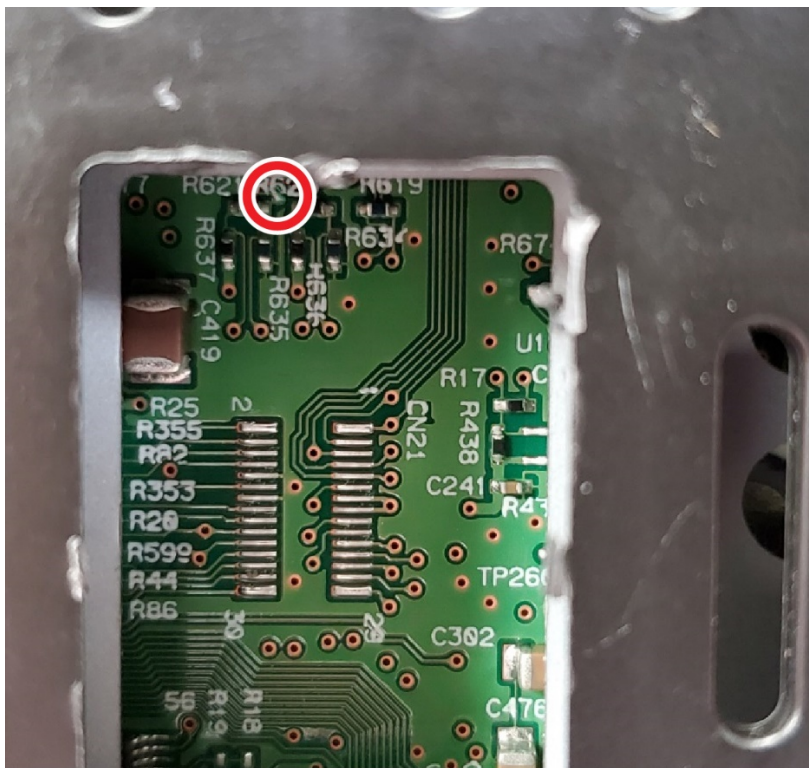
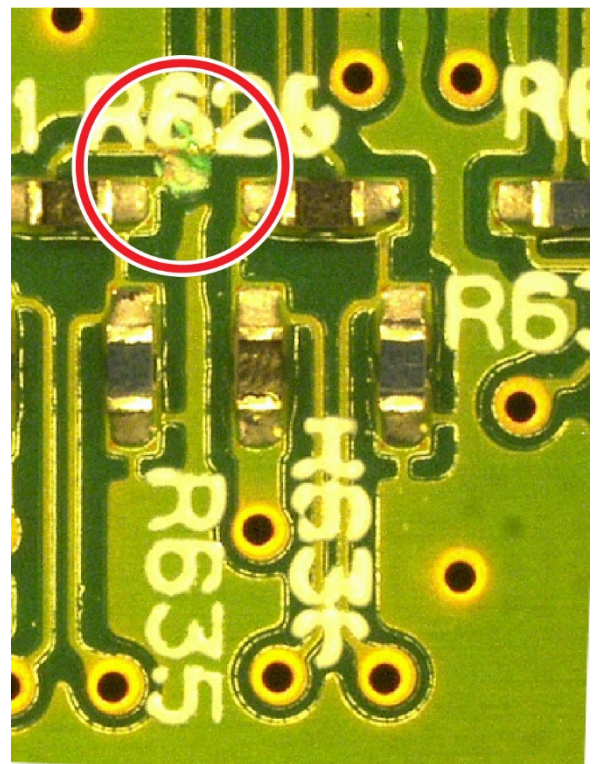
From our investigation of returned gauge control modules, we found the printed circuit boards were damaged. Here's a look and a closer look at one of those circuit boards. We've circled the damaged area in red.

We've concluded this damage happened when either removing the access cover from the back of the module or when lowering the pogo head onto the circuit board with the Z-axis control knob. You can easily damage this printed circuit board when doing either of those actions, so you need to be extra careful.

To remove the access cover, **always** use a small snipping tool (as called out in the bulletin) and make sure it doesn't contact the circuit board while you're snipping. **Never** use a screwdriver or a pry tool.

When lowering the pogo head onto the circuit board with the Z-axis control knob, turn the knob **slowly** and stop as soon as you feel the pogo head lightly contacting the circuit board. **Don't** keep turning the knob.
