Stop Sale: R 1250 GS, R 1250 GSA, R 1250 RT/RTP, S 1000 RR, S 1000 XR Caliper

Service Information Bulletin

34 02 20

ADVANCED INFORMATION: RECALL CAMPAIGN 20V-XXX CHECKING BRAKE CALIPERS

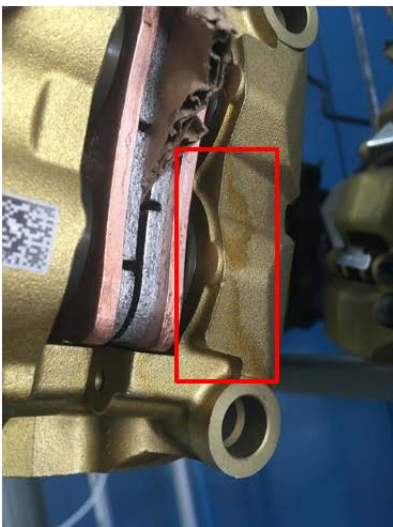
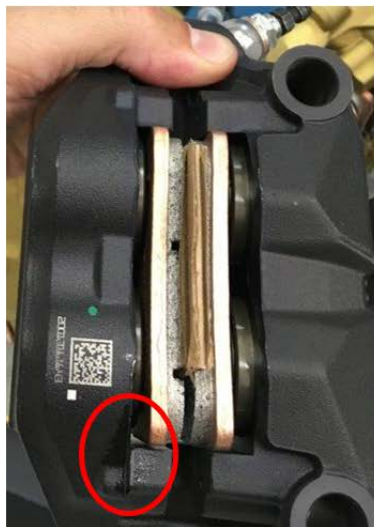
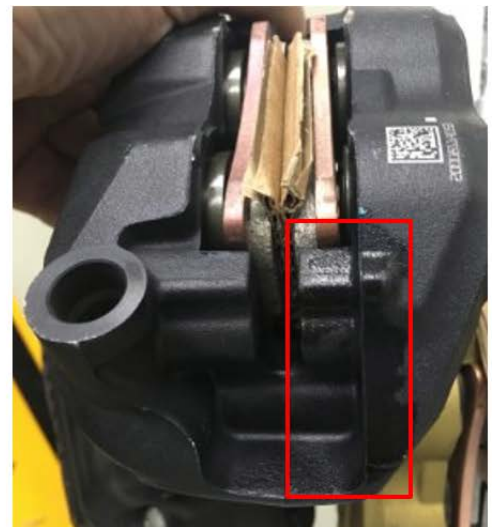
Examples of traces of brake fluid:

The front brake calipers may show slight sweat marks or isolated drops of brake fluid. Although this low-pressure leakage has been shown to have no effect on brake performance, BMW Motorrad is conducting a non-compliance recall to inspect each vehicle as the front brake calipers do not meet a Federal Regulation.

A visual inspection of the front brake calipers must be performed to check for staining or isolated drops. If traces of brake fluid are found on the outer surfaces, the calipers must be replaced. Calipers must always be replaced in pairs.

A TSARA case must be created for any vehicle requiring a caliper replacement. Within the case, clear pictures of the leakage must be included as well as pictures of the DOT matrix code. TSARA will evaluate the case and a parts order will be placed for your dealership by BMW . The TSARA case number will be used as the order reference number.
