Mercedes-Benz

Campaign No. 2020090006, October 2020

SUBJECT: **Model GLB-Class vehicles (247 platform)**  
**Model Year 2020**  
**Check Rear Spoiler**

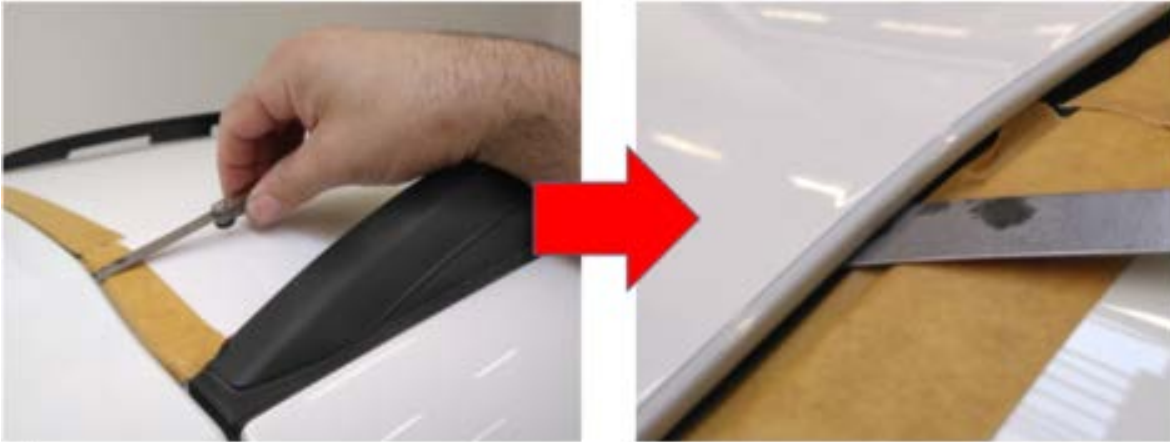
Figure 3 (OK)

3. Carefully attempt to slide the gauge between the outer shell and the spoiler lip.

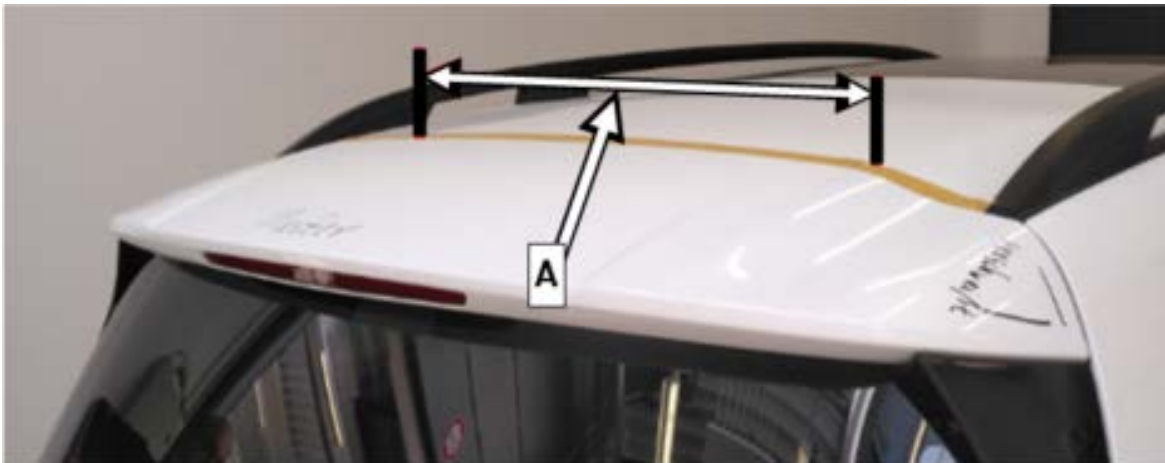
Figure 4

**i** The test must be performed along the length shown (A, Figure 4), starting from the roof center and extending approx. 100 mm to the left and right roof railings.

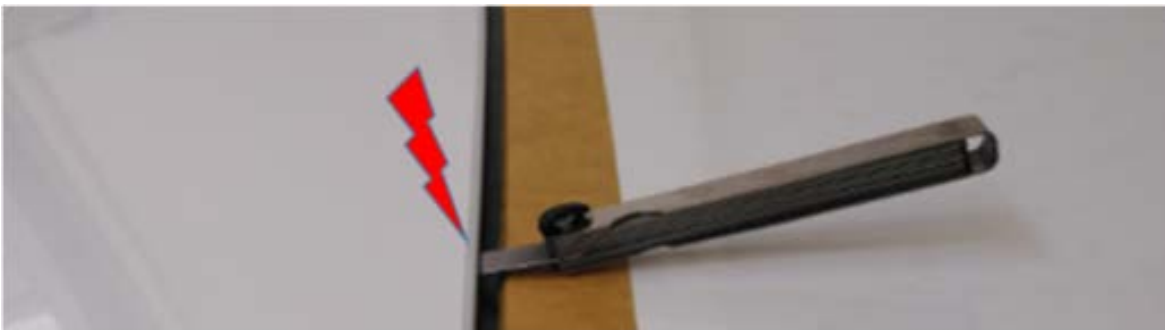
Figure 5 (not OK)

**i** It **must not be possible** to slide the gauge between the spoiler lip and the outer shell of the center rear spoiler. (Figure 5, not OK)

- a. The gauge can be inserted between the spoiler lip and the outer shell or the spoiler lip can be detached from the outer shell or is damaged: Carry out **work procedure A**. (includes work procedure B operation steps)
- b. The spoiler lip brushes heavily against the sealing seam: Carry out **work procedure B**.
- c. The center retaining clip is loose: Carry out **work procedure C**.
- d. No fault on center rear spoiler: **End measure**.

1. Replace center rear spoiler (**AR72.20-P-4000MFD**).

**i** Also replace mounting screws, retaining clips, and adhesive strips.

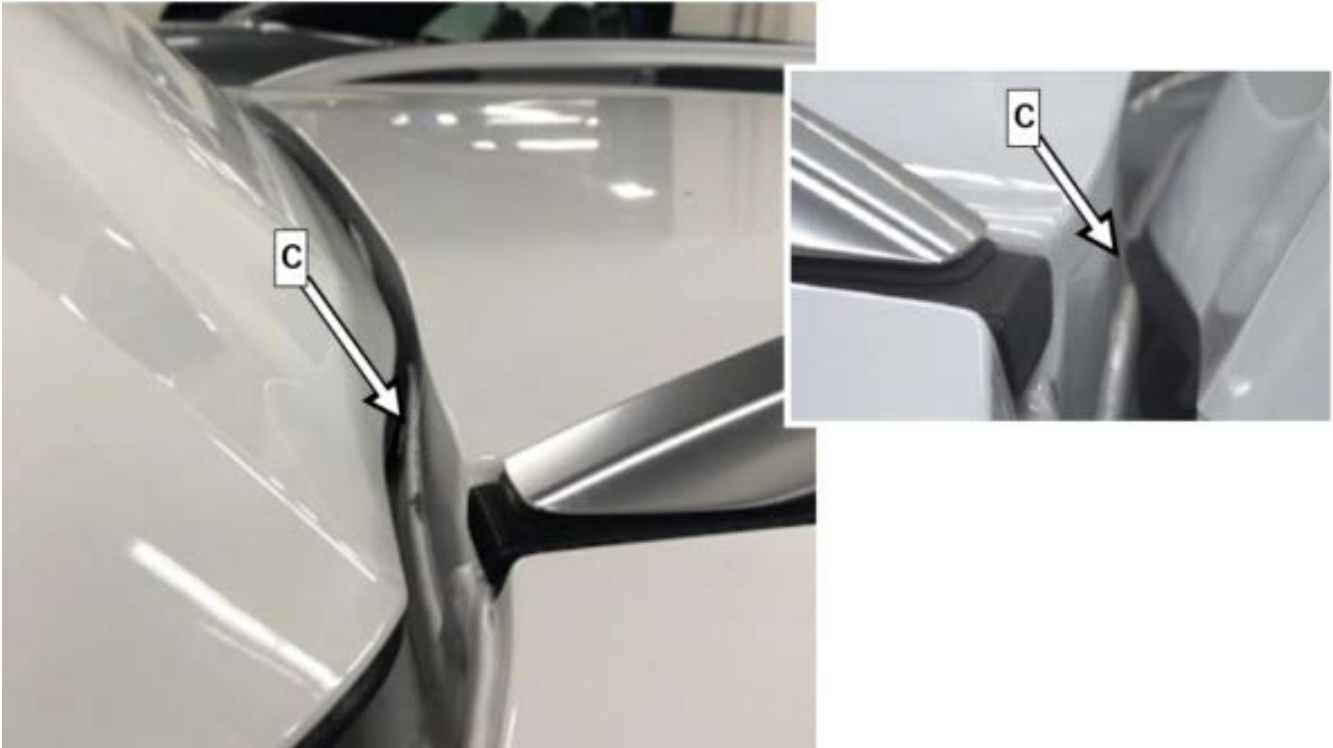
Figure 8

6. Open and close tailgate and check whether the spoiler lip brushes against the seam seal in the area of the roof edge (C, Figure 8).

- i** Minimal brushing without the spoiler lip snapping is acceptable.
- i** The test must be performed along the entire length of the seam seal.
- i** Should the spoiler lip have been damaged by the collision the complete center rear spoiler must be replaced.

2. Check again whether the spoiler lip brushes against the seam seal in the area of the roof edge (**C, Figure 8**).

**i** Minimal brushing without the spoiler lip snapping is acceptable.

**i** The test must be performed along the entire length of the seam seal.

**i** Should the spoiler lip still brush heavily against the seam seal, the seam seal must be removed or replaced in the collision area. (To do this, the tailgate must be removed)

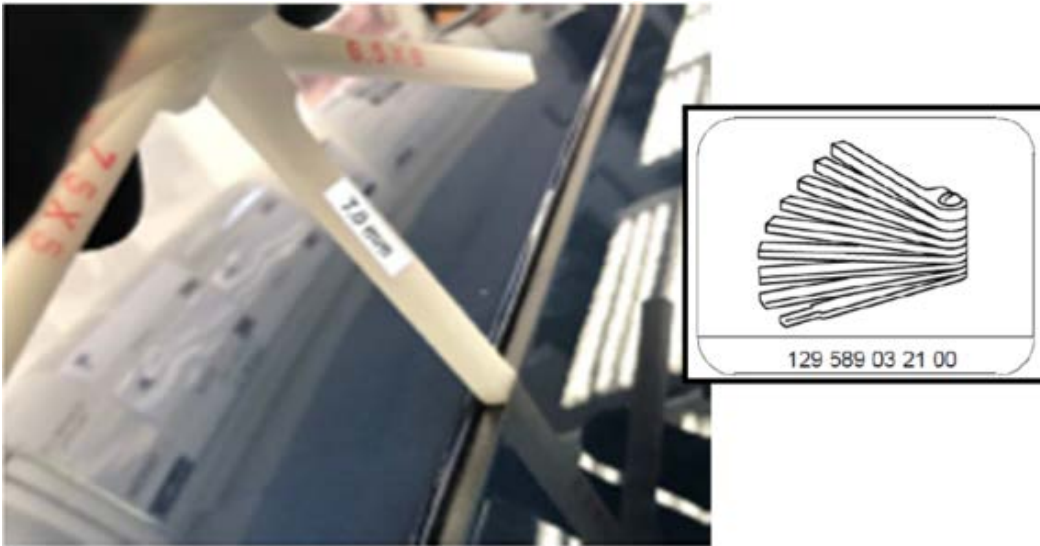
Figure 10

1. Adjust gap dimension between tailgate and roof edge to **7 mm**.
