# Safety Recall

## Code: 72K9

**Subject** Front Seat Backrest Frame Welds

**Release Date** September 4, 2020

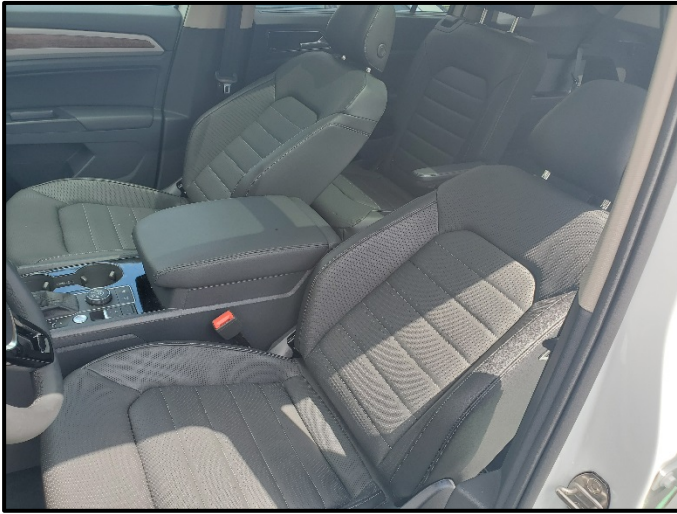
- Fully recline left front and right front seats.

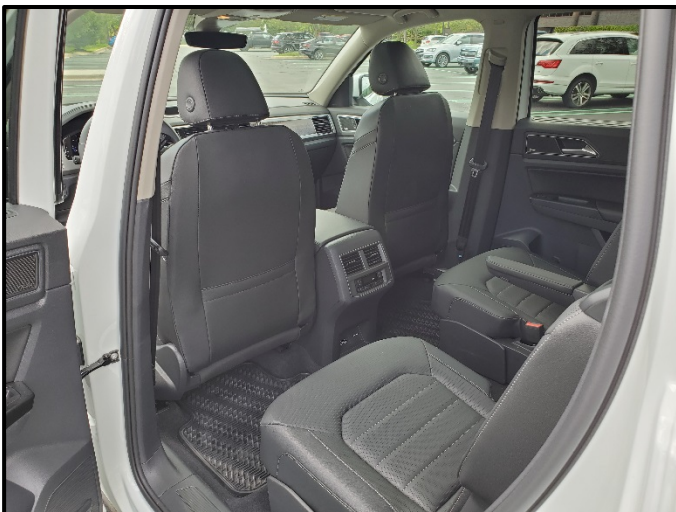
- Bring the seats to the fully upright and forward position.

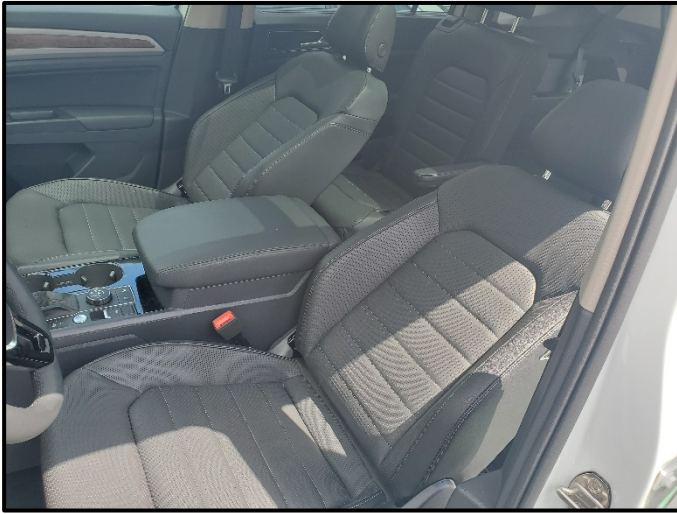
- Fully recline left front and right front seats.

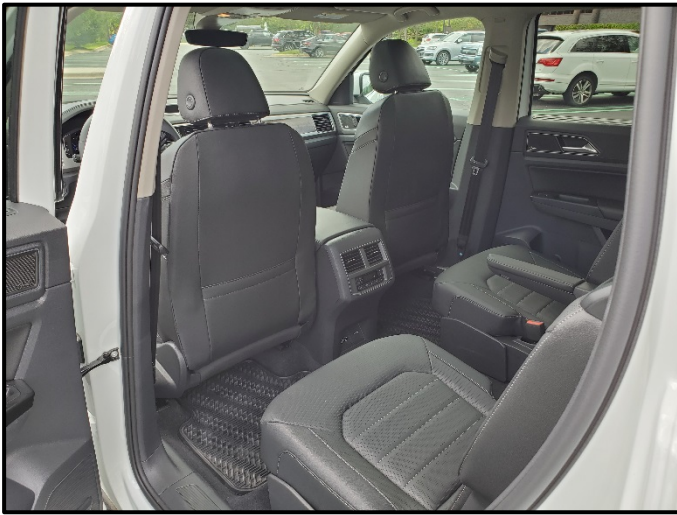
- Bring the seats to the fully upright and forward position.
