Safety Recall

Code: 72L1

Subject Front Seat Backrest Frame Welds

Release Date September 4, 2020

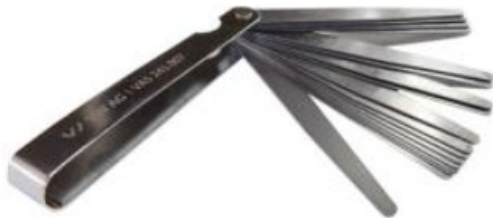
Feeler Gauge
(locally sourced)

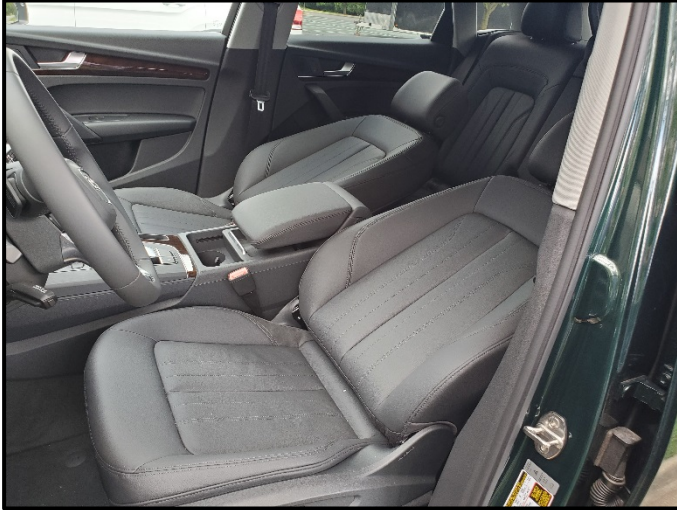
Section B – Inspecting Seat Frames

- The inboard and outboard recline mechanisms must be inspected on both front seats.
- The inspection must be done with the seats fully reclined and with the seats in the fully upright position.
- Fully recline left front and right front seats.

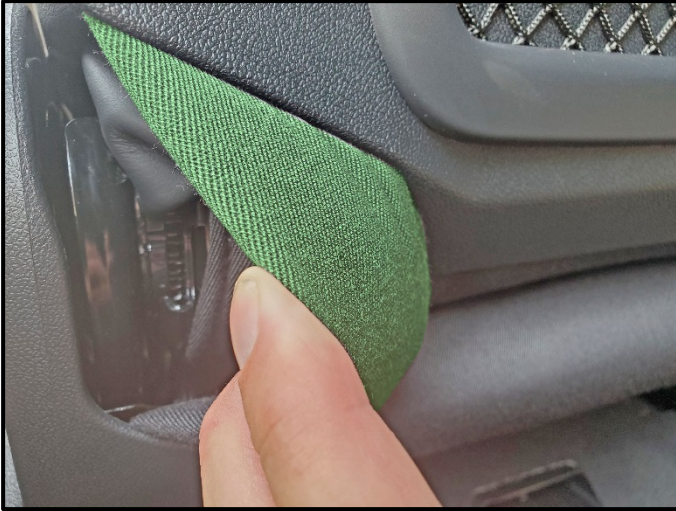
Method 1:

- Carefully pull the fabric away from the recline mechanism.
- If the fabric cannot be pulled away without potentially damaging the fabric, or if the recline mechanism cannot be accessed, use method 2 to access the recline mechanism.

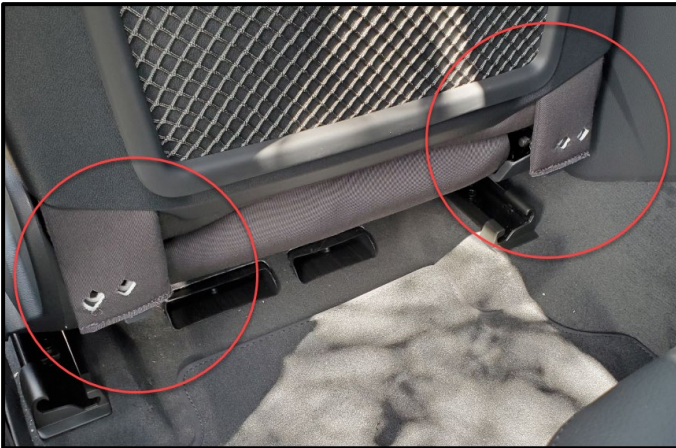
Method 2:

- Carefully pull away the plastic side trim from the backrest and remove the fabric trim from behind the seat trim.
