Safety Recall

Code: 72K8

Subject Front Seat Backrest Frame Welds

Release Date September 4, 2020

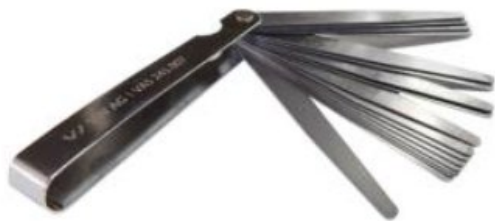
Feeler Gauge
(locally sourced)

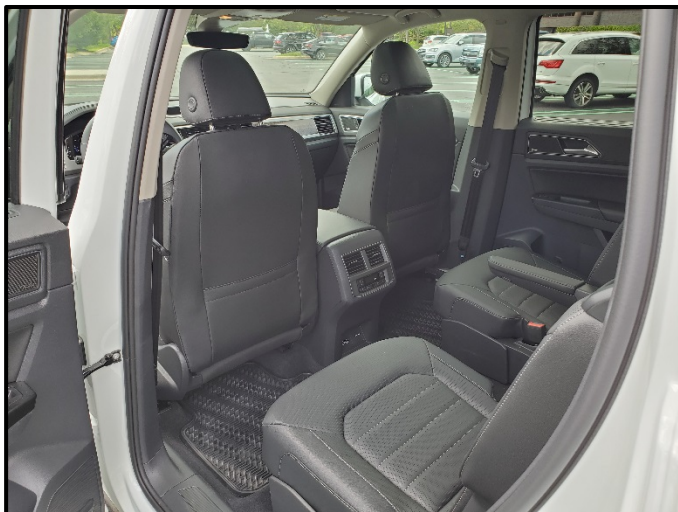
- Bring the seats to the fully upright and forward position.

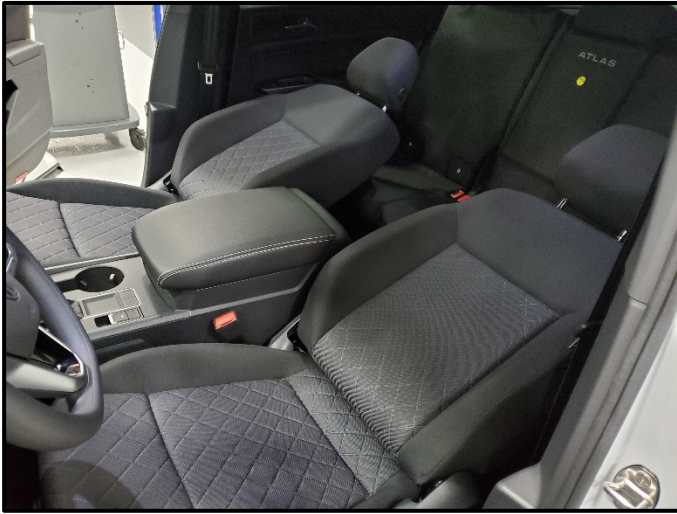
- Fully recline left front and right front seats.

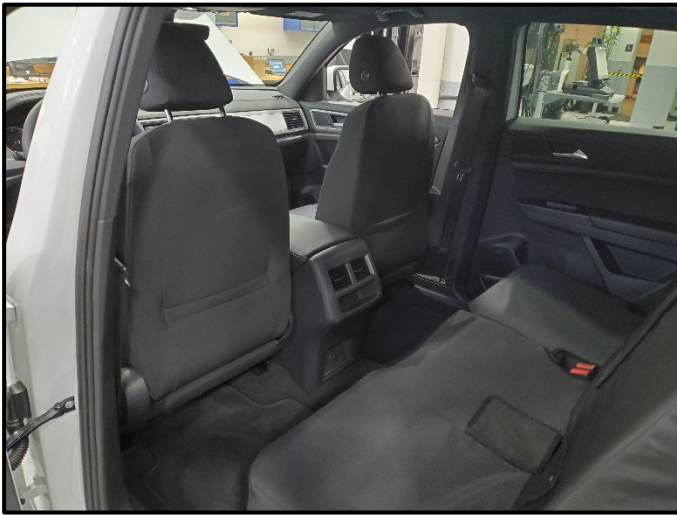
- Bring the seats to the fully upright and forward position.
