SIB 63 04 20

RECALL 20V-528: HEADLAMP (SCENIC-LIGHT) LENS

Non-Compliance Recall
20V-528
Headlamp (Scenic-Light) Lens
Model Year 2020-2021
BMW SAVs (X5, X5M, X6, X6M, X7)
Issue Date: 08/26/2020
Last Update: 08/26/2020

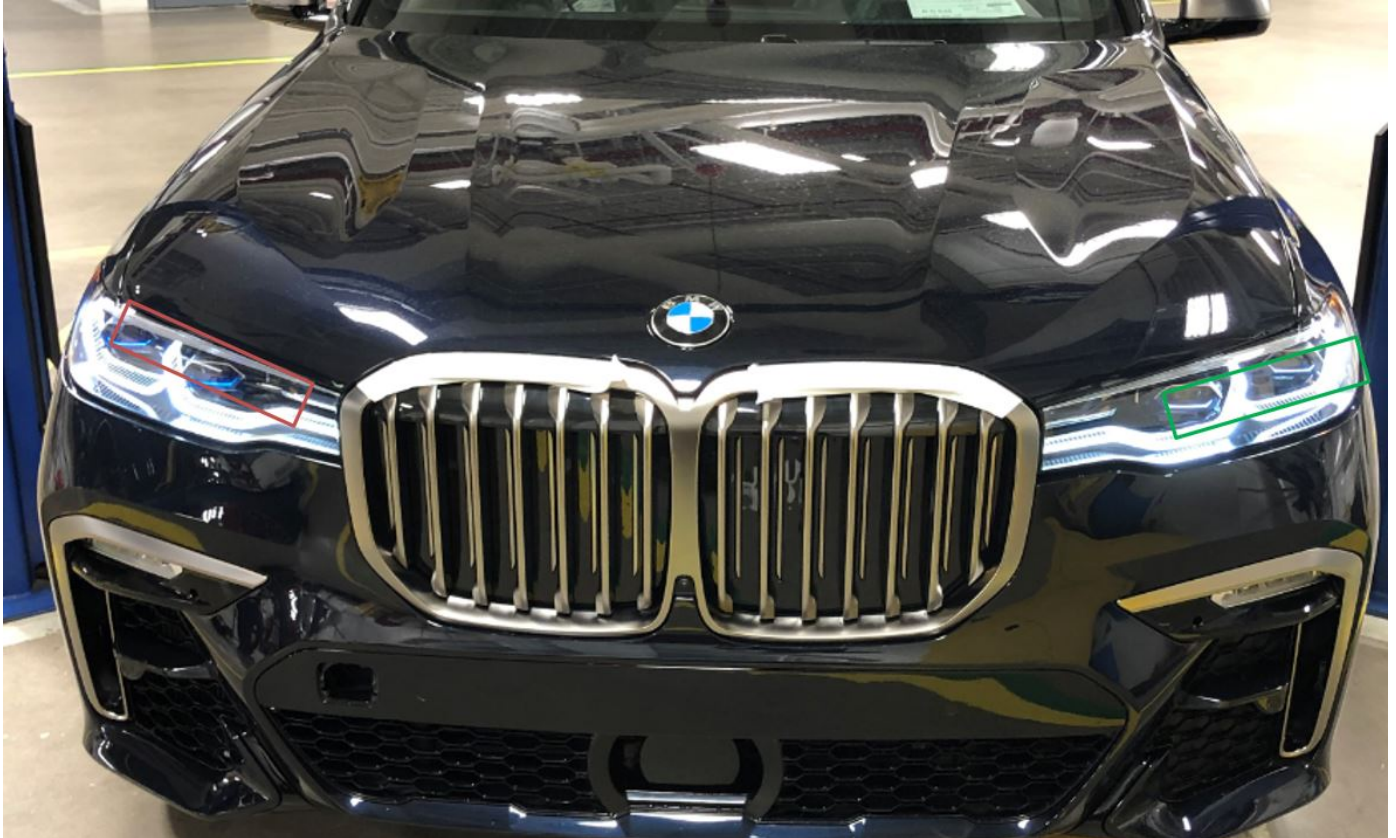
The left and/or right headlamp may contain a specific version of the “scenic-light” lens which allows for blue light to illuminate. This lens may not meet a Federal requirement, because the blue light is outside of the allowable light color spectrum.

1. Adjust the headlight switch so that only the parking lights (halos) are set to “on”. Ensure the headlights are turned OFF. Inspection will not be possible with the headlights on.
2. Inspect the color of the light emitted from the X shaped finisher within the headlight. The photo below shows an example of a vehicle with one blue light on the passenger side (NOT OK) and one white light on the driver side (OK).

No: Replace whichever headlight is emitting the blue light following the applicable repair instructions within ISTA for the model of vehicle being repaired.
