SAFETY RECALL

VOLVO Trucks North America
Greensboro, NC USA

Date	Number	Page
09/20	RVXX2004	1 (31)

Pedal Carrier Date Code Inspection

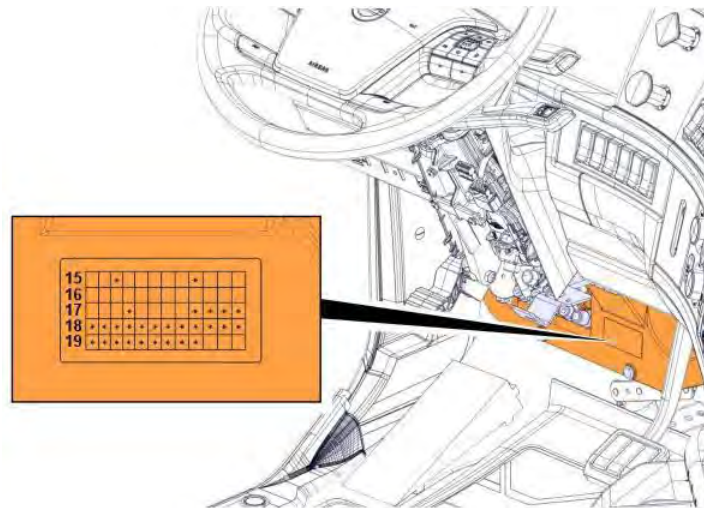
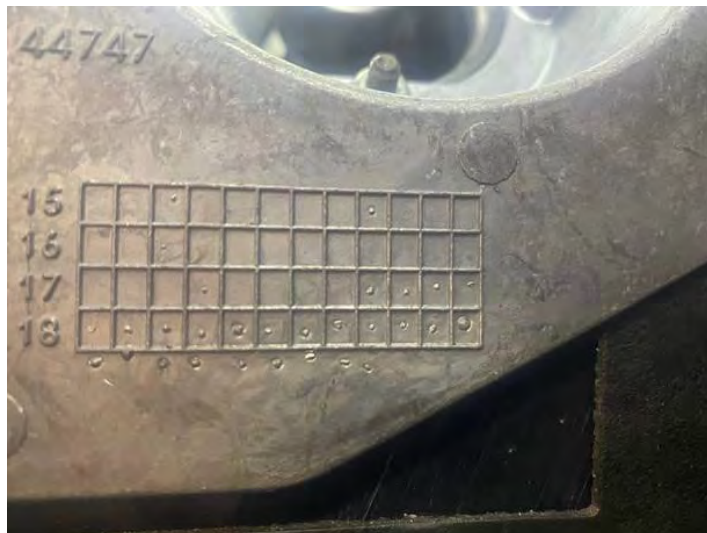
23. Check the date code on the pedal carrier.

Note: A) Find the row which indicates the year.

For example: the row under 18 is 19 and indicates year 2019.

B) Count the number of dots or the position of the dots.

For example: One dot in the first position is January.

Photo shows an example of September, 2019 date code

24. If the date code shows 9 or 10 dots in row 19 this indicates September, 2019 or October, 2019. Then continue to the Test Procedure next.

25. If date code IS **NOT** 9 or 10 dots, then replace all removed components in reverse order and return the truck to service. File claim as Part "A" Only.

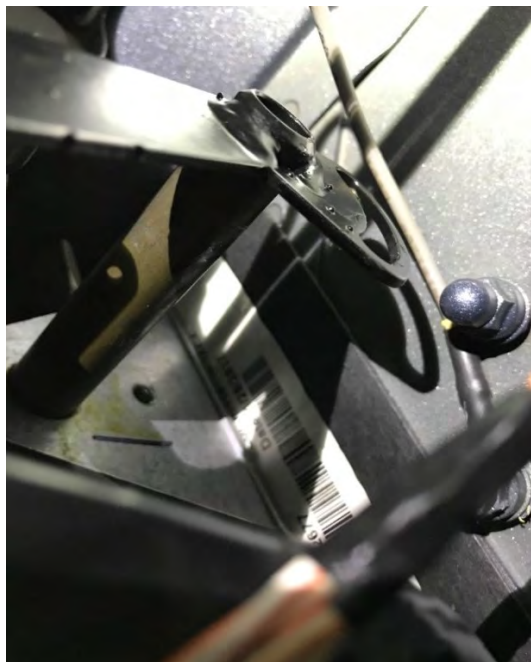
3. Remove the bolt.
4. Pull the brake pedal shaft out enough to inspect casting.

- From the driver's perspective; thoroughly inspect both sides of the right most ear for possible defects. The defects seem to resemble a crack with some discoloration. Use examples below to determine defective parts See Fig. 1 and Fig. 2 (circled line/cracks show the signs of defective parts)

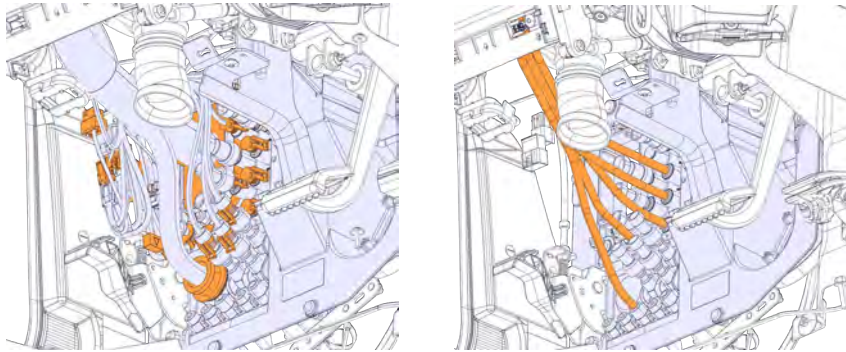
20. Label and take photos of all electrical and air connections on the pass-through.

Electrical and Pneumatic connections inside the cab

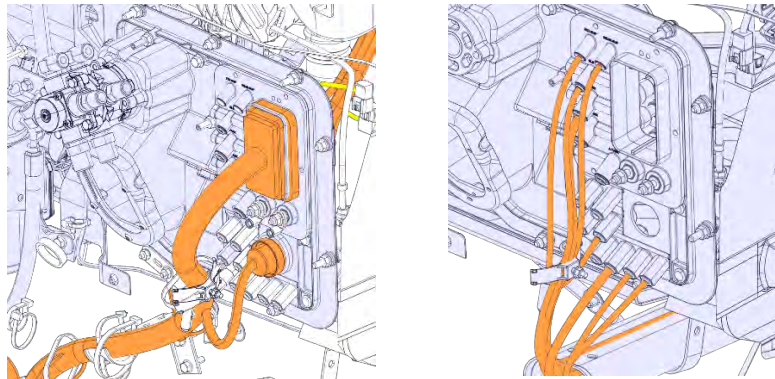
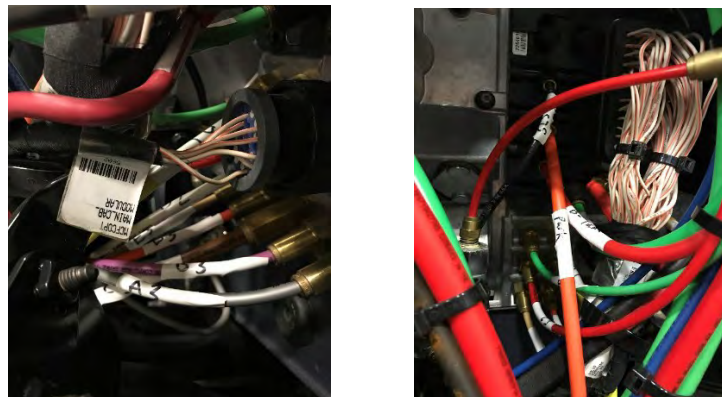
Electrical and Pneumatic connections outside of the cab
(Engine compartment)

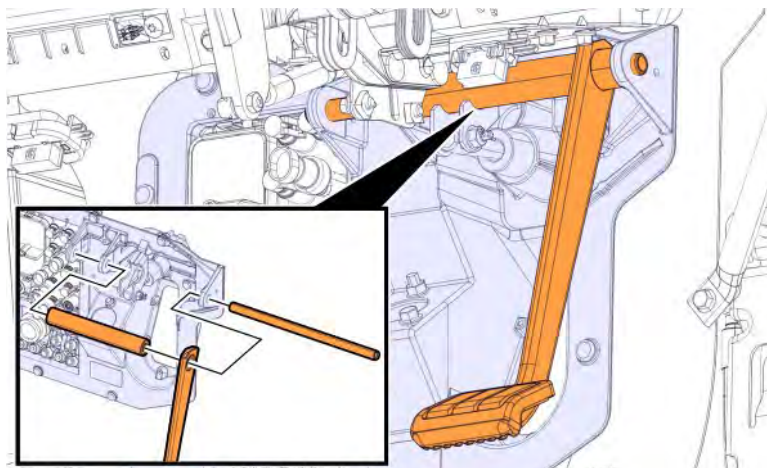
29. Remove the brake pedal and brake pedal shaft from the pedal plate.

Note: The pedal plate will not clear the steering column brackets without removing the brake pedal.

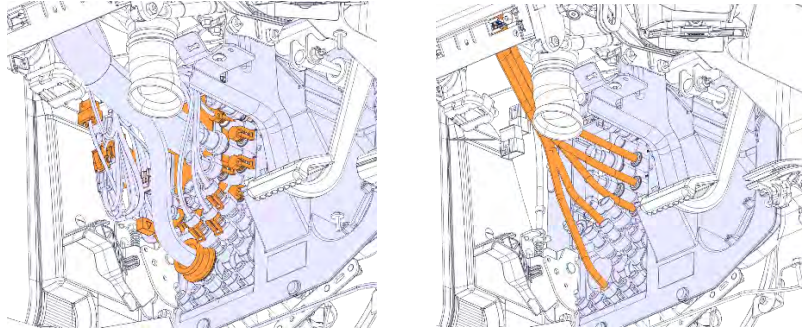
Electrical and Pneumatic connections inside the cab

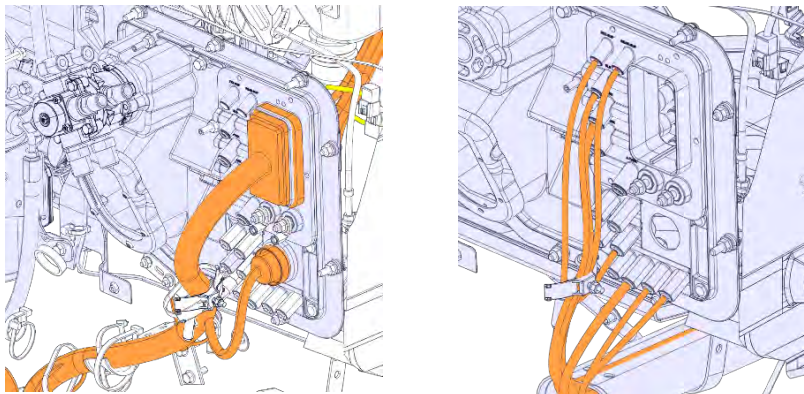
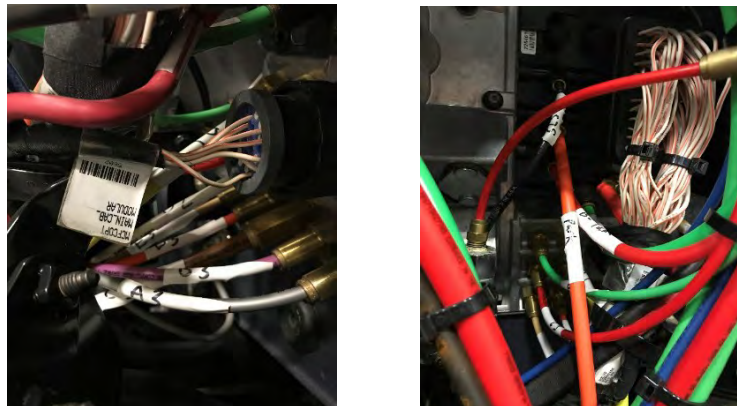
Electrical and Pneumatic connections outside of the cab
