Keystone RV Company

SAFETY ADVISORY # 20-386

Yukon Egress Window Crank

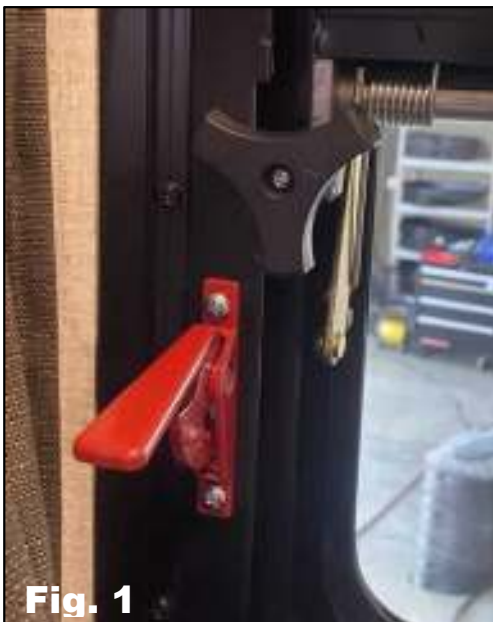
Fig. 1

Locate the bedroom egress window. Figure 1

The remedy is to replace the black round knob on the bedroom egress window with the narrow crank handle.
