Mercedes-Benz

Campaign No. 2020090020, October 2020

SUBJECT: **Model GLB-Class vehicles (247 platform)**
Model Year 2020
Catch Mechanism Second Row Seat

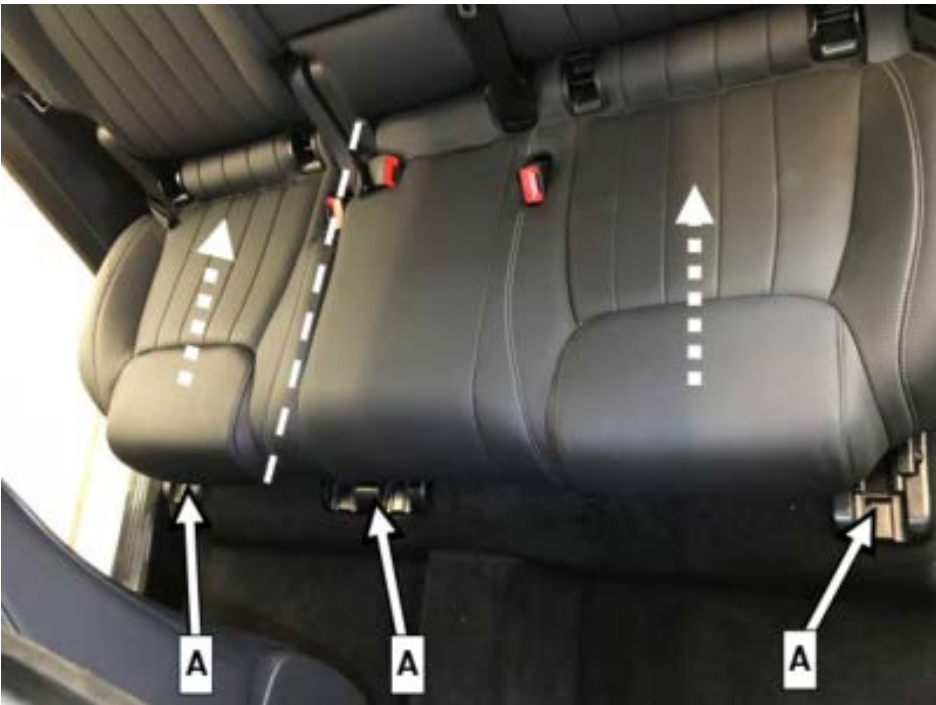
Figure 1

2. Remove covers (**A**, figure 1).

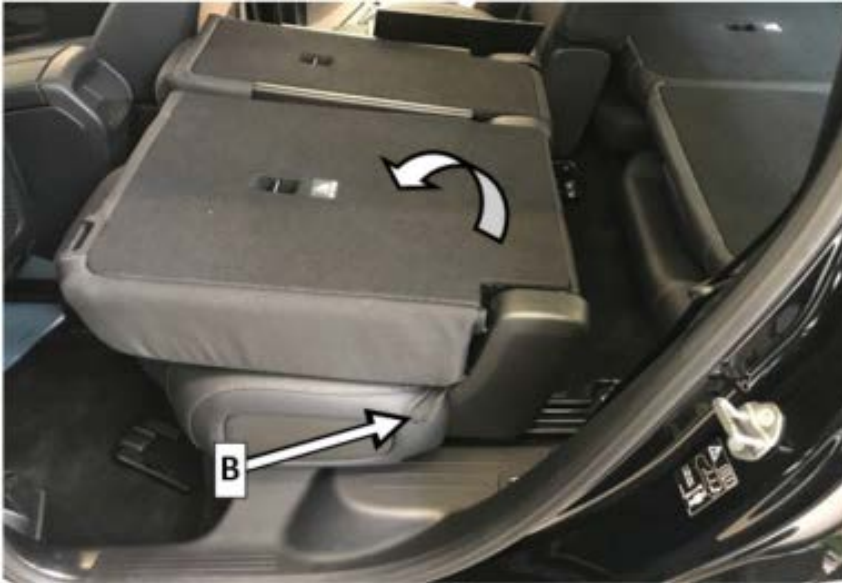
Figure 2

4. Fold seat backrest forward.
 - i** Release seat backrest by **pulling the loop (B, figure 2)** and fold forward.
 - i** Do **not** release seat backrest via handle at top on seat backrest.

- i** Release seat backrest by **pulling the loop (B, figure 2)** and fold forward.
- i** Do **not** release seat backrest via handle at top on seat backrest.

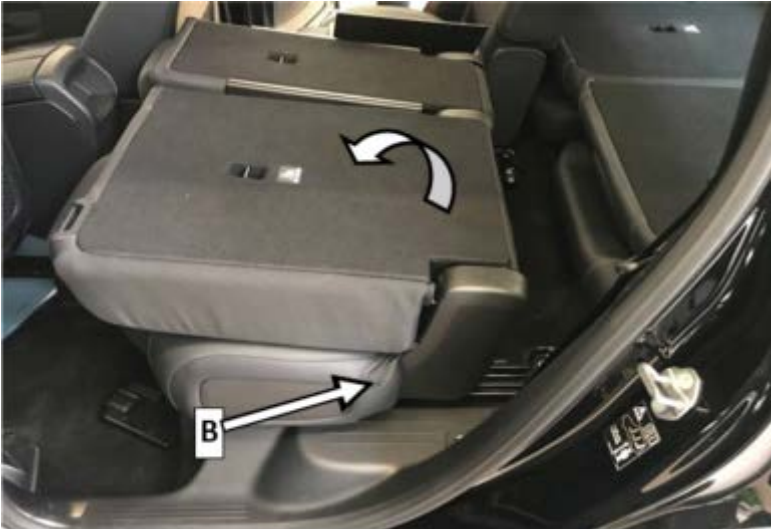
Figure 3

12. Fold seat backrest forward.

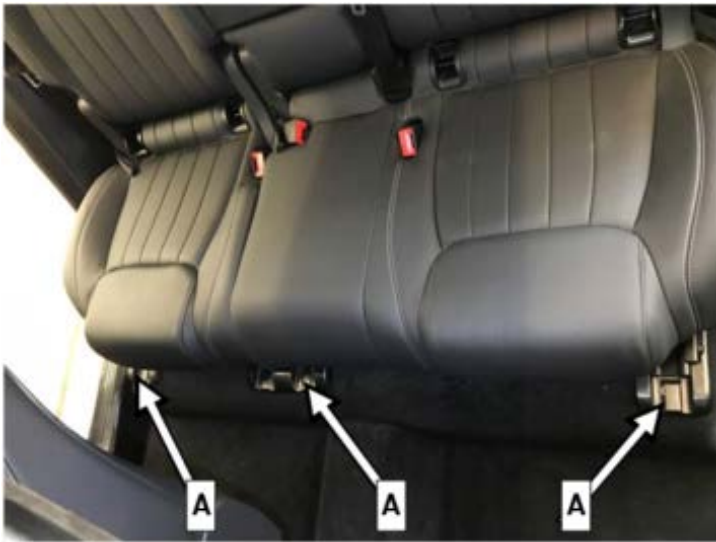
Figure 4

16. Install covers (A, figure 4).
