Revision (1) January 2021

Dealer Service Instructions for:

## **Safety Recall W67 / NHTSA 20V-580 Front Seat Belt Retractor**

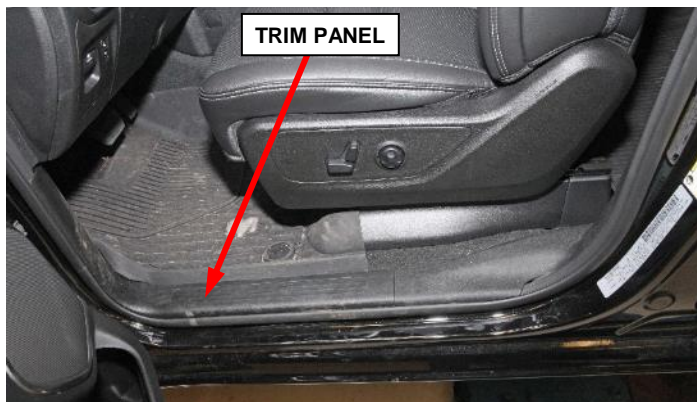
**Figure 3 – Cowl Trim Panel**

7. Using a trim stick or equivalent, disengage the retainer clips securing the cowl trim panel from the door sill (Figure 3).

8. Pull the cowl trim panel rearward and remove it from the vehicle (Figure 3).

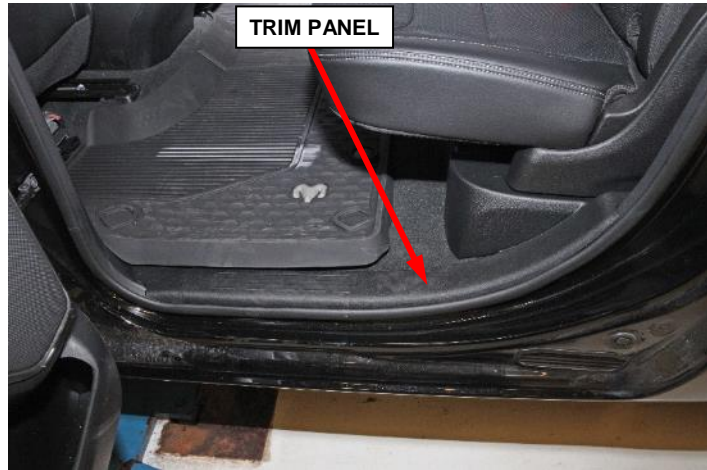
**Figure 4 – Rear Door Sill Trim Panel**

9. Using a trim stick or equivalent, release the retaining clips and lift the rear door sill trim panel near the B-pillar. It is not necessary to fully remove the door sill trim panel from the vehicle (Figure 4).

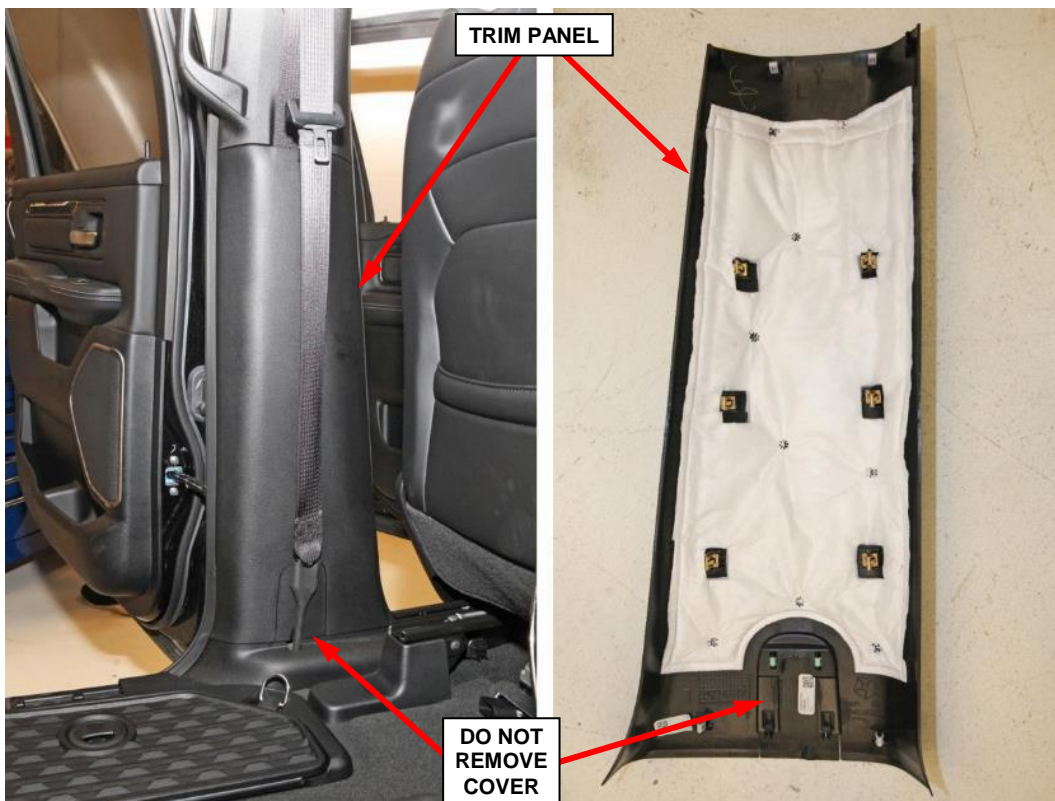
**Figure 5 – B-Pillar Middle Trim Panel**

10. Using a trim stick or equivalent release the retaining clips and remove the B-pillar middle trim panel as one piece. It is not necessary to remove the access cover from the trim panel (Figure 5).

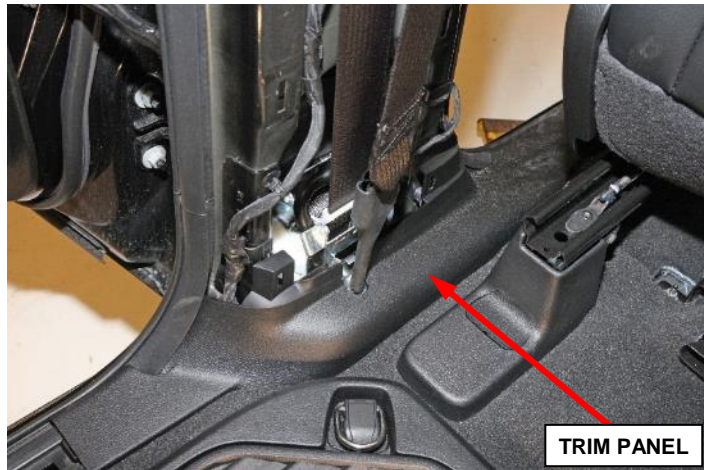
**Figure 6 – B-Pillar Lower Trim Panel**

11. Using a trim stick or equivalent release the retaining clips and remove the lower B-pillar trim panel (Figure 6).

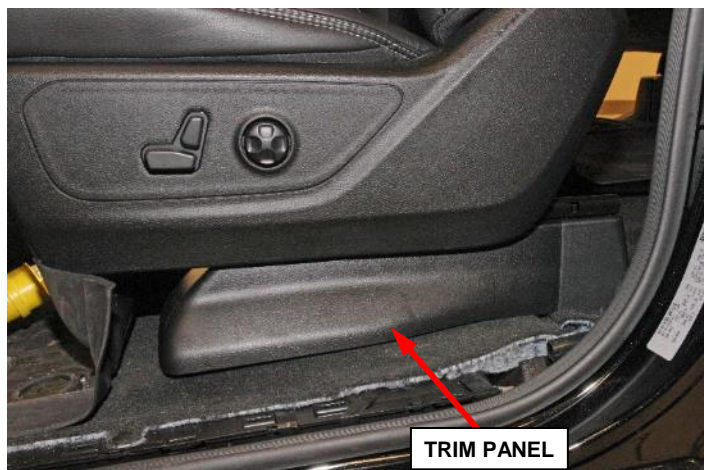
**Figure 7 – Seat Track Outboard Trim Panel**

12. Using a trim stick or equivalent release the retaining clips and remove the outboard seat track side trim panel (Figure 7).

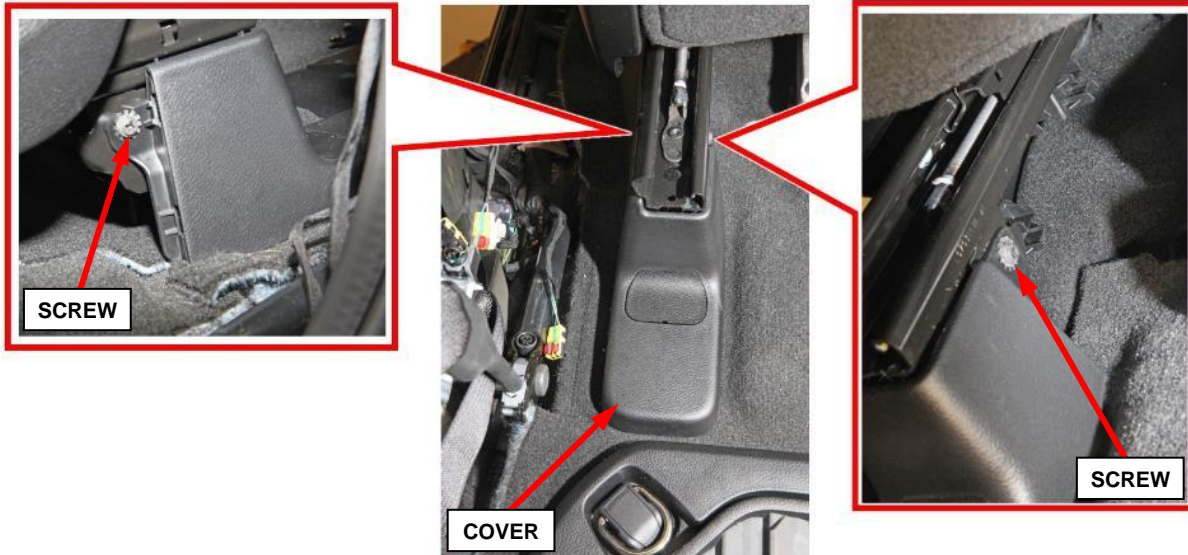
**Figure 8 – Seat Track Outboard Rear Trim Cover**

- Remove the two retaining screws then remove the outboard seat track rear trim cover (Figure 8).

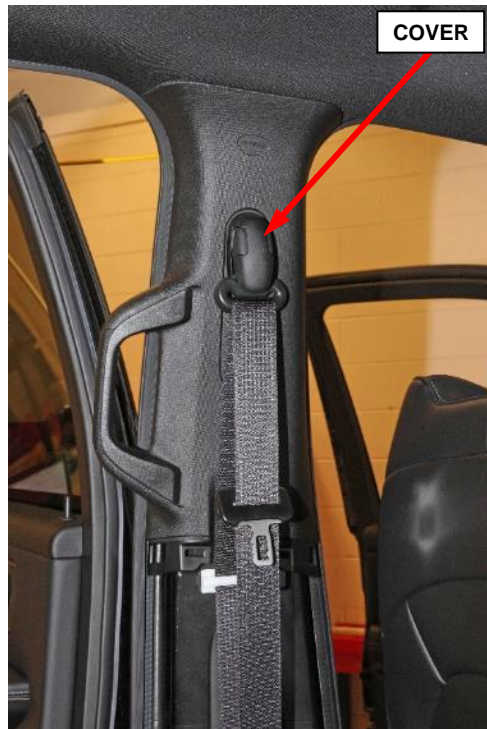
**Figure 9 – Seat Belt Height Adjuster Cover**

- Squeeze the release buttons together and gently unsnap the trim cover from the height adjuster on the upper B-pillar to access the front seat belt turning loop mounting nut (Figure 9).

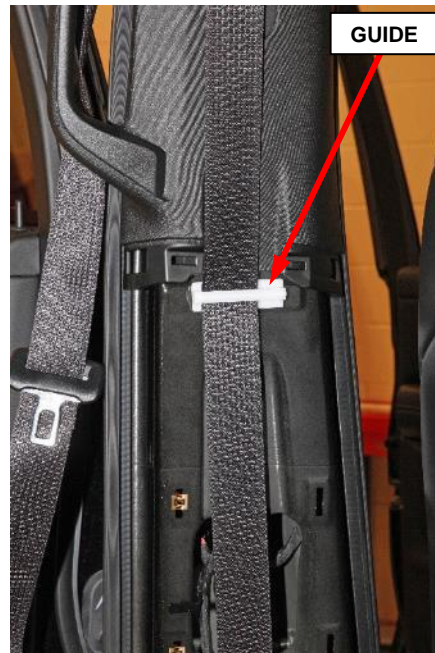
**Figure 10 – Seat Belt Webbing Guide**

15. Release the seat belt webbing guide from the B-pillar (Figure 10).

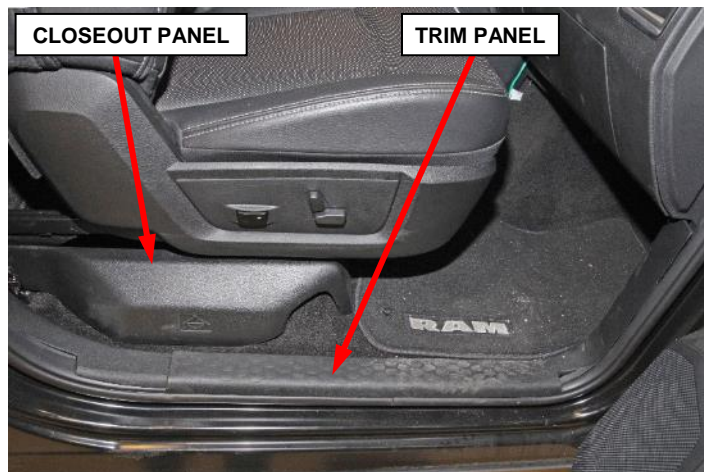
**Figure 17 – Seat Track Closeout Panel and Cowl Trim Panel**

7. Remove the seat track closeout panel (Figure 17).

8. Using a trim stick or equivalent, release the retaining clips and lift the cowl trim panel in the front door sill area. The cowl trim panel does not require removal from the vehicle (Figure 17).

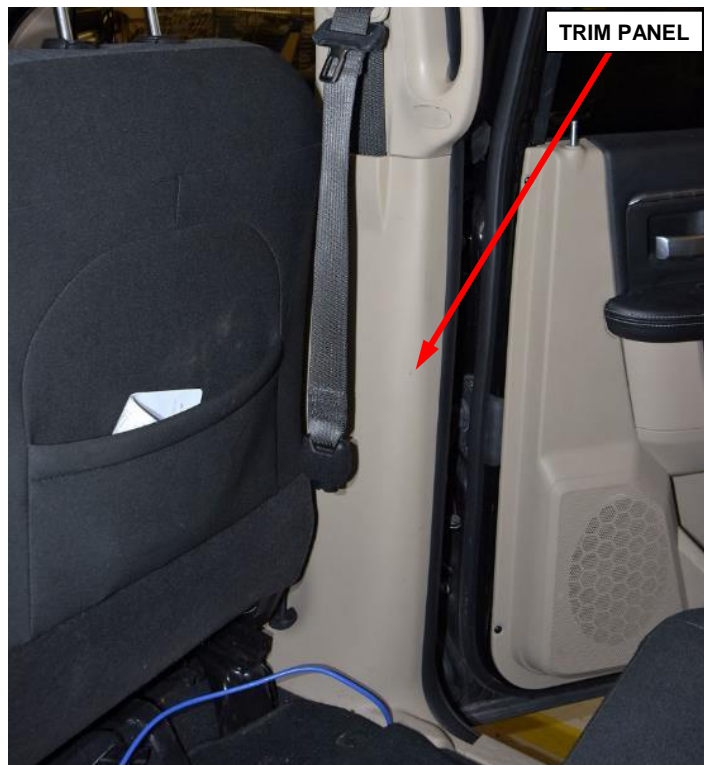
**Figure 20 – B-Pillar Lower Trim Panel**

- Using a trim stick or equivalent, release the lower B-pillar trim panel retaining clips from the B-pillar. Then slide the tensioner cable through the slot on the lower B-pillar trim panel while removing the lower B-pillar trim panel from vehicle (Figure 20).

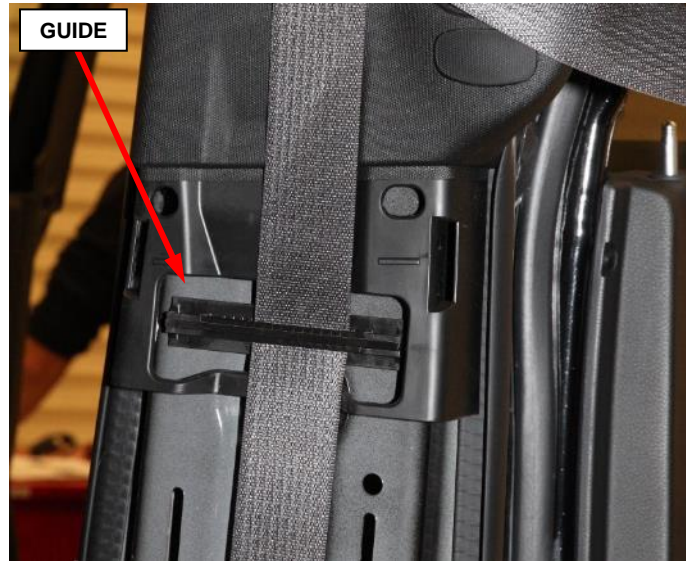
**Figure 21 – Seat Belt Webbing Guide**

12. Release the seat belt webbing guide from the B-pillar (Figure 21).

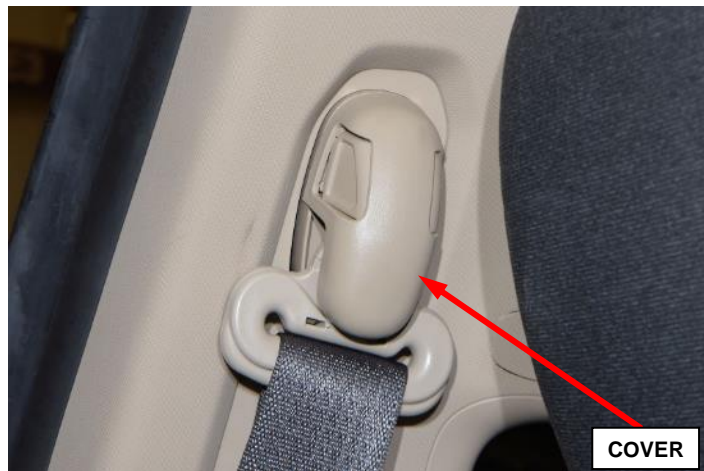
**Figure 22 – Seat Belt Height Adjuster Cover**

13. Firmly grasp the top of the trim cover for the front seat belt height adjuster on the B-pillar and pull it away from the height adjuster far enough to unsnap it, then disengage the lower snap features of the trim cover from the height adjuster (Figure 22).

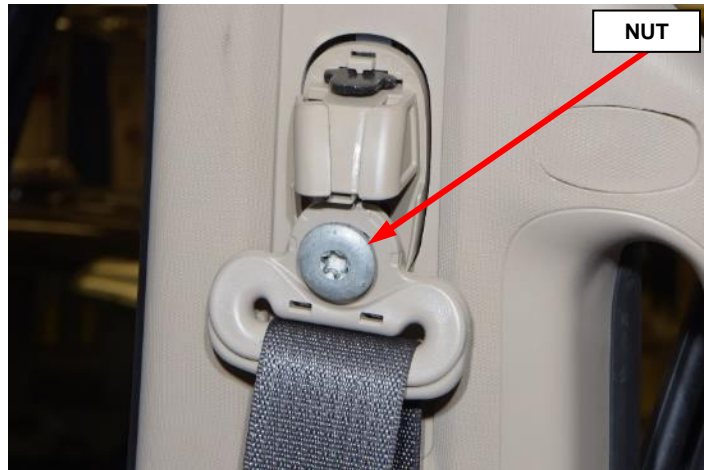
**Figure 23 – Seat Belt Turning Loop**

14. Remove the bolt with seat belt turning loop from the height adjuster on the B-pillar (Figure 23).

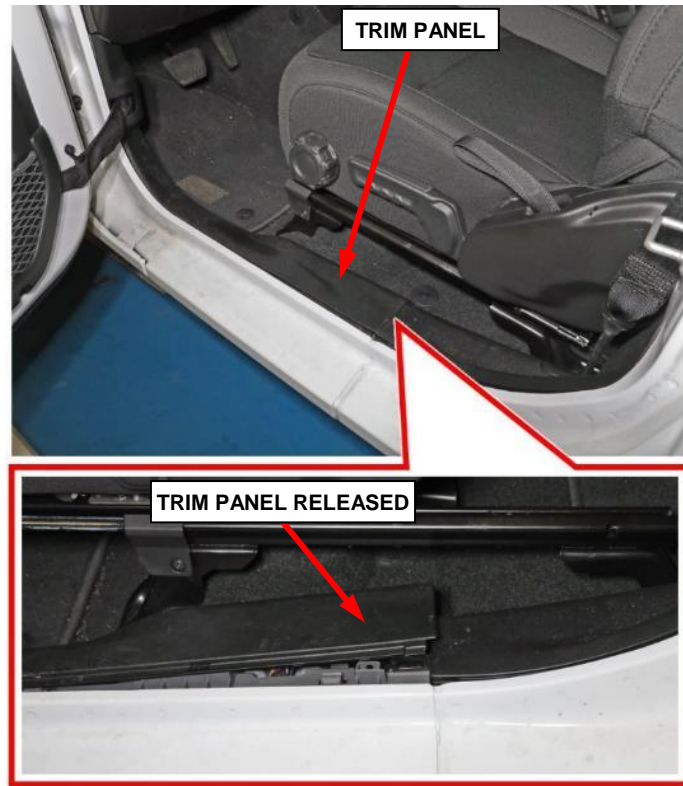
**Figure 31 – Cowl Trim Panel**

7. Using a trim stick or equivalent, release the retainer clips and lift the rear portion of the front door opening cowl trim panel (Figure 31).

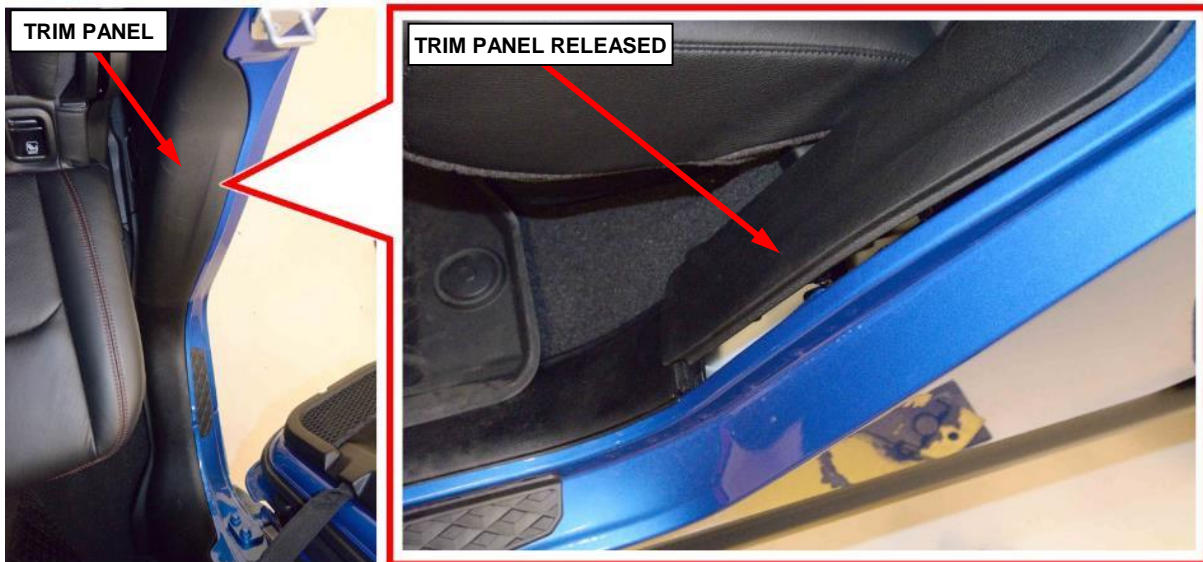
**Figure 32 – (JT) Gladiator ONLY: Quarter Trim Panel**

8. **(JT) Gladiator ONLY:** Using a trim stick or equivalent, release the retainer clips and lift the front portion of the rear door opening quarter trim panel (Figure 32).

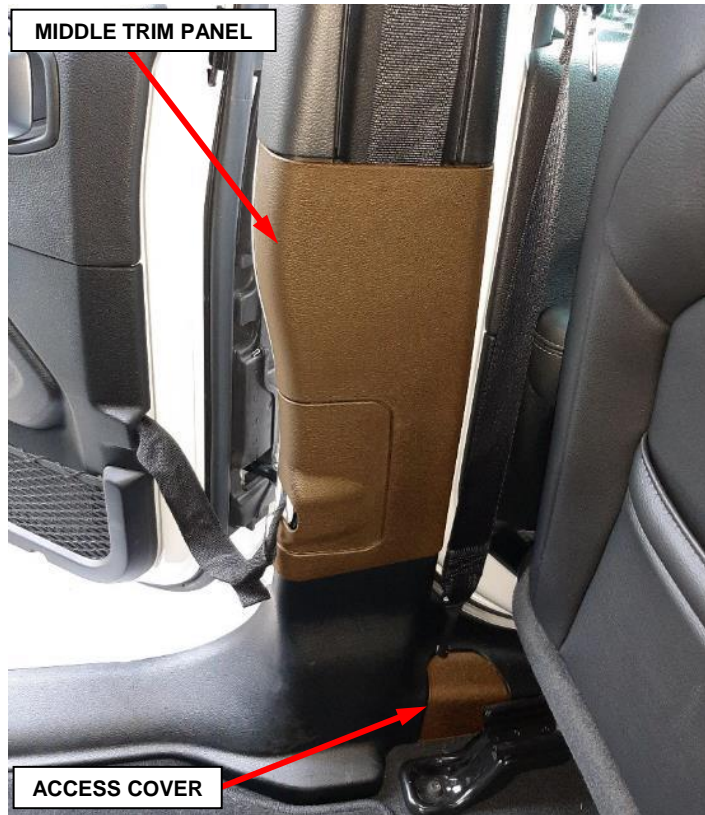
**Figure 33 – (JT) and (JL) 4-Door ONLY: B-Pillar Middle Trim Panel and Seat Belt Access Cover**

10. **(JL) 4-Door Wrangler and (JT) Gladiator ONLY:** Using a trim stick or equivalent, remove the B-pillar seat belt access cover (Figure 33).

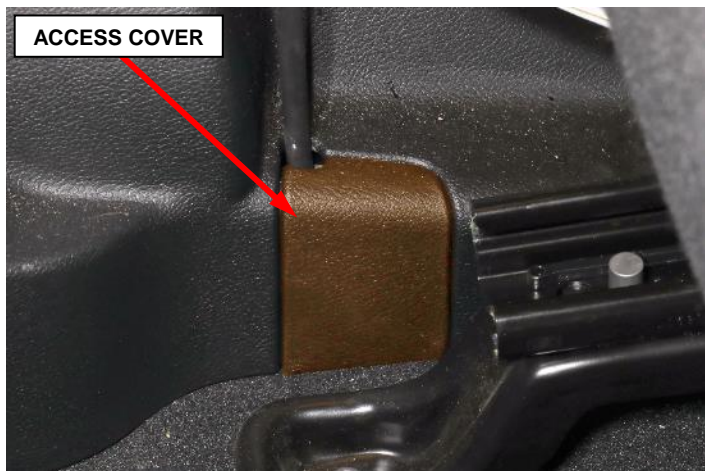
**Figure 34 – (JL) 2-Door ONLY: B-Pillar Seat Belt Access Cover**

11. **(JL) 2-Door Wrangler ONLY:** Using a trim stick or equivalent, remove the B-pillar seat belt access cover (Figure 34).

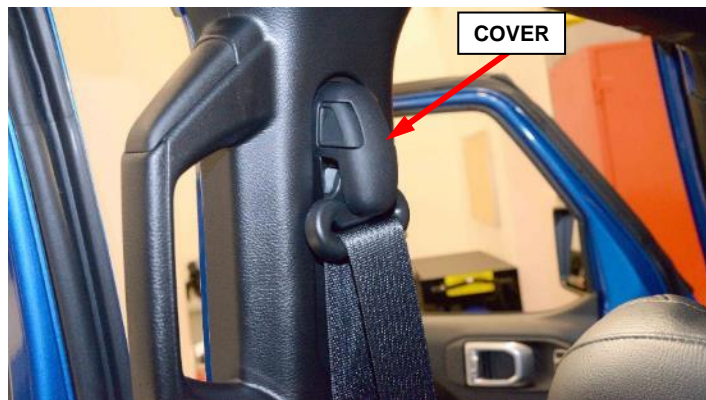
**Figure 38 – Seat Belt Height Adjuster Cover**

17. Remove the protective cover from over the nut for the seat belt height adjuster (Figure 38).

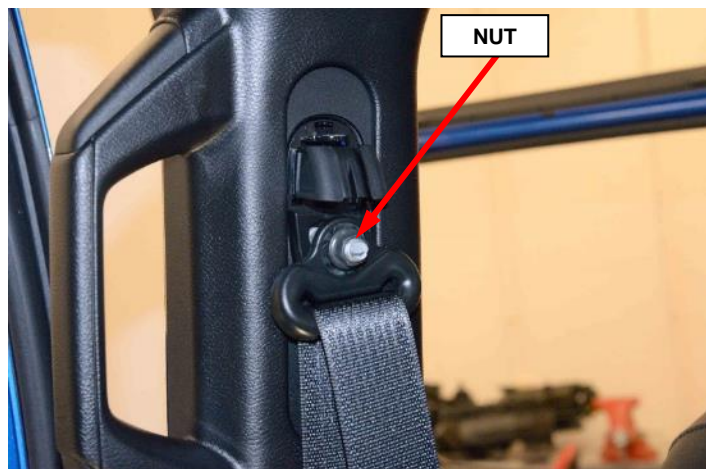
**Figure 39 – Seat Belt Turning Loop**

18. Remove and **SAVE** the nut that secures the seat belt turning loop to the height adjuster (Figure 39).

19. Remove the seat belt turning loop from the height adjuster (Figure 39).

29. Install the bolt that secures the tensioner to the B-pillar. Tighten the bolt to 45 N·m (33 ft. lbs.). Ensure the tensioner is held securely after tightening. If the tensioner can be rotated easily, increase the torque by as much as additional 9 N·m (7 ft. lbs.) if necessary (Figure 41).
30. Connect the two wire harness connectors to the retractor and the tensioner (Figure 40).
31. Wipe clean the height adjuster turning loop stud threads to remove any loose debris (Figure 39).
32. Position the seat belt turning loop to the height adjuster (Figure 39).
