Driver and Passenger 6way Power seats –wire routing and circuit protection

Bulletin Type:	Safety Recall
Bulletin #s:	20V-600 US Units 2020-476 CN Units
Job Code:	9903521
Flat Rate(s):	RC024 1.5 Hrs. Inspect, add loom, add 2 Breakers RC025 1 Hr. Inspect and Add 2 Beakers

Publication Date:	December 04, 2020
Make:	Entegra
Models:	Aspire Anthem Cornerstone Reatta XL
Model Years:	2021

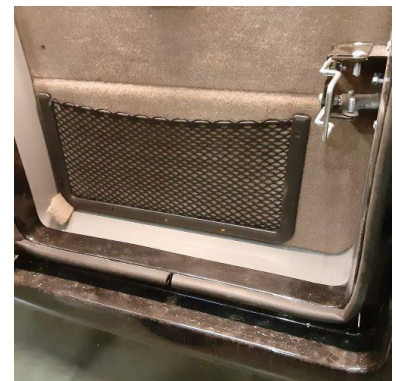
1. **Disconnect all power connections to the unit. The load center generator/fender compartment breaker must be turned off prior to starting the repair.**
2. Locate the breakers (for replacement) in the exterior fender compartment. Remove the lower panel by grasping the sides and pulling it towards you. There is no fastener removal required.
3. Use a screw gun with a square bit, to remove the (4) screws from the upper panel corners. Carefully remove the panel by pulling towards you as there are wires attached to the back of the panel.

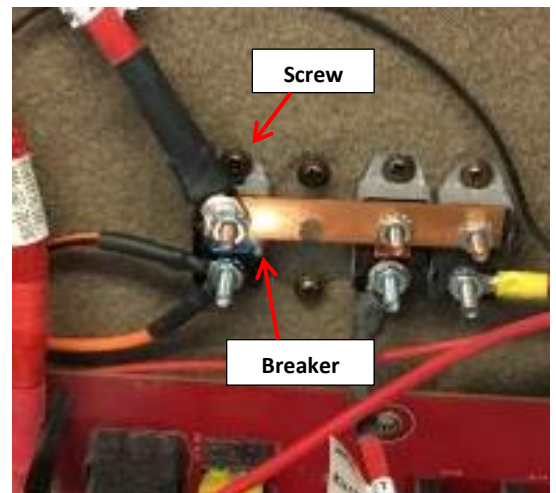
5. Use the screw gun with the square bit, to remove the screw on the breaker (for the wire you just removed). Set aside for reuse.
6. Remove the breaker from behind the bus bar.

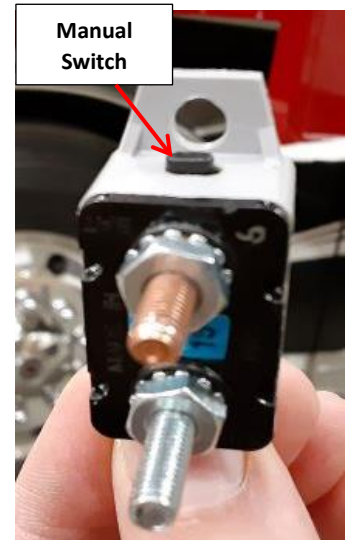
7. Install the new breaker where the original one was removed. The manual switch should be installed at the top.

NOTE: Caution should be taken when installing the new breaker as to not damage or break the manual switch feature.

8. Reinstall the feed wire and the orange wire.

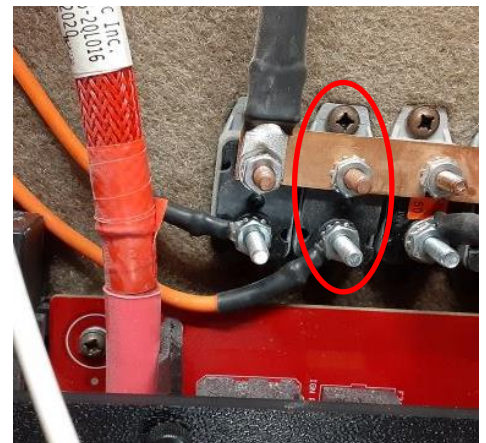
9. Repeat the process on the next breaker (next to the one just replaced).

10. Replace (both) cover panels and the latch if it was removed.
