SIB 61 13 21

## RECALL 20V-601: HIGH-VOLTAGE BATTERY

BMW AG is conducting a Voluntary Safety Recall (effective September 24, 2021) on certain Model Year 2020-2021 BMW Plug-In Hybrid-Electric (PHEV) vehicles that were produced between March 4, 2020 and January 22, 2021. This is an expansion to recall 20V-601 from 2020.

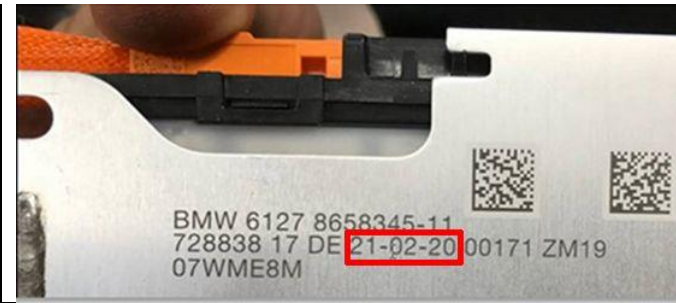
The date in the serial number of the High-voltage module can be displayed in two different formats:

Variant A: YYMMDD
--	-------------------

**Variant B (shown here): DDMMYY**

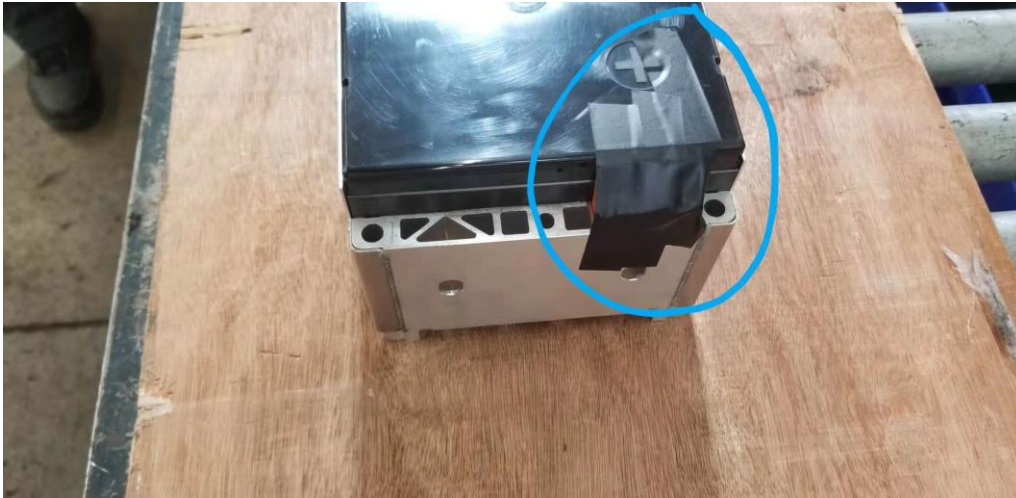
**(Photo 4b. # 1 above)**

- b. Ensure terminals are thoroughly covered with proprietary cover & electrically non-conductive tape to ensure no portion of terminals are exposed. **SEE PHOTO 4b. #1 & #2.**
- c. With electrically non-conductive tape, tape any cable leads that may be extending from the battery module. Attach cable to module with tie wrap/zip tie, like new module. **If the plastic cable end is intentionally “pinched”, it could create a short circuit.** Then cut off the excess length of tie wrap/zip tie. **SEE PHOTOS 4c #1 - #3.**

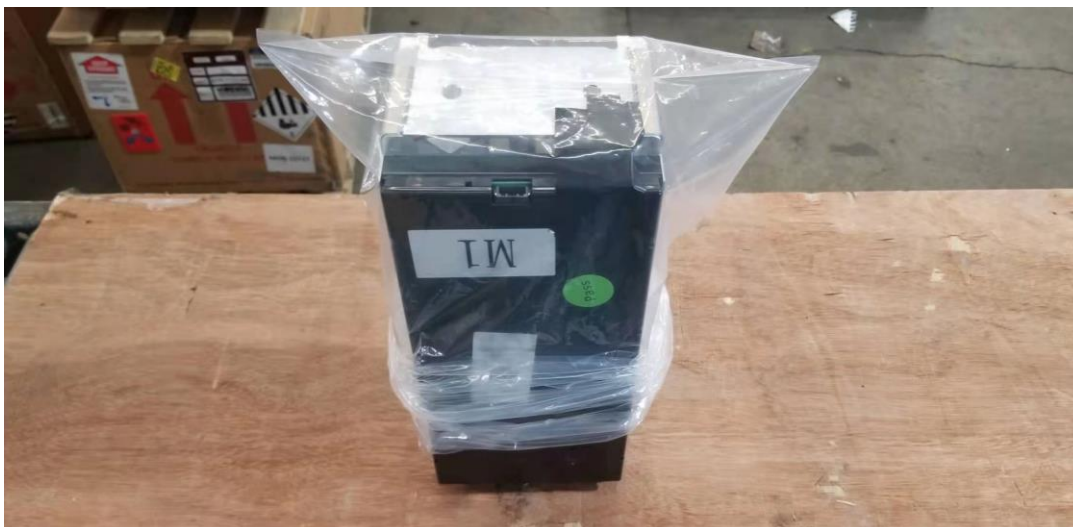
(Photo 6a. above)

- a. Lay the battery module vertically with cable lead side facing upward. Do not lay module where cable lead side is at the bottom bearing weight of module – there shouldn't be any unnecessary weight on this component that could cause damage to cable lead as mentioned in section 4.c. **SEE PHOTO 6a. (Actual module in photos is not part of this project - only an example. Module in photos do not have a cable lead)**

**Section 6:** PER BAGGING/SEALING INSTRUCTIONS IN SECTION 6, WHEN POSITIONING THE MODULE VERTICALLY OR HORIZONTALLY, NEVER PLACE (1) THE CABLE LEAD SIDE OF THE MODULE, NOR (2) THE TOP SIDE (TERMINAL/PLASTIC SIDE) AT THE BOTTOM, BEARING WEIGHT OF MODULE. THIS PHOTO EXAMPLE CONTAINS A MODULE THAT DOES NOT HAVE A CABLE LEAD, SO IT WAS ABLE TO BE PLACED VERTICALLY ON BOTH SIDES. THAT IS NOT THE CASE WITH THIS PROJECT'S BATTERY MODULES.

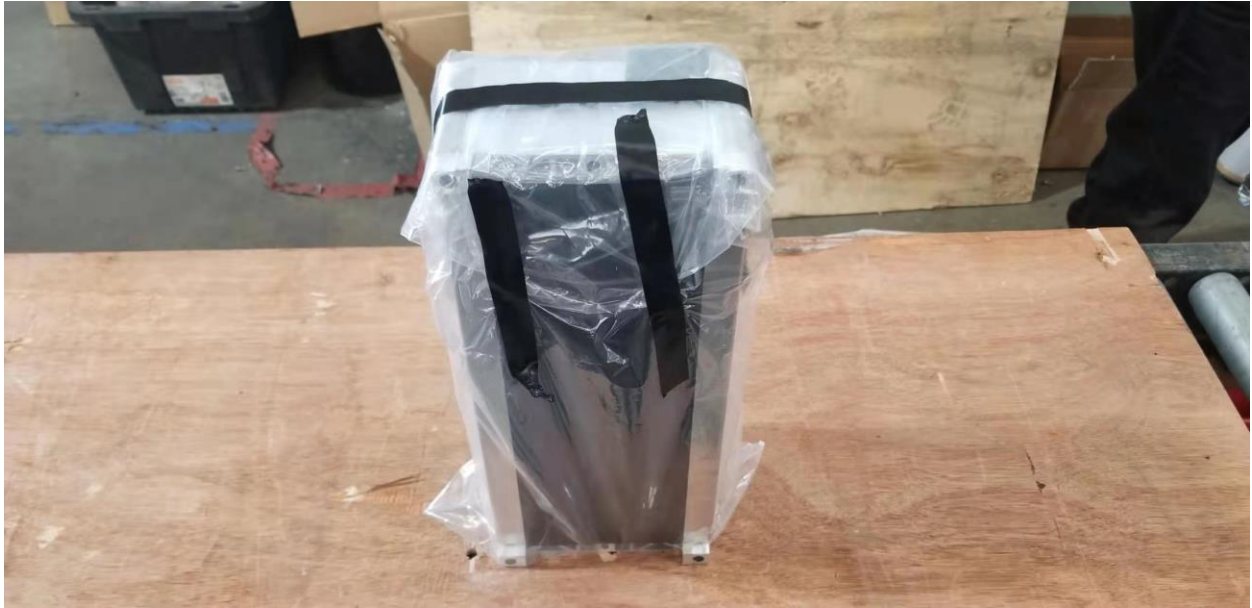
**(Photo 6e. above)**

- e. In its current horizontal position, proceed to closing/sealing bag. If using tape to seal bag, fold the battery bag where there is no longer an opening, and excess air has been removed from bag. Then tape it thoroughly so that it is sealed. If using a zip tie, place the zip tie at the center point of the excess portion of the bag opening to not stretch/rip bag, remove excess air from bag, & then zip tie the bag closed. Keep battery module laying horizontally. **SEE PHOTO 6e. (Module in photo does not include a cable lead. This photo is only an example of a closed/sealed bag. THE PROCESS OF CLOSING/SEALING MODULE NEEDS TO BE PERFORMED WHILE LAYING HORIZONTALLY AS DESCRIBED ABOVE).**

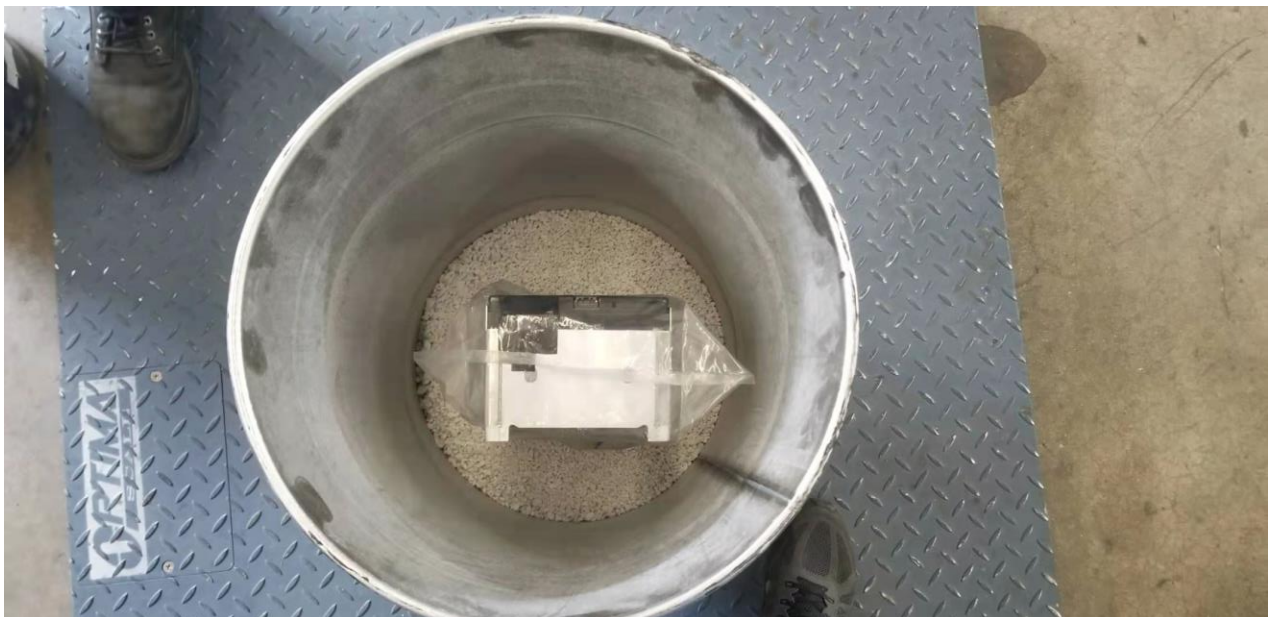
**(Photo 7b. above)**

- a. Remove bag of perlite from selected drum & place on the floor temporarily.
- b. Then with the cable lead end of the module facing upward, place the bagged/sealed battery module vertically at the center of the drum on the base of loose perlite material, so that cable lead end of module is on top. With the module properly centered, the space between the module & inside wall of drum should be ~ 3.5" (no closer than 3") on one axis, & ~4.5" (no closer than 4") on the other; space measurements are based off the center of the drum and the module per axis. **SEE PHOTO 7b. (module in photo does not have a cable lead).**

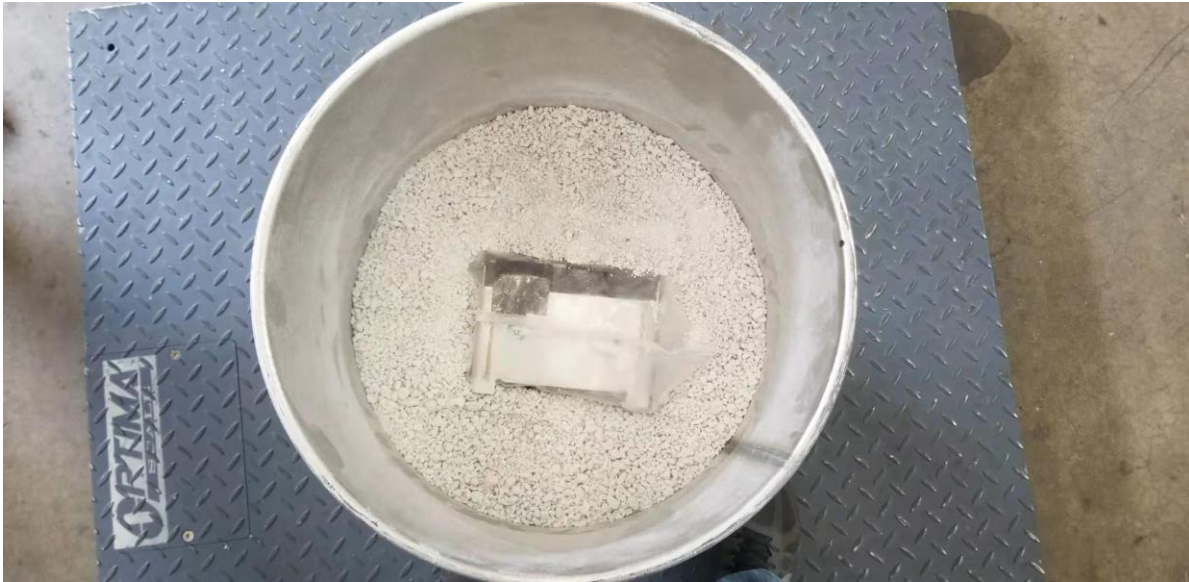
**(Photo 7c. above)**

- c. Open the bag of perlite & begin gently pouring the perlite material in the space around the battery module that is between the battery & the inner wall of the drum till you have reached the height of battery module. **SEE PHOTO 7c.**

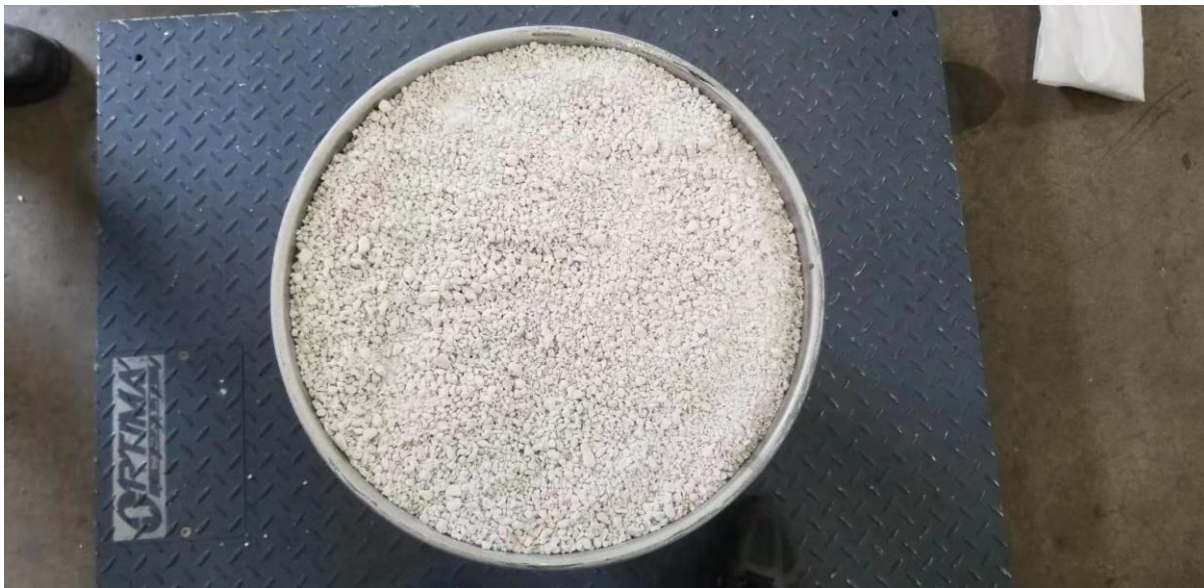
**(Photo 7e. above)**

- e. Then pour the balance of the perlite material onto the drum, completely filling the drum. **SEE PHOTO 7e.**
- f. Then fold the empty bag & place on top of open drum for return.

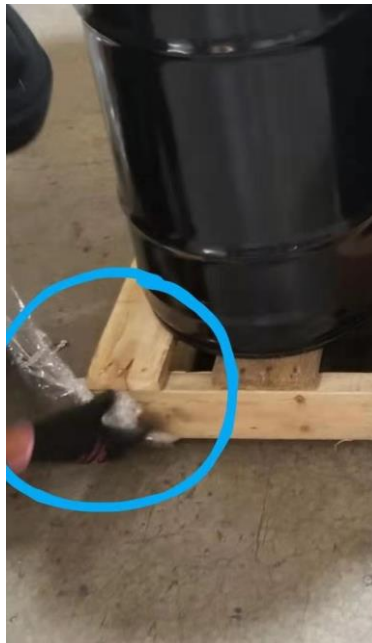
(Photo 11c. above)

- c. Starting at any corner of the pallet, insert shrink wrap through the underside of a corner & pull out the other perpendicular side of the corner & tie a strong knot. **SEE PHOTO 11c.**

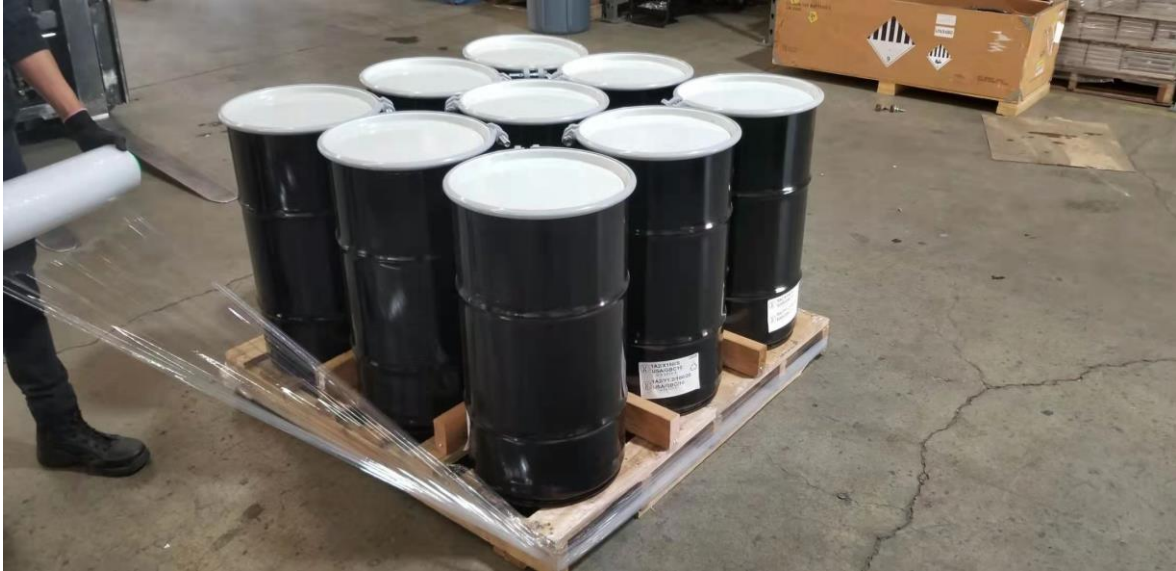
**(Photo 11d. above)**

**Section 11 continued: photo illustration only of stretch wrapping/palletizing instructions. Per section 9, labels/markings need to be placed on each drum before stretch wrapping drums/pallet(s).**

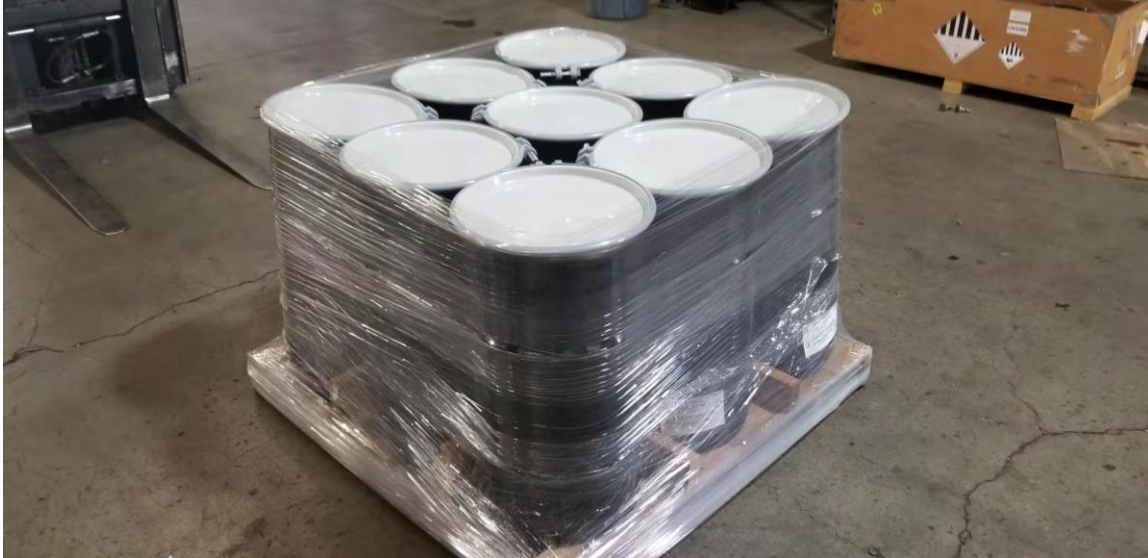
**(Photo 11e. #2 above)**

**Section 11 continued: photo illustration of properly stretch wrapped/palletized pallet. Per section 12, additional labels and markings need to applied after this step is completed.**
