Mercedes-Benz

Campaign No. 2020100006, October 2020

SUBJECT: **Model C-Class vehicles (205 platform)**
Model Year 2019
Check Center Console Storage Compartment

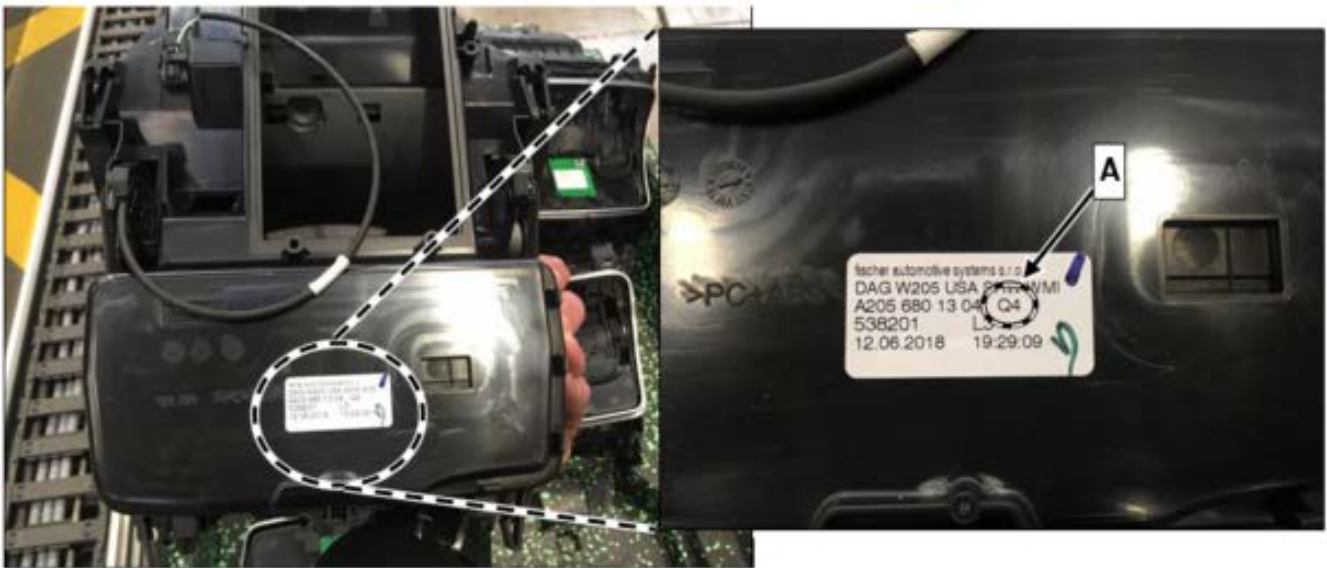
Figure 1

1. Remove the front center console stowage compartment.
 - i** For basic data, see **AR68.20-P-0901LWM**.
2. Check Q-status of the front center console stowage compartment.
 - i** The Q-status must be **at least Q-status 4**.
 - i** The Q-status can be read from the replacement part adhesive label after the replacement part number. It will be indicated as **Q4 (A, figure 1)**.
 - i** The replacement part adhesive label is located on the underside of the front center console stowage compartment (**figure 1**).

- a. If the Q-status is **less than 4**: Carry out **work procedure**.
- b. If the Q-status **is 4** or higher: **End measure**.

1. Replace the front center console stowage compartment.
 - i** For basic data, see **AR68.20-P-0901LWM**.
