RECALL

ORIGINAL CREATION DATE:	10/8/2020
REVISION DATE:	10/8/2020
SUBJECT:	Power Steering Hose Recall
RATIONALE:	A power steering hose made from an incorrect material may have been installed in certain Proterra Buses
VINs AFFECTED:	Service Specified Buses
SERVICE CAMPAIGN #:	SC-20-141
NHTSA RECALL NUMBER:	20V-621
REVISION DESCRIPTION:	This is the original version.
REMEDY KIT NAME / NUMBER:	N/A
ESTIMATED LABOR TIME:	3 Hours

POWER STEERING HOSE RECALL CAMPAIGN

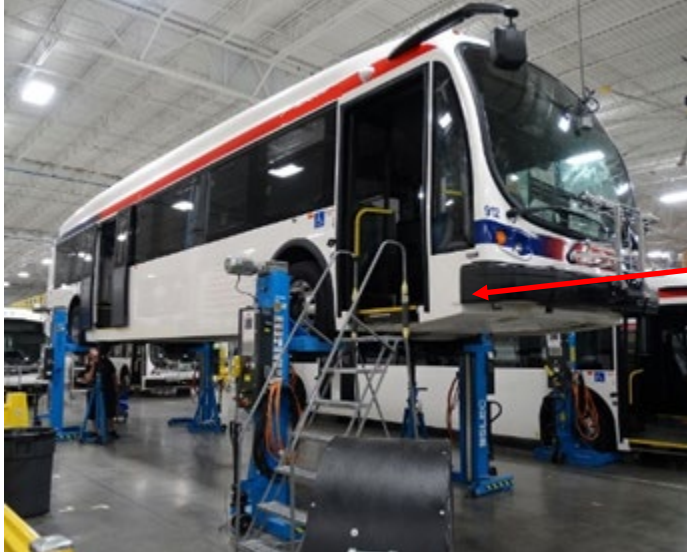
1. Complete the Proterra approved Lockout/Tagout procedure to make the bus safe for work.
2. Using Wheel Lifts raise the bus. Use four Jack Stands to support the bus after it is lifted.

Safely Raise
and Secure
the Bus

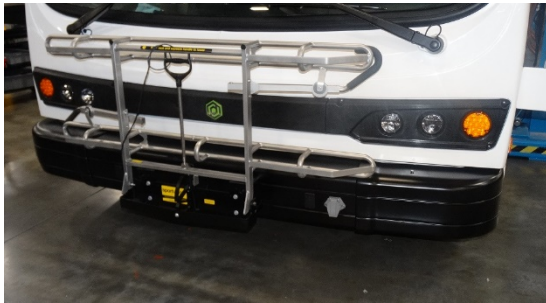
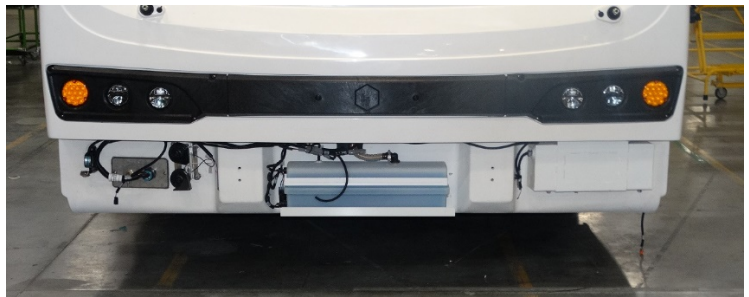
3. Using a 13mm Ratchet/Socket and a 13mm Combination Wrench, remove the front bumper.

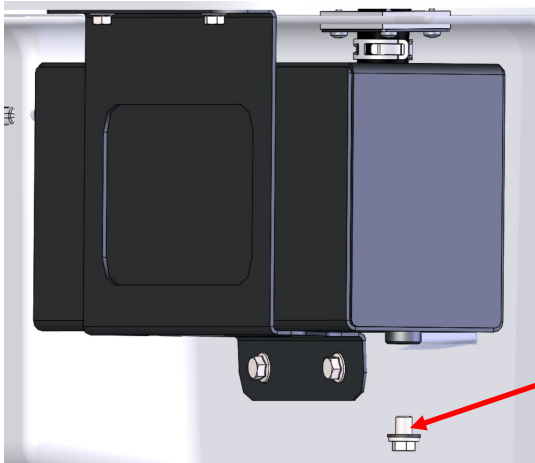
4. Place a Catch Pan underneath the power steering reservoir drain plug.
5. Using a 17mm Combination Wrench, remove the power steering reservoir drain plug and allow the Power Steering Fluid to drain into a clean Catch Pan. The Power Steering Fluid will be reused.

Remove Drain Plug

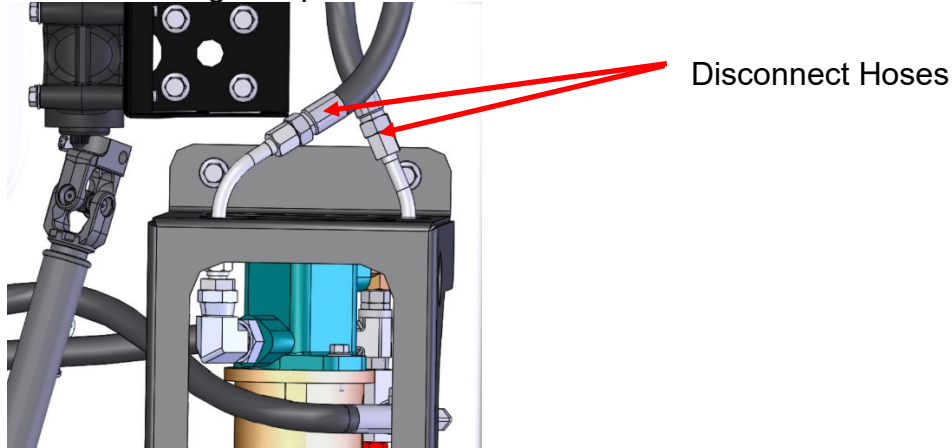
6. Using 1-Inch and 7/8-Inch Combination Wrenches, disconnect the hoses that connect the Power Steering Pump to the reservoir.

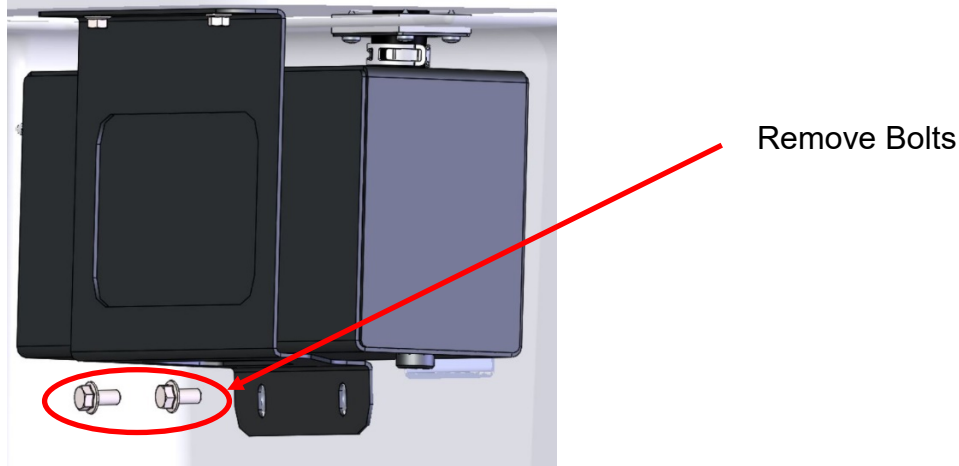
7. Using a 15mm Ratchet/Socket, remove the two bolts that attach the reservoir to the vertical surface of the bus body.

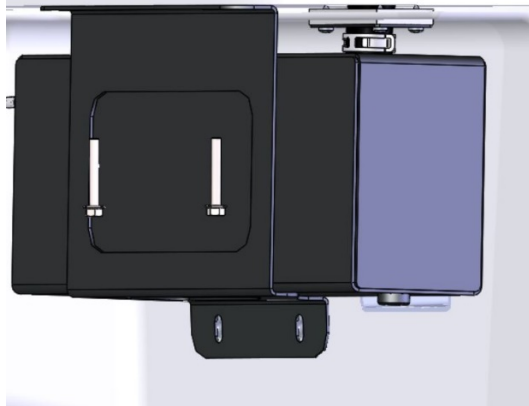
8. Using Hose Clamp Pliers, squeeze the Clamp on the fill neck so that it can be removed. Using a 13mm Ratchet/Socket, remove the two bolts that attach the reservoir to the horizontal surface of the bus body. Disconnect the level sensor from the harness.

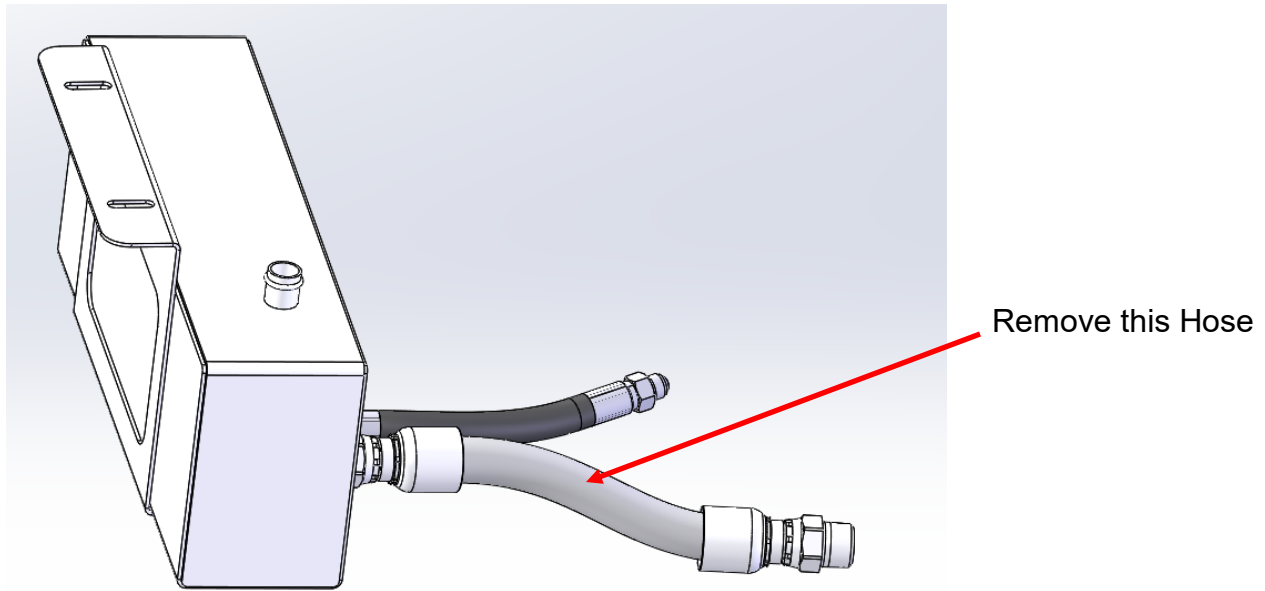
9. Remove the Tank and its attached hoses.

10. Using a 1-1/2-Inch Combination Wrench, remove the hose and fittings shown in the previous illustration. Carefully remove the push lock fittings from the hose and inspect them for damage. They will be reused.

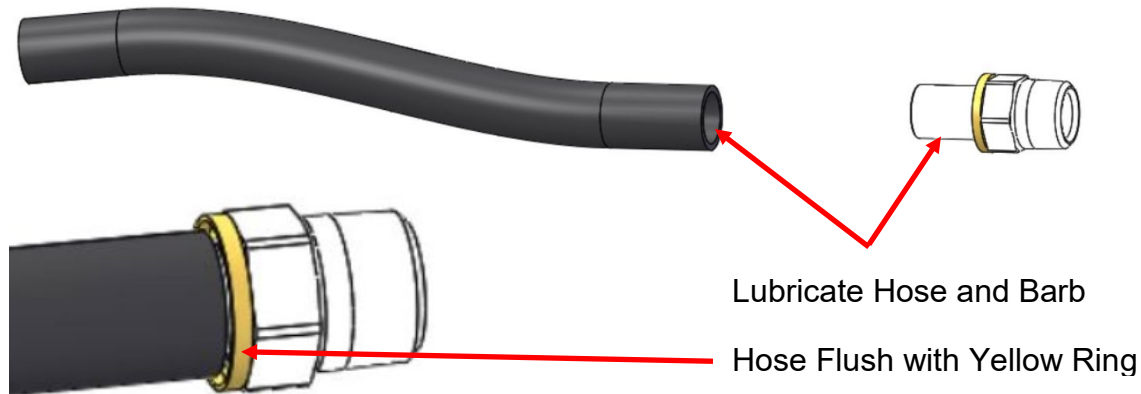
11. Apply a small amount of Automatic Transmission Fluid to the inside of one end of the 1-inch Hose (051490) and to the hose barb of Push Lock Fitting from the old hose to lubricate them. Press on one of the Push Lock Fittings into the lubricated end of the hose. The fitting must be inserted into the hose until it is flush with the yellow ring as shown in the second illustration below. Do not install the second Push Lock Fitting at this time. These fittings are permanent and cannot be removed.

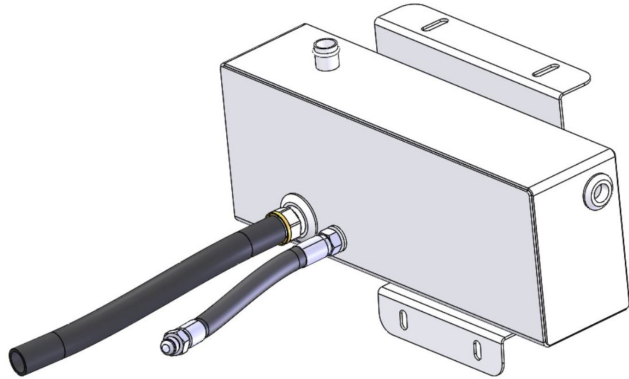
12. Using a 1-1/2-Inch Combination Wrench, attach the Hose (0051490) and Fitting (051491) assembled in the previous step to the new Tank (047041) as shown. Using a Calibrated Torque Wrench with a 1-1/2 Inch Crows Foot Socket, **torque the fitting to 112-foot pounds.**

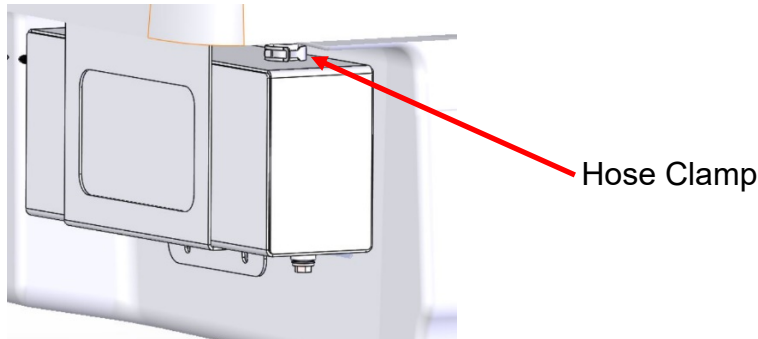
13. Thread the hoses back through the opening in the bus. Place the Hose Clamp on the Filler Neck hose that is protruding through the bus body. Carefully attach this hose with the Hose Clamp to the Filler Neck.

Note: It may be necessary to access the filler hose from inside the Driver Workplace if the hose cannot be connected from outside the bus.

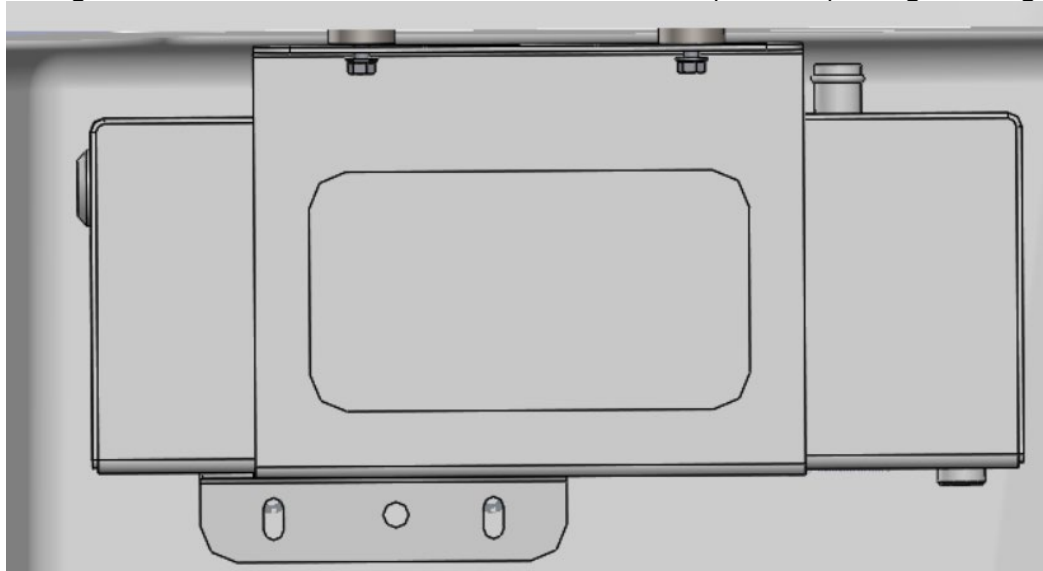
14. Using a 15mm Ratchet/Socket, reinstall the Tank (047041) using the original fasteners.

15. Using a Calibrated Torque with a 15mm Socket, **torque the upper tank bolts to 15-foot pounds.** Using orange Torque Stripe Pain, mark the torqued fasteners.

16. Using a Calibrated Torque with a 13mm Socket, **torque the lower tank bolts to 37-foot pounds**. Using orange Torque Stripe Pain, mark the torqued fasteners.

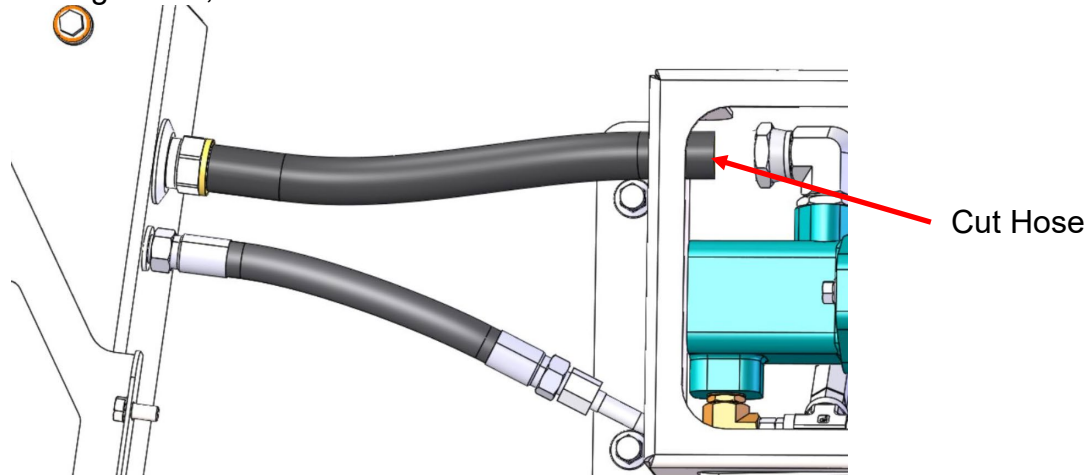
18. Carefully measure the length of 1-Inch Hose (051490) required to connect the Hose to the pump using a Push-on Fitting (051491). The Hose should be cut long enough to allow it to be seated flush with the yellow ring on the fitting, but not so long as to cause kinking. Using a Tubing Cutter, cut the Hose.

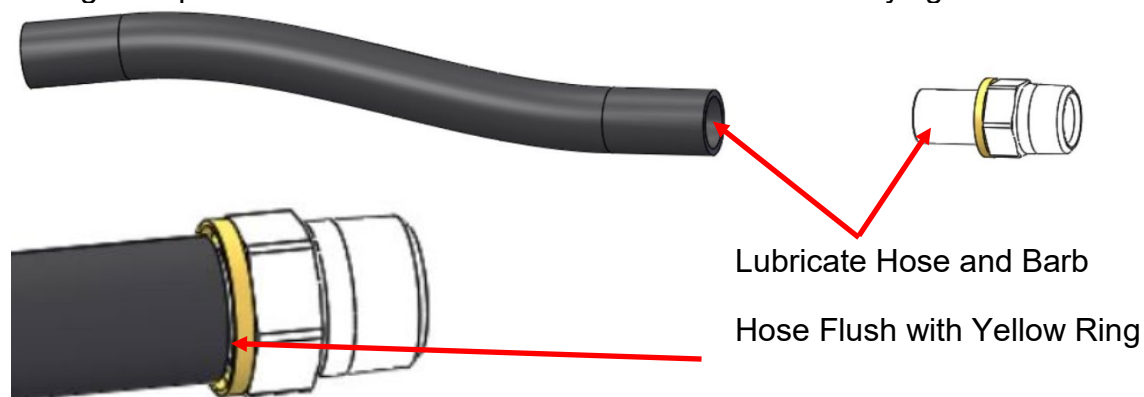
19. Apply a small amount of Automatic Transmission Fluid to the inside of the free end of the 1-Inch Hose (051490) and to the barb on the Push Lock Fitting from the old hose to lubricate them. Press on the Fitting into the lubricated end of the Hose. The fitting must be inserted into the hose until it is flush with the yellow ring as shown in the second illustration below. These Fittings are permanent and cannot be removed without destroying the Hose.

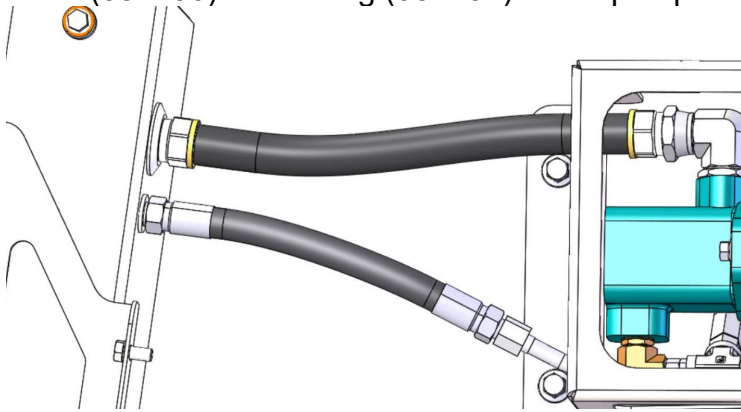
20. Using a 1-3/8 Inch Combination Wrench and a 1-1/2 Inch Combination Wrench, connect the Hose (051490) and Fitting (051491) to the pump as shown in the following illustration.

21. Using a 1-1/2 Inch Combination Wrench and a Calibrated Torque Wrench with a 1-1/2 Inch Crows Foot Socket, **torque the fitting to 112-foot pounds.**

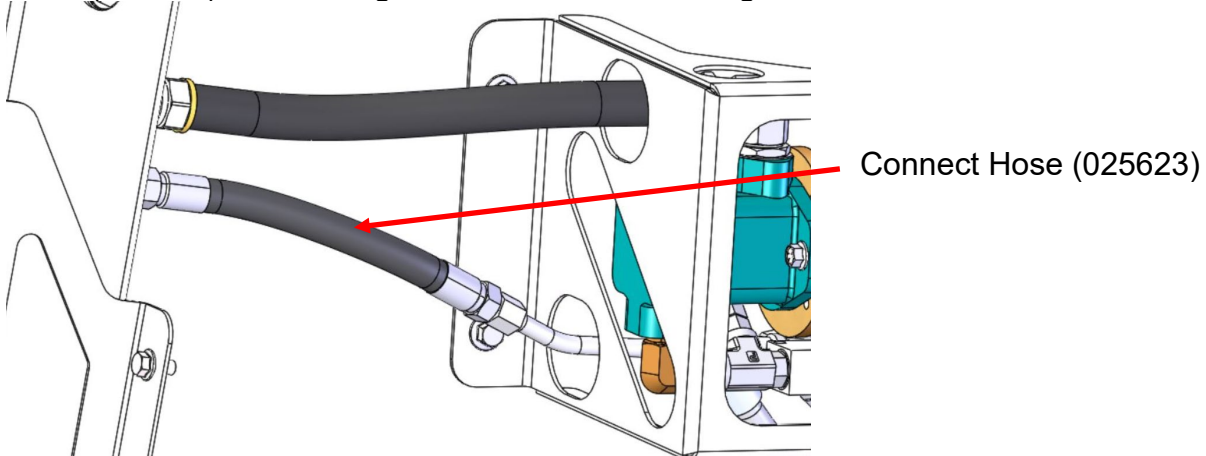
22. Using a 7/8-Inch Combination Wrench and a 1-Inch Combination Wrench, connect the smaller Hose (025623) to the fitting as shown in the following illustration.

23. Using a Calibrated Torque Wrench with a 7/8-Inch Crows Foot Socket and a 1-Inch Combination Wrench, **torque the fitting to 40-foot pounds.**
