Mercedes-Benz

Campaign No. 2020100016, November 2020

SUBJECT: **Model GLE-Class and GLS-Class vehicles (167 platform)**  
**Model Year 2020**  
**Installation of the Illuminate Star**

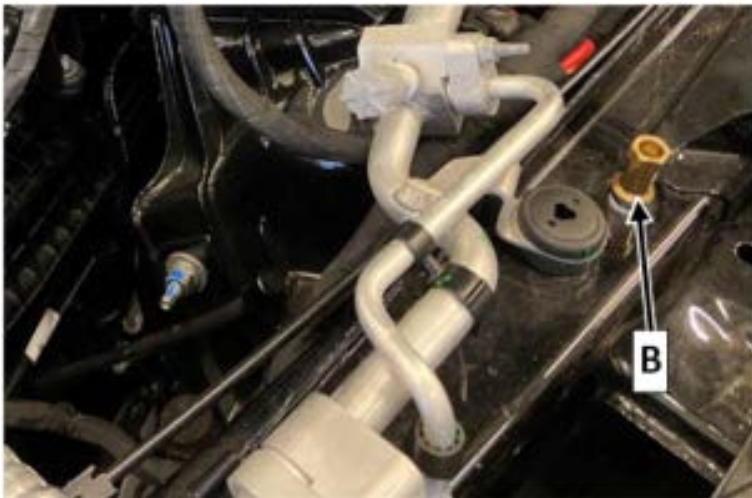
Figure 2

5. Unscrew brass sleeve (**B, figure 2**) at jump-start connection point.

6. Route illuminated star ground line (**A, figure 1**) to jump-start connection point and attach to threaded pin of jump-start connection point.
7. Screw on brass sleeve (**B, figure 2**).  
Nm Brass sleeve **16 Nm**.
8. Secure illuminated star ground line (**A, figure 1**) up to jump-start connection point.  
i Ensure a chafe-free routing and attachment of the illuminated star ground line. See **AZ88.40-P-0011-01ME**
9. Check anti-twist protection (**C, figure 3**) of cable lug of ground **point W9** for damage.
