# Safety Recall W81 / NHTSA 20V-657

## Front Lower Control Arm

2021 (KL) Jeep® Cherokee

About 700 of the above vehicles may have been built with one or both lower control arms with hardness below specification. A front lower control arm manufactured with hardness below specification may result in a fracture while driving that may result in a loss of steering control, which can cause a crash without prior warning.

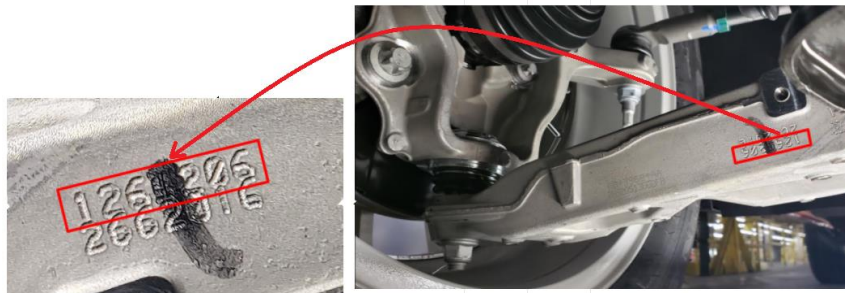
**Figure 1 – Lower Control Arm Lot Number Inspection**

2. Inspect the marking on each control arm for lot #1264206. If neither arm is part of this lot, lower the vehicle, and return it to the owner. If either

arm is from this lot, the arm(s) must be replaced. Proceed to **B. Remove Control Arm** (Figure 1).

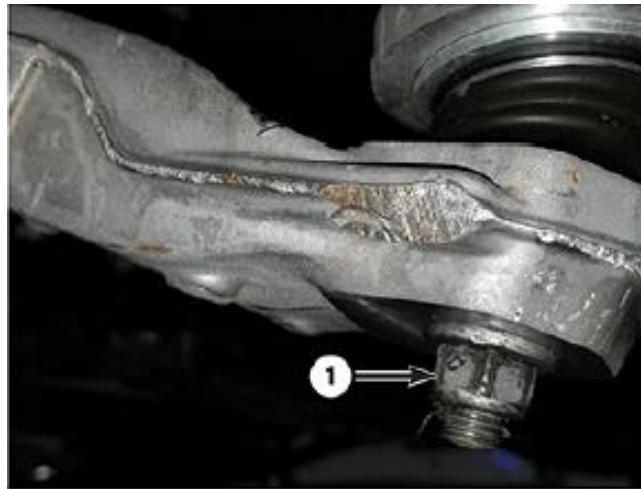
**Figure 2 – Ball Joint Nut**

1. Lower the vehicle, and disconnect and isolate the negative battery cable. If equipped with an Intelligent Battery Sensor (IBS), disconnect the IBS connector first before disconnecting the negative battery cable. Raise and support the vehicle.
2. Remove the wheel mounting bolts and the tire and wheel assembly.
3. Remove and DISCARD the lower ball joint nut (1) (Figure 2).
4. Using the Ball Joint Press C-4150A, separate the lower ball joint stud from the control arm.

**NOTE: Make sure the ball joint boot does not get cut when separating the ball joint stud from the control arm.**

**NOTE: After separating the control arm from the knuckle, do not let it swing rapidly back up. This can tear the ball joint dust boot.**

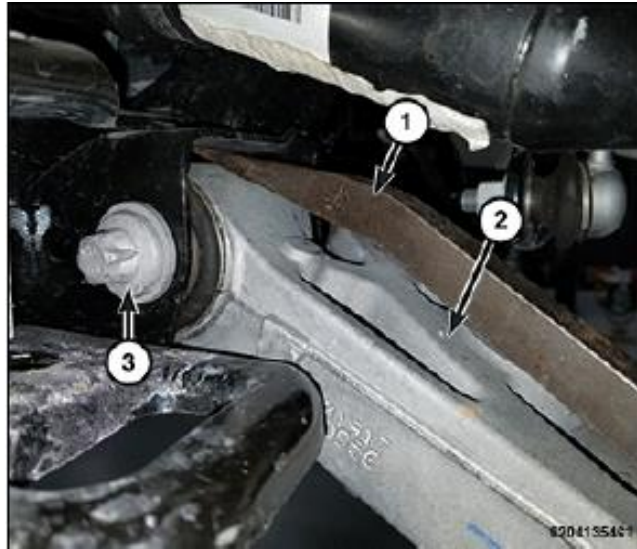
**Figure 3 – Pry Lower Control Arm**

5. Insert a pry bar (1) in the opening between the control arm front mounting bolt and the front fascia support beam (Figure 3).
6. Pry down on the control arm (2) until the ball joint stud is clear of the control arm, then push the knuckle assembly to the side when it is clear of the ball joint stud and slowly release the control arm (Figure 3).

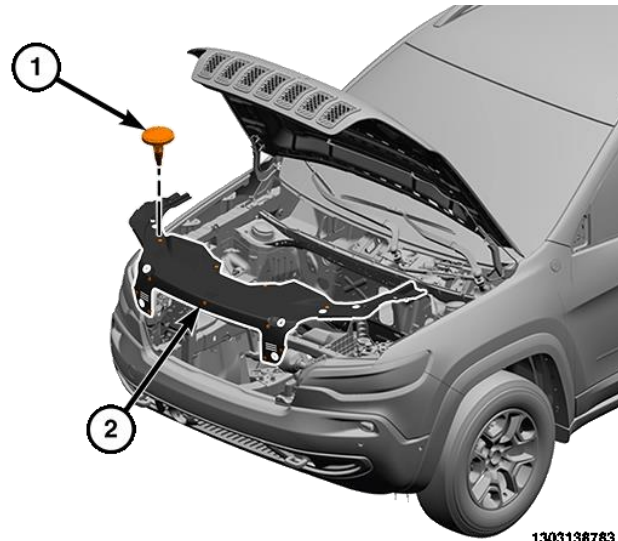
**Figure 4 – Radiator Closeout Panel**

7. Remove the supports, and lower the vehicle to access the engine compartment.
8. Remove the push pin fasteners (1) and remove the radiator closeout panel (2) (Figure 4).

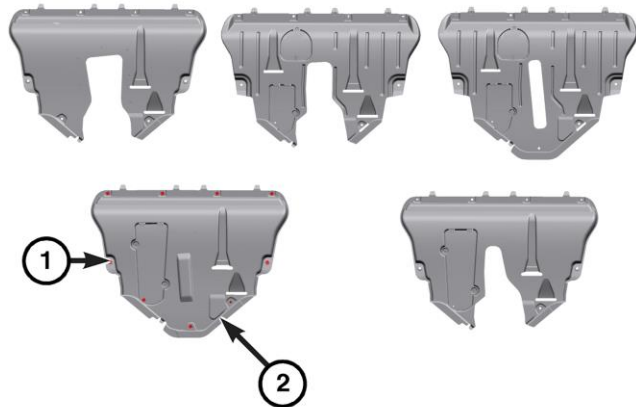
**Figure 5 – Engine Belly Pan**

10. Remove the fasteners (1) securing the engine belly pan (2) (Figure 5).

11. Remove the engine belly pan (2) from the underside of the vehicle (Figure 5).

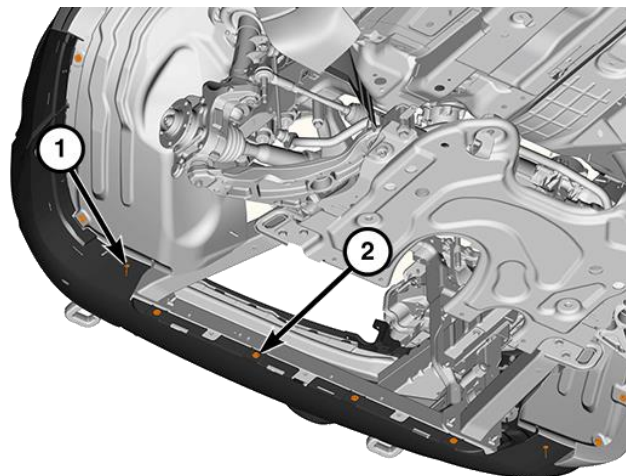
**Figure 6 – Lower Fascia Fasteners**

12. Remove the two rivets (1) (Figure 6).

13. Remove the four lower support fasteners (2) (Figure 6).

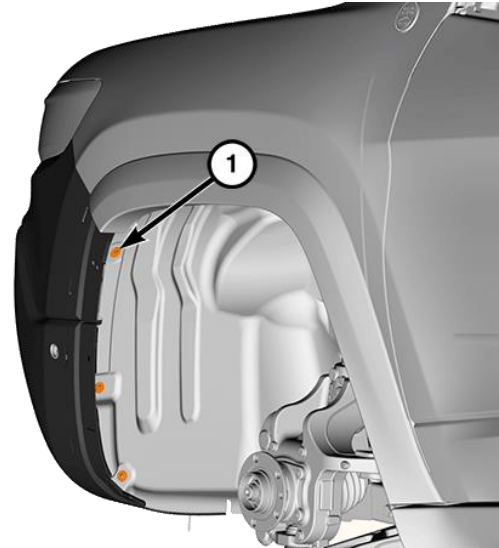
**Figure 7 – Wheelhouse Splash Shield Fasteners**

14. Remove the three screws (1) and position aside the wheelhouse splash shields (Figure 7).

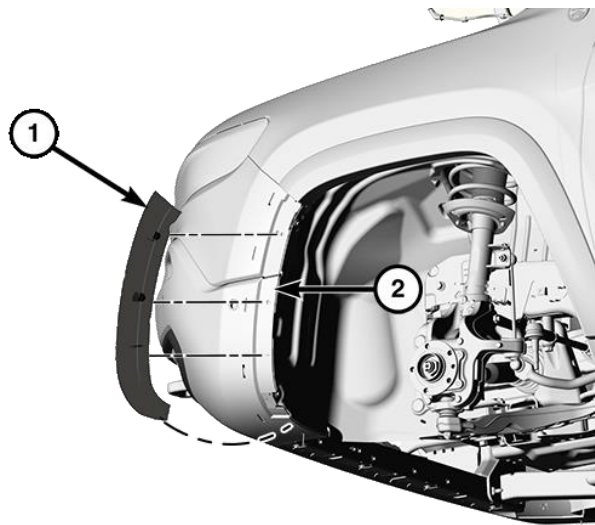
**Figure 8 – Front Flare Moldings**

15. From inside the wheel well, release the clips and remove the front flare moldings (1) (Figure 8).

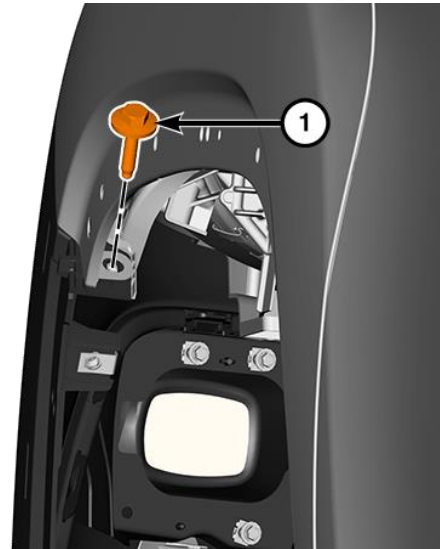
**Figure 9 – Fascia to Fender Fasteners**

16. Remove the fasteners (1) attaching the sides of the fascia to the fenders (Figure 9).

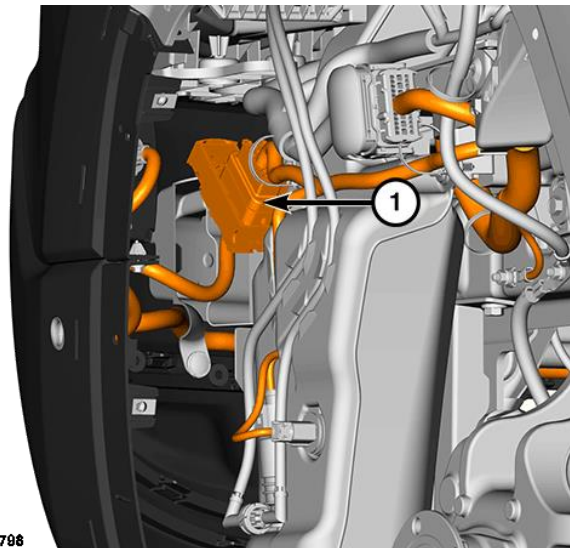
**Figure 10 – Wire Harness Connector**

17. Disconnect the wire harness connector (1) (Figure 10).

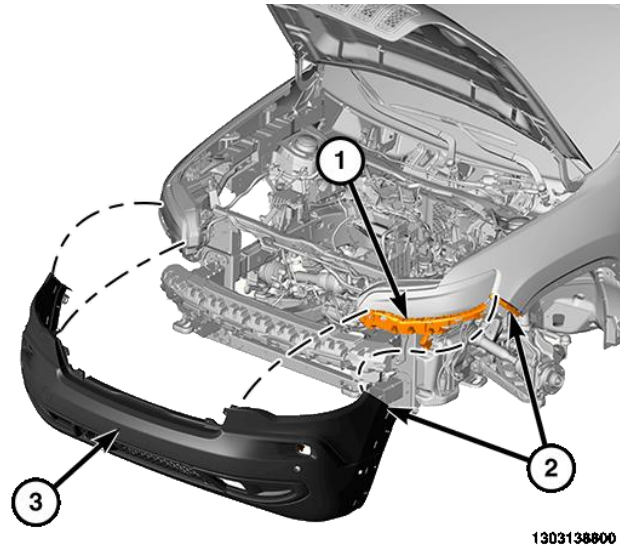
**Figure 11 – Wire Harness Connector**

18. Carefully pull out on the upper and lower fascia sides to release the fascia retaining tabs at the fender (2) and below the headlight (1). Repeat on the opposite side (Figure 11).
19. Remove the fascia (3) from the vehicle (Figure 11).

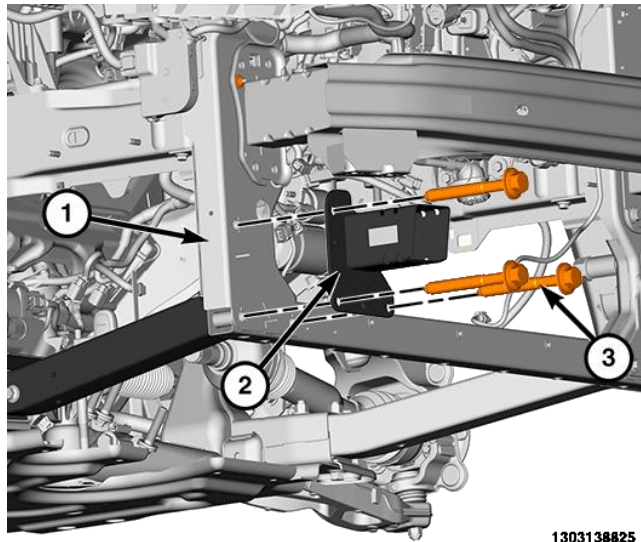
**Figure 12 – Lower Load Beam Extension Bolts**

20. Remove the bolts (3) and the lower load beam extensions (2) (Figure 12).

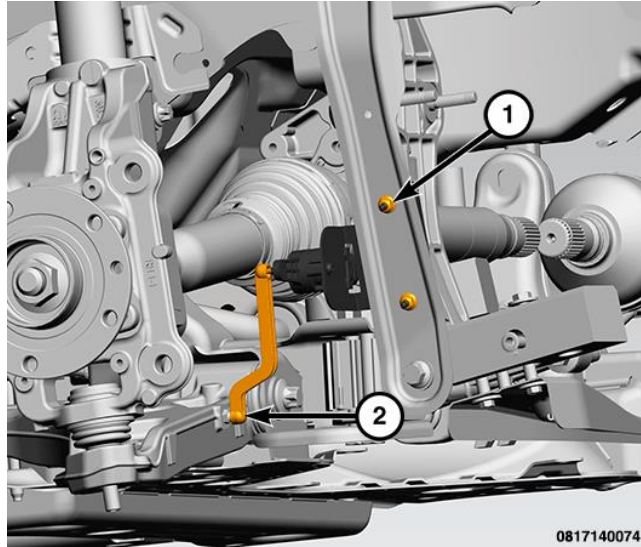
**Figure 13 – Vehicle Height Sensor Actuator Rod**

21. If equipped, locate the front axle vehicle height sensor from within the right front fender wheel house (Figure 13).
22. Disconnect the actuator rod (2) (Figure 13).
23. Remove the fasteners (1) and separate the sensor from the vertical bracket (Figure 13).

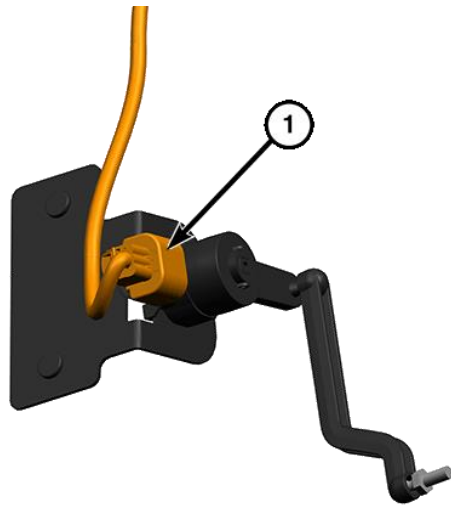
**Figure 14 – Vehicle Height Sensor Connector**

24. Disconnect the wire harness connector (1) from the axle sensor (Figure 14).

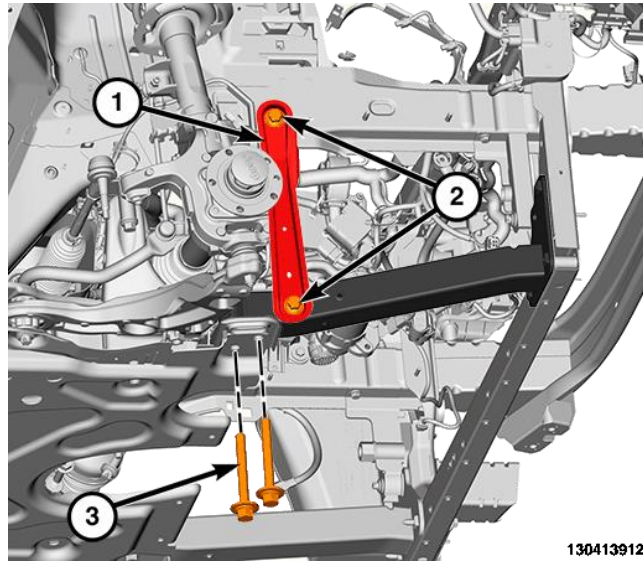
**Figure 15 – Vertical Bracket**

- 25. Remove the bolts (2) and remove the vertical bracket (1) from the side of the lower load beam (Figure 15).
- 26. Remove the two bolts (3) (Figure 15).

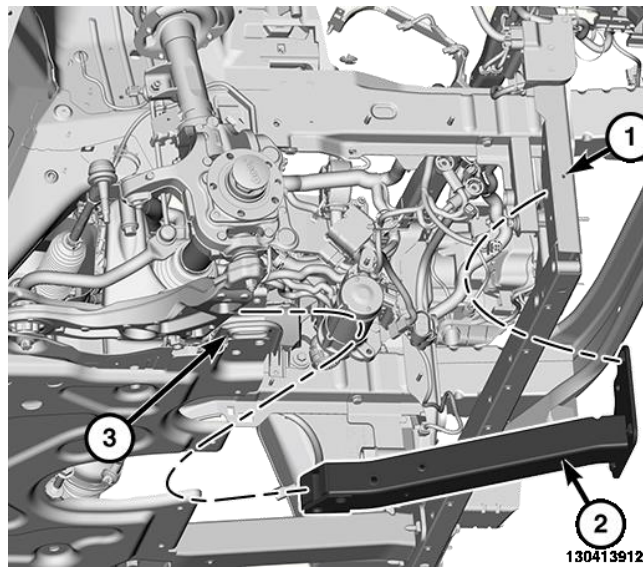
**Figure 16 – Lower Load Beam**

- 27. Remove the lower load beams (2) (Figure 16).

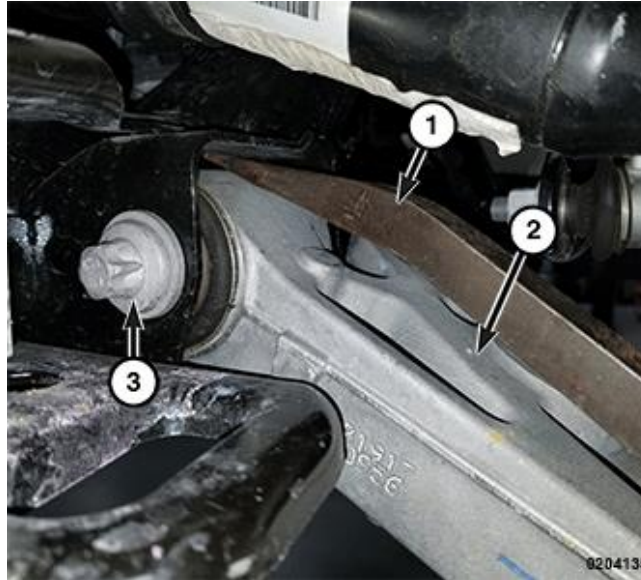
**Figure 17 – Lower Load Beam**

28. Remove and DISCARD the front lower control arm bolt (3). Then remove the bolt attaching the lower control arm to the front suspension crossmember (Figure 17).

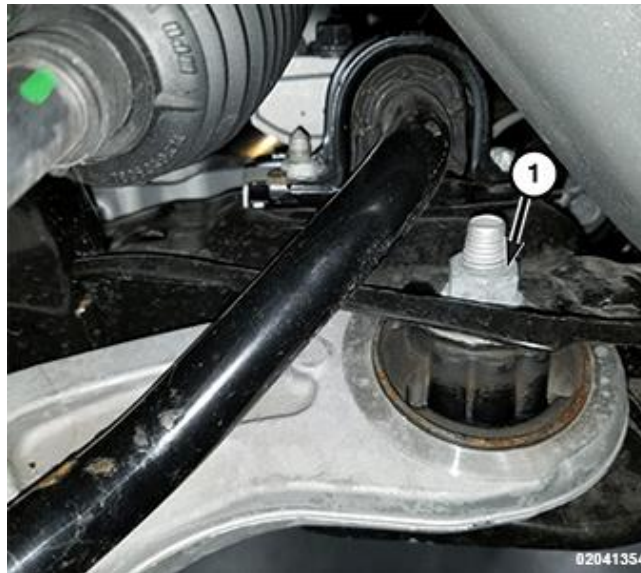
**Figure 18 – Lower Control Arm Nut**

29. Remove and DISCARD the rear lower control arm nut (1). Then remove the lower control arm bolt (Figure 18).

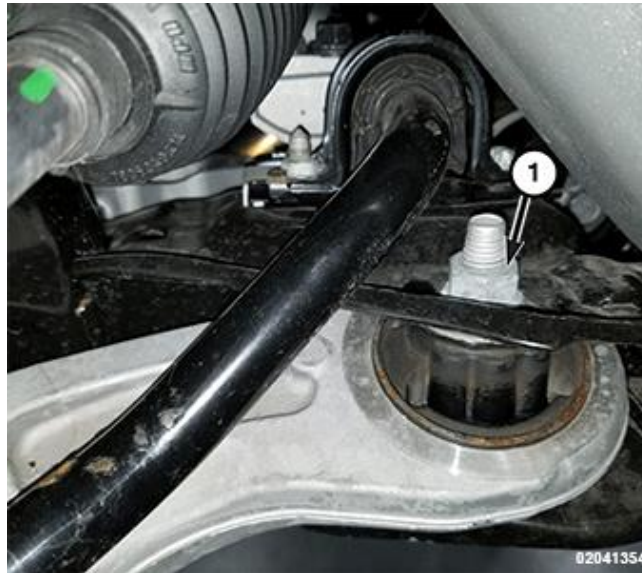
**Figure 19 – Lower Control Arm Nut**

1. Position the lower control arm in the front suspension crossmember.
2. Install a NEW lower control arm rear vertical bolt and a NEW lower control arm rear vertical nut (1). Do not tighten to specification at this time (Figure 19).

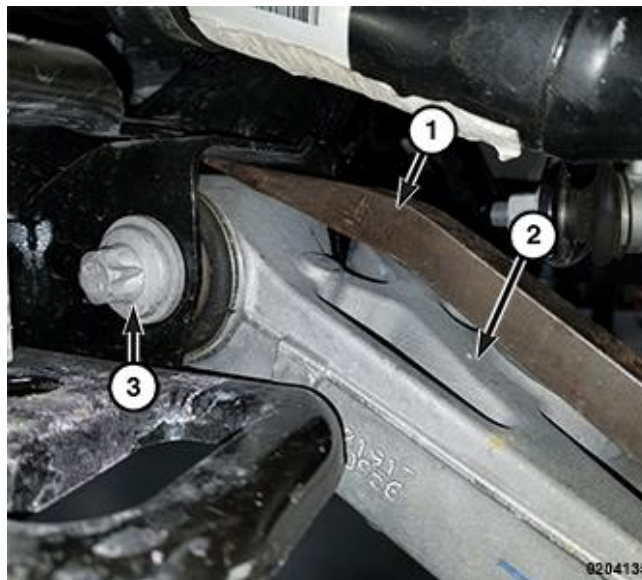
**Figure 20 – Lower Load Beam**

3. Install a NEW lower control arm front horizontal pivot bolt (3). Do not tighten to specification at this time (Figure 20).

4. Insert a pry bar (1) in the opening between the control arm front mounting bolt and the front fascia support beam (Figure 20).
5. Pry down on the control arm (2) until the ball joint stud is clear of the control arm, align the stud with hole in control arm then slowly release the control arm (Figure 20).
6. Lower the vehicle and install a floor jack under the control arm. Raise the jack until the lower control arm is at ride height.
7. Tighten the lower control arm front horizontal pivot bolt to 47 N·m plus 300 degrees (35 ft. lbs. plus 300 degrees).
8. Tighten the lower control arm rear vertical bolt to 37 N·m plus 106 degrees (27 ft. lbs. plus 106 degrees).
9. Raise the vehicle back up to the original position.
10. Position a lower load beam (2) on into the crossmember (3) and against the front end module (1) (Figure 21).

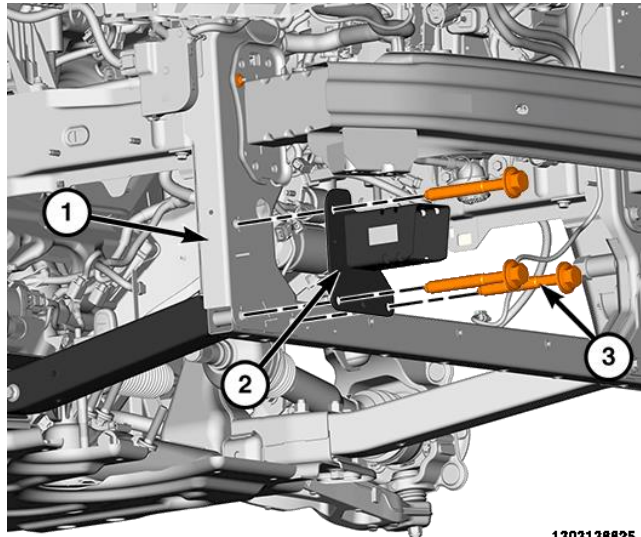
**Figure 22 – Lower Load Beam Extension Bolts**

11. Position the lower load beam extensions (2) and install the bolts (3) (Figure 22).
12. Tighten the lower load beam extension bolts (3) to 45 N·m (33 ft. lbs.).

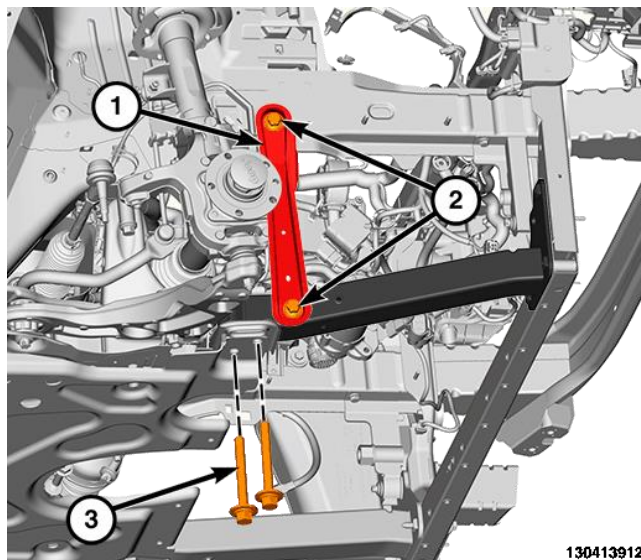
**Figure 23 – Vertical Bracket**

13. Install the two lower bolts (3) and tighten to **89 N·m (66 ft. lbs.)** (Figure 23).
14. Install the vertical bracket (1) and install the bolts hand tight (2) (Figure 23).

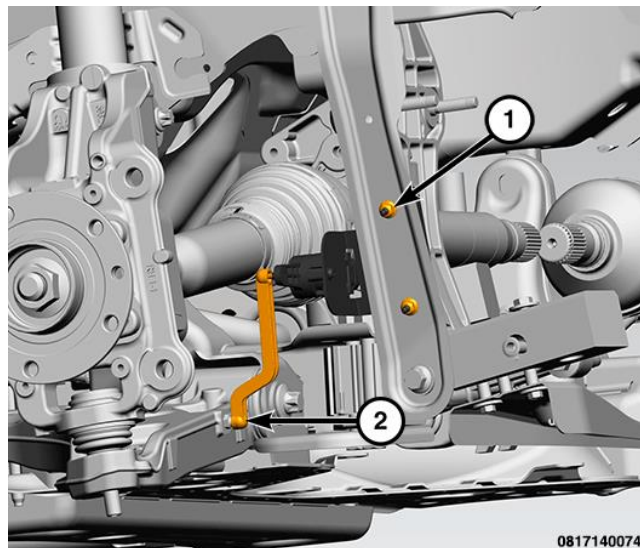
**Figure 25 – Vehicle Height Sensor Actuator Rod**

16. Install the sensor onto the vertical bracket and install and securely tighten the fasteners (1) (Figure 25).
17. Seat the actuator rod (2) onto the ball stud fully (Figure 25).

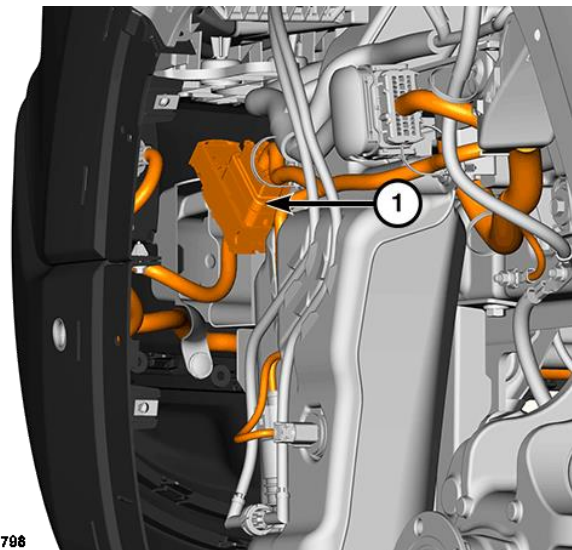
**Figure 29 – Wire Harness Connector**

23. Connect the wire harness connectors (1) (Figure 29).

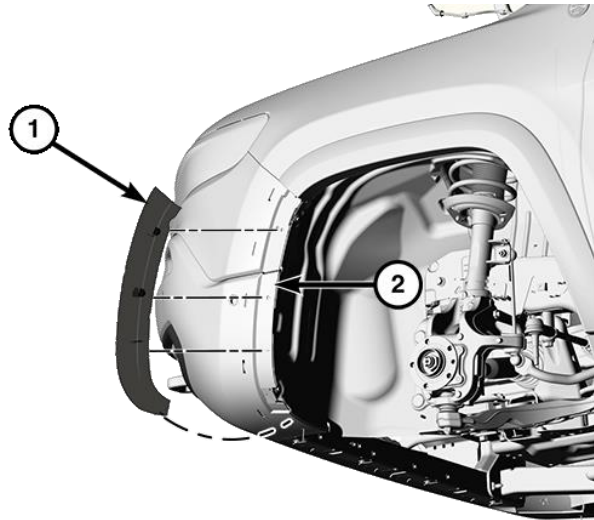
**Figure 30 – Front Flare Moldings**

24. Position the front flare moldings (1) back and seat the fasteners fully onto the fascia (2) (Figure 30).

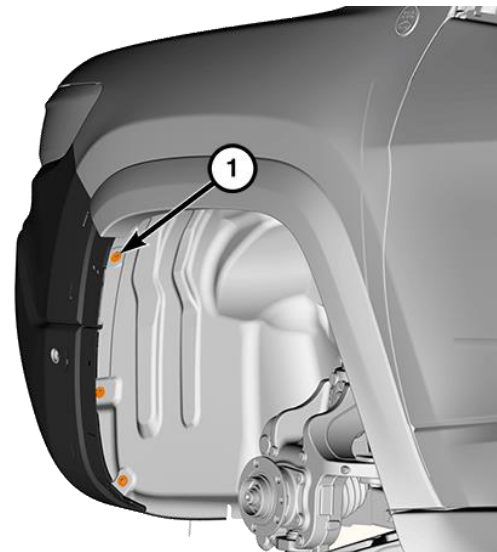
**Figure 31 – Wheelhouse Splash Shield Fasteners**

25. Position the wheelhouse splash shields back and install the three screws (1) (Figure 31).

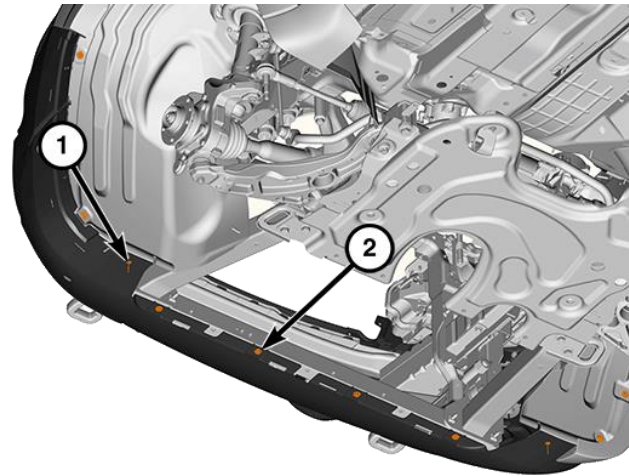
**Figure 32 – Lower Fascia Fasteners**

- 26. Install two new rivets (1) and install the four lower fasteners (2) (Figure 32).

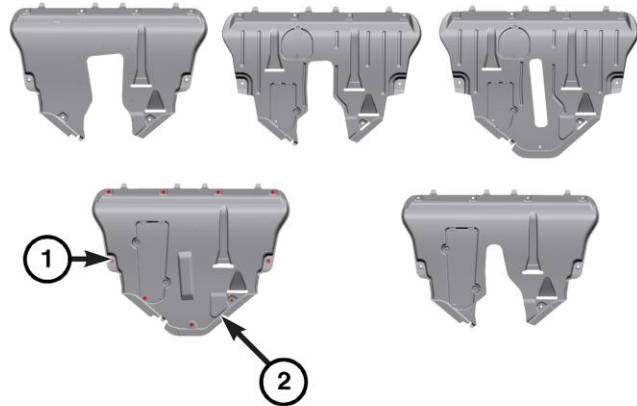
**Figure 33 – Engine Belly Pan**

- 27. Insert the tabs into the slots on the fascia and position the engine belly pan (2) to the underside of the vehicle (Figure 33).
- 28. Install the fasteners (1) securing the engine belly pan (2) and tighten to 20 N·m (15 ft. lbs.) (Figure 33).

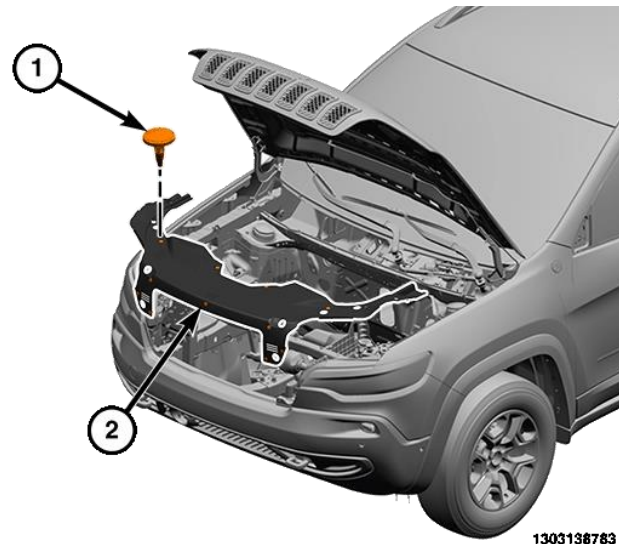
**Figure 34 – Radiator Closeout Panel**

29. Install the radiator closeout panel (2) and install the push pin fasteners (1) (Figure 34).
