Recall Campaign

May 2021
FL868A
NHTSA #20V-690

Subject: TBB Minotour Wheelchair Lift Interlock

Wheelchair Lift Interlock Procedure

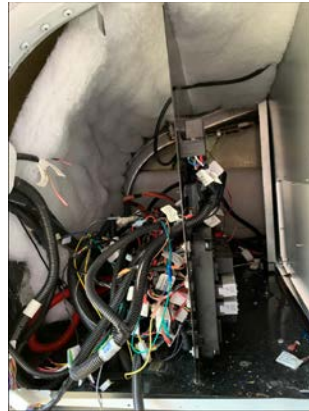
Figure 1

Electrical Compartment Side View

Remove Existing Wheelchair Lift Harness and Replace with New Harness P/N 227436

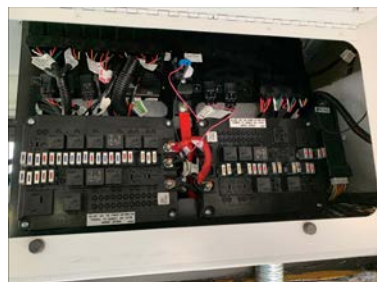
Figure 2

Electrical Compartment Front Access
