# EUROLOFT™ BED LIFT MOTOR REPLACEMENT

TSB Number:	20E-074
Product:	EuroLoft™ Bed Lift Motor
Date:	10/21/2020

Select motors (PN 346074) received from an LCI supplier have the potential for primary gear failure, allowing for the possibility of the bed frame to drop a short distance before the safety strap catches the bed frame assembly. This document will describe the process of removing a defective motor and replacing it with a new motor.

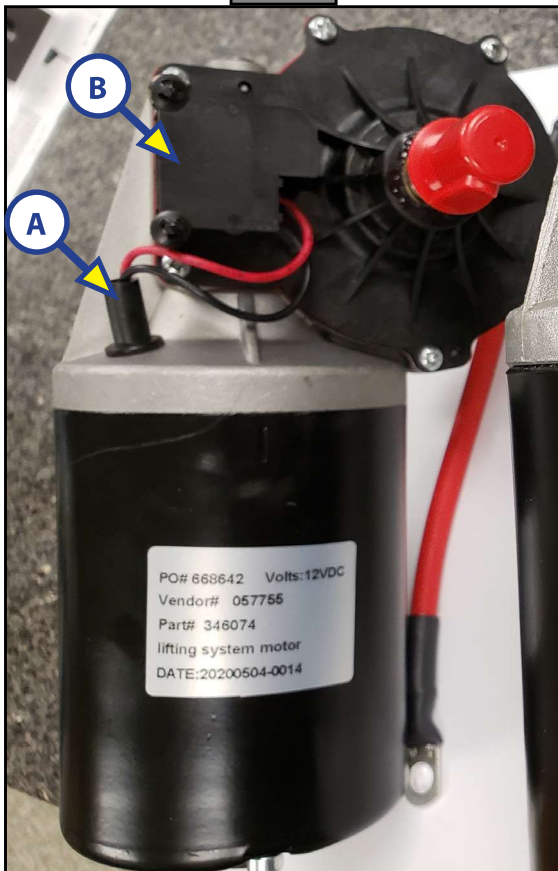
Fig. 1

**NOTE:** OLD defective motors (Fig.1) have red and black wires (Fig.1A) exiting the motor, and no LCI logo on the plastic casing of the gear box cover (Fig.1B). NEW replacement motors (Fig.2) will have green and black wires (Fig.2A) exiting the motor, and a molded LCI logo on the plastic gear box cover (Fig.2B).

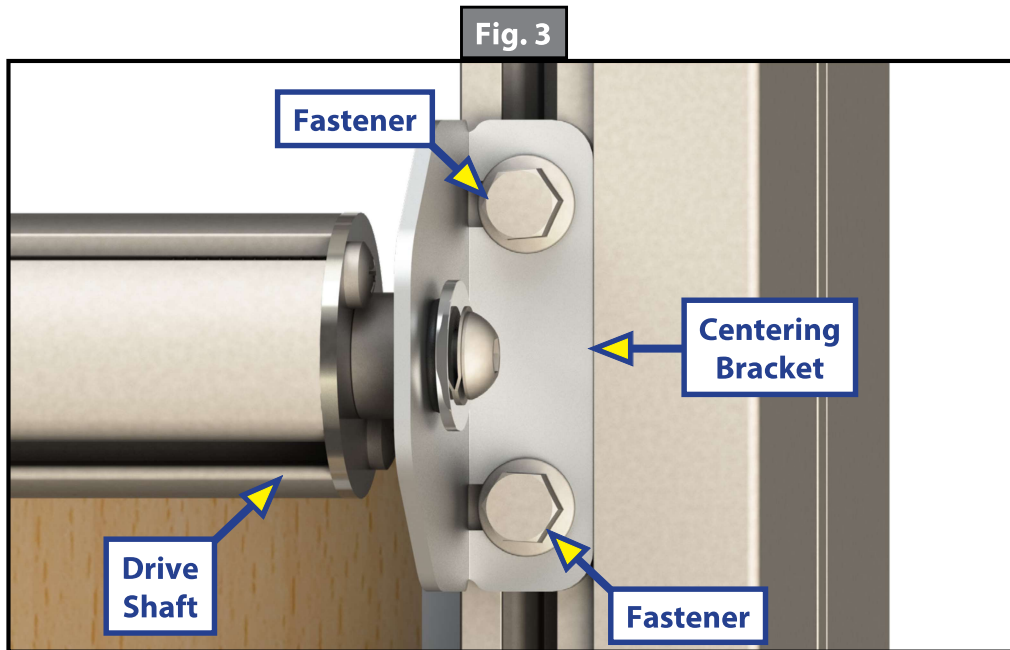
1. Support the bed frame at all lift strap locations, or so that all four corners cannot drop while working underneath the bed frame.
2. Remove the mattress from the bed frame.
3. Disconnect the main wire harness from the motor.
4. Locate the drive shaft centering bracket (Fig.3) that is attached to the drive shaft, located on the opposite side of the motor support bracket (Fig.4). Mark the position of the centering bracket with a non-permanent method of marking.
5. Remove the two fasteners (Fig.3) that hold the centering bracket (Fig.3) in place.

**NOTE:** Do not allow the bed support belts to unspool. If this happens, re-wrap the belts the same amount of rotations on the drive shaft.

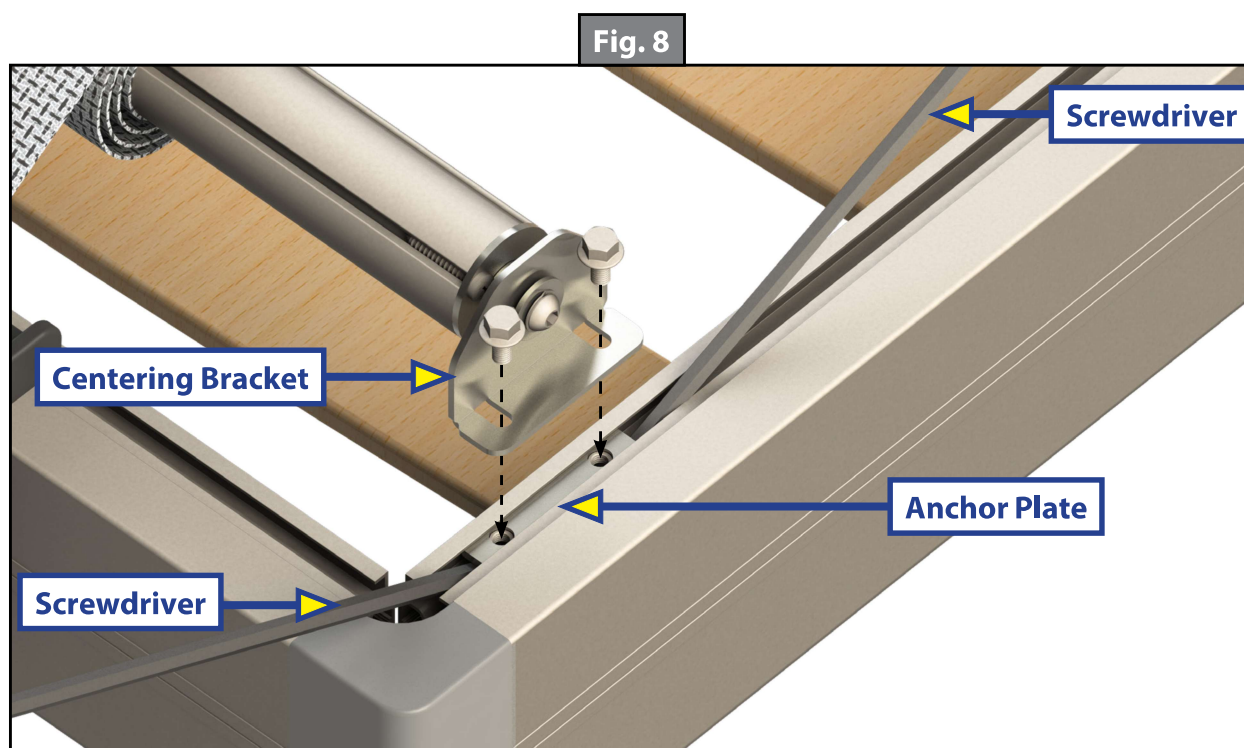
- Place the centering bracket (Fig.8) of the previously-removed drive shaft over the corresponding channel within the bedframe.

- Support the anchor plate within the channel using two flathead screwdrivers (Fig.8), and have an assistant fasten the two previously removed fasteners into the anchor plate.

**NOTE:** Use reference mark made in previous steps, to lineup the centering bracket.
