Technical Service Bulletin

GROUP RECALL	NUMBER 21-01-047H-1
DATE JULY 2021	MODEL(S) VERACRUZ (EN)

SUBJECT: T-JOINT LEAK INSPECTION AND OIL PROTECTOR INSTALLATION
(RECALL CAMPAIGN 197)

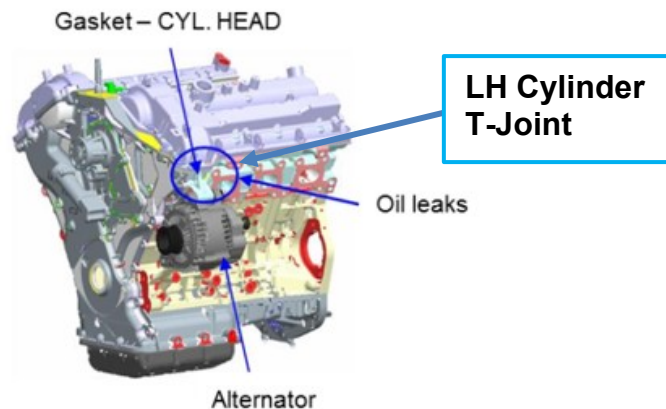
Some Veracruz (EN) vehicles may have an engine that potentially leaks oil from the front cylinder bank's valve cover onto the alternator. A sufficient amount of oil could damage the alternator resulting in illumination of the charging system warning lamp and disablement of the charging system. If the vehicle is continually driven without recharging the battery, the engine will eventually shut off, increasing the risk of a crash. This bulletin outlines the procedures to inspect for T-joint leakage and install an oil protector to address this issue.

- If the T-Joint shows no leakage, install oil protector.
- If the T-Joint shows leakage, replace the LH cylinder head cover gasket, alternator, and install the oil protector.

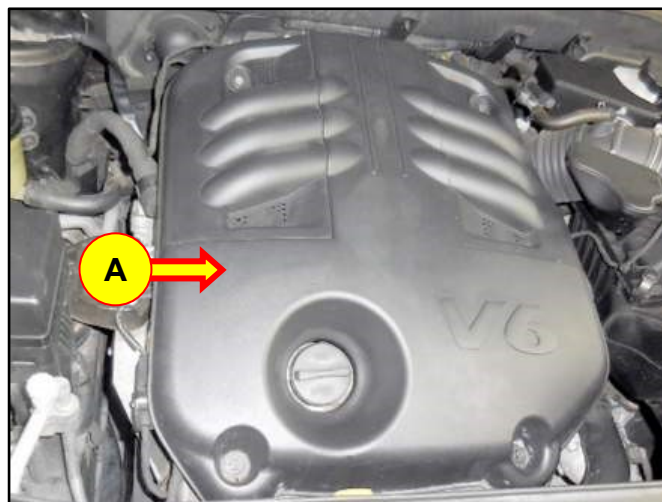
2. Remove the engine cover (A).

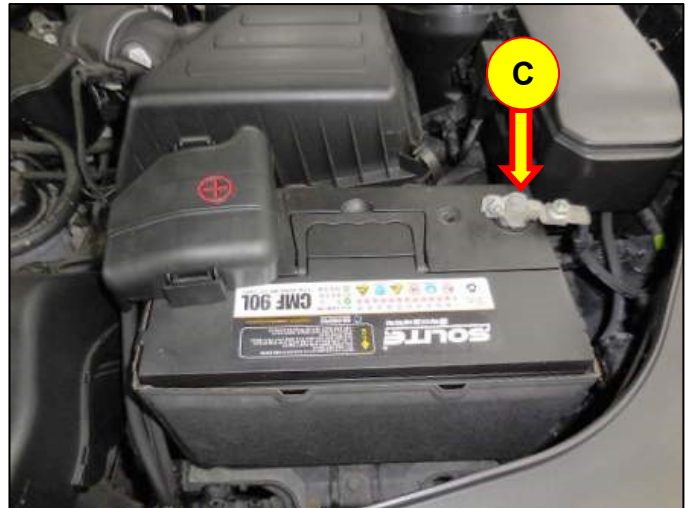
- Loosen the battery tray mounting fasteners and remove the battery tray (D).

Set aside the removed battery tray (D) to a safe area so that it does not interfere during the alternator removal process.

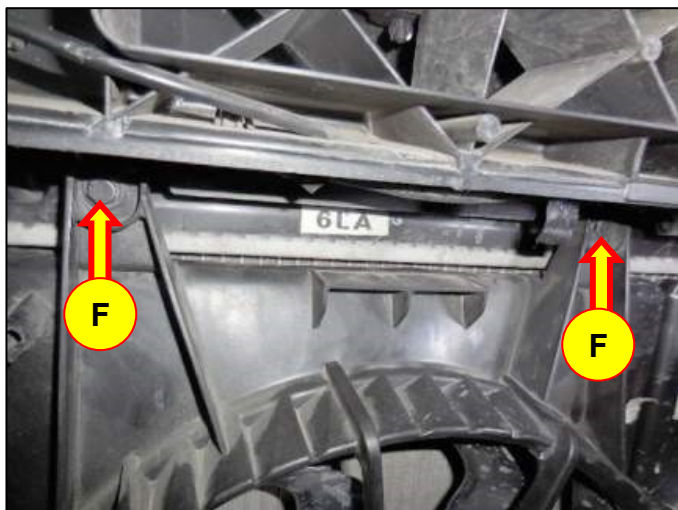
7. Remove the LH fan shroud bolts (F).

***Tightening torque specification:
5.0 lb-ft (60 lb-in, 6.8 Nm)***

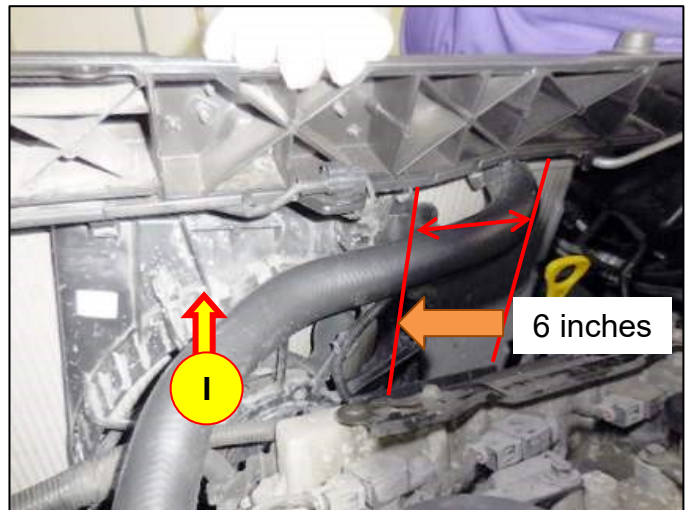
10. Move the RH fan shroud (I) about 6 inches towards the driver's side of the vehicle (as shown by the orange arrow) to provide enough working space to move and/or replace the alternator.

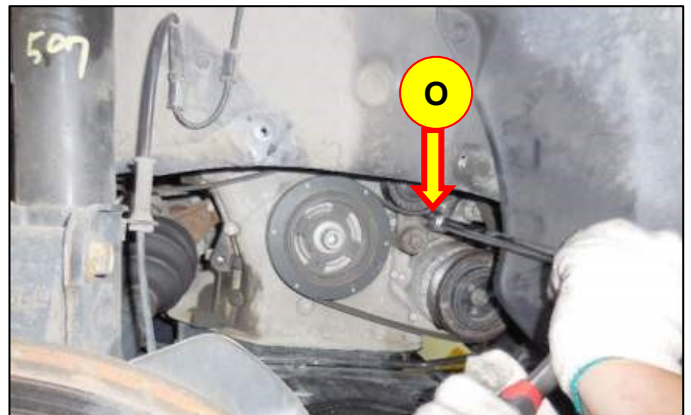
16. Remove the drive belt after relaxing the belt tension by rotating the tensioner pivot bolt (O).

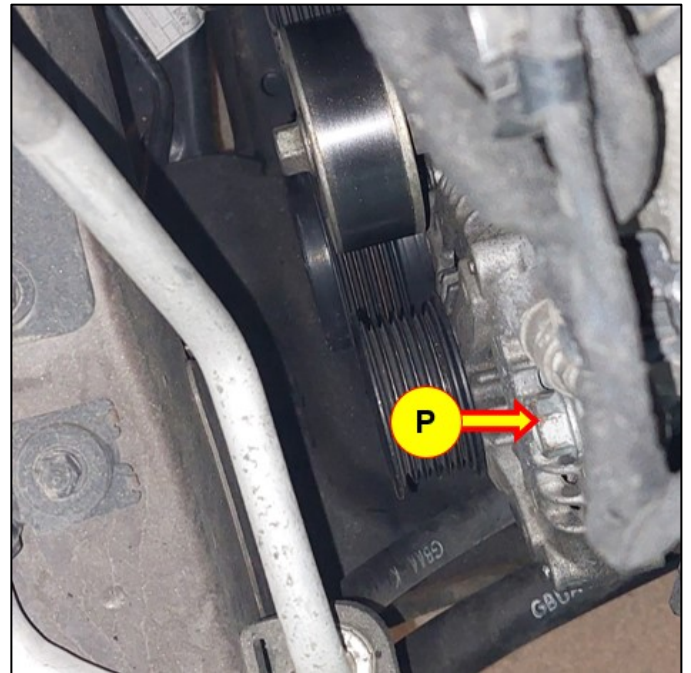
17. Remove the alternator upper mounting bolt (P).

***Tightening torque specification:
22 lb-ft (29.8 Nm)***

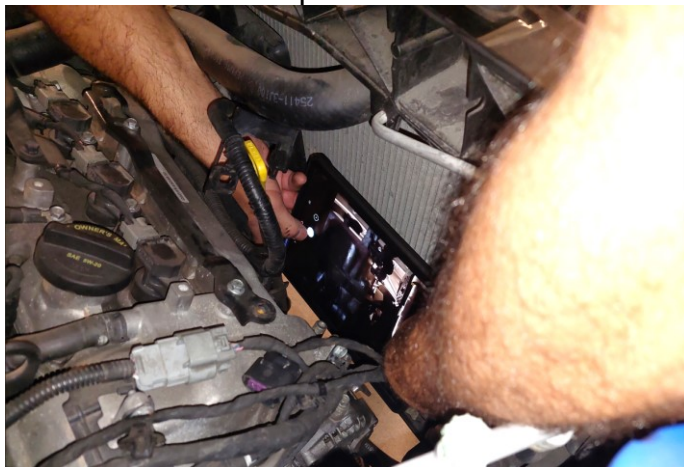
- 18. **Take photo of the T-joint area as shown** using GDS tablet STUI camera photo upload function. Save and submit to HMA.

Reverse the tablet camera for front picture taking and orient the tablet as shown to be able to view and take the photo:

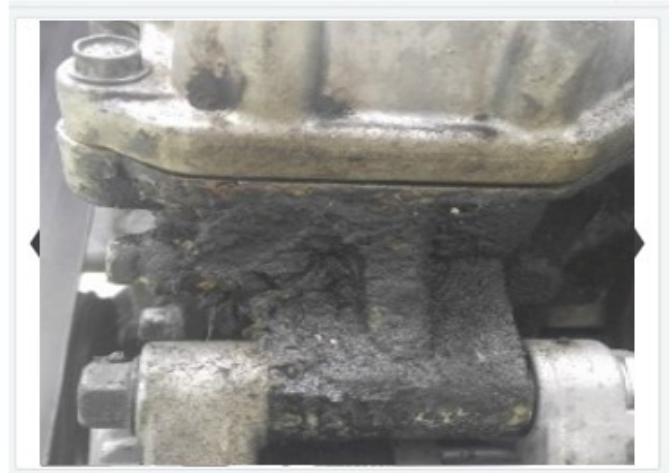
Required STUI camera photo:

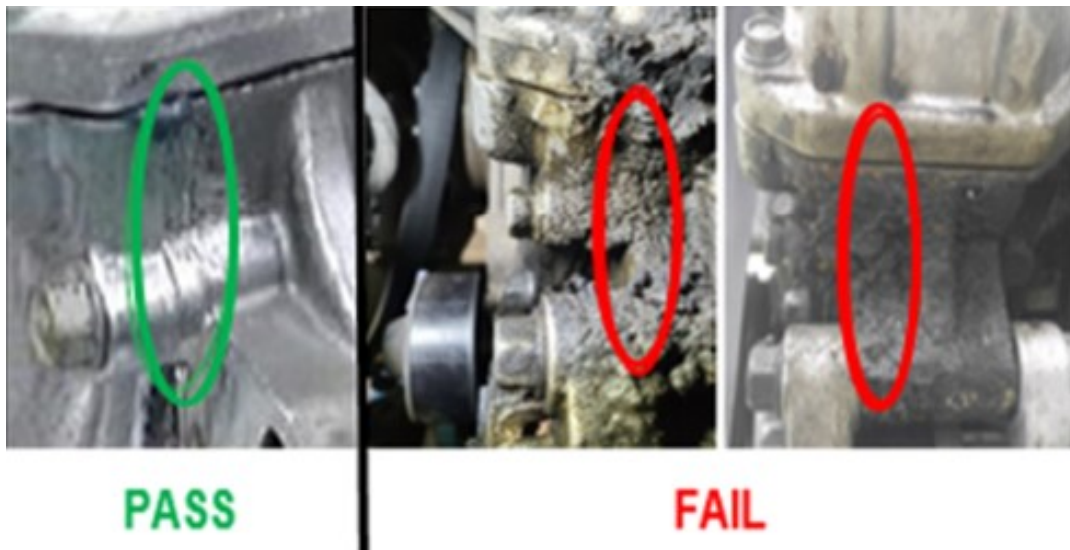
- 19. Inspect T-Joint area for oil leakage:

20. IF T-JOINT HAS NO LEAKAGE (PASS):
(Only the Oil Protector will be installed).

IF T-JOINT HAS LEAKAGE (FAIL):
(Head Cover Gasket and Alternator will be replaced. Oil Protector will be installed).

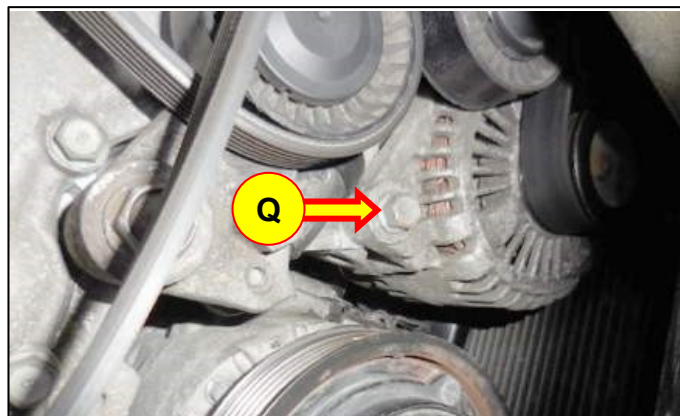
- Loosen the alternator lower mounting bolt (Q).

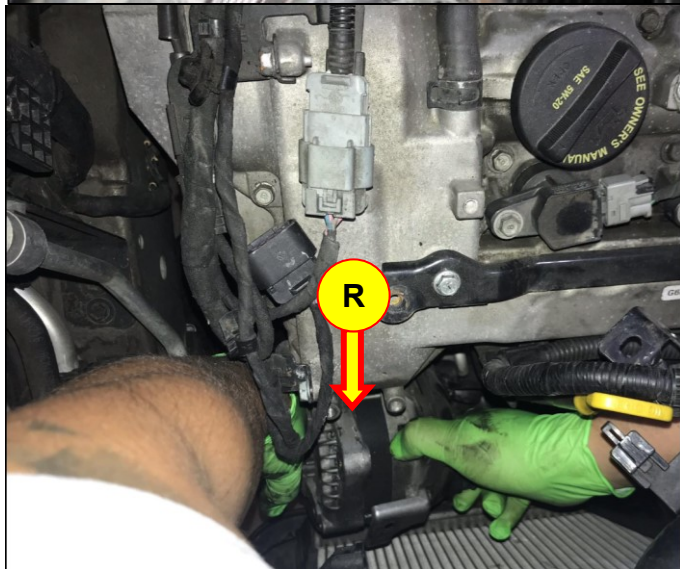
- Remove the alternator lower mounting bolt (Q) and remove alternator (R).

NOTE: Alternator will be replaced.

***Tightening torque specification:
22 lb-ft (29.8 Nm)***

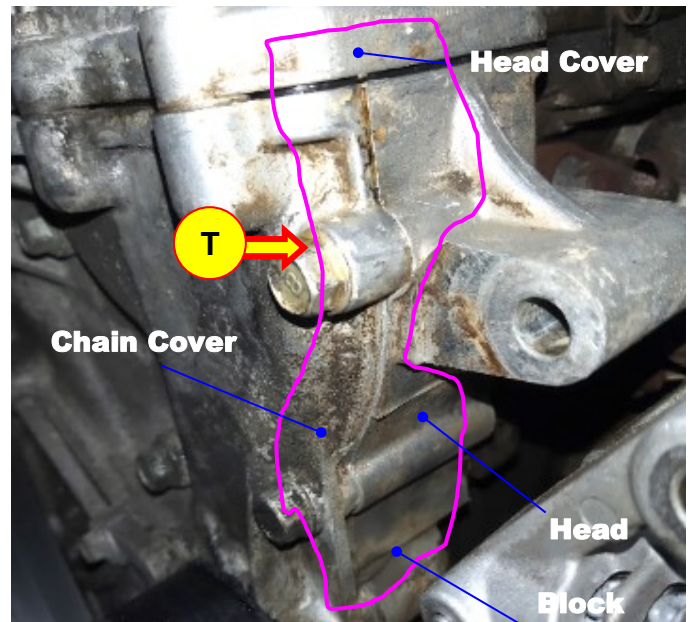
- 24. The oil protector will be sealed to the engine at this point. **It is crucial that this area is free from oil and contaminates.**

(T) Area: Head, Head Cover, Chain Cover, and Block

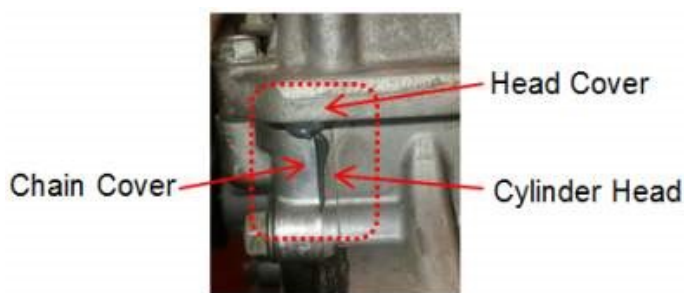
25. Remove all liquid gasket residue (including outside area of the cylinder head and chain cover as shown in the picture to the right).

- *The removed liquid gasket residue should not fall into the engine.*

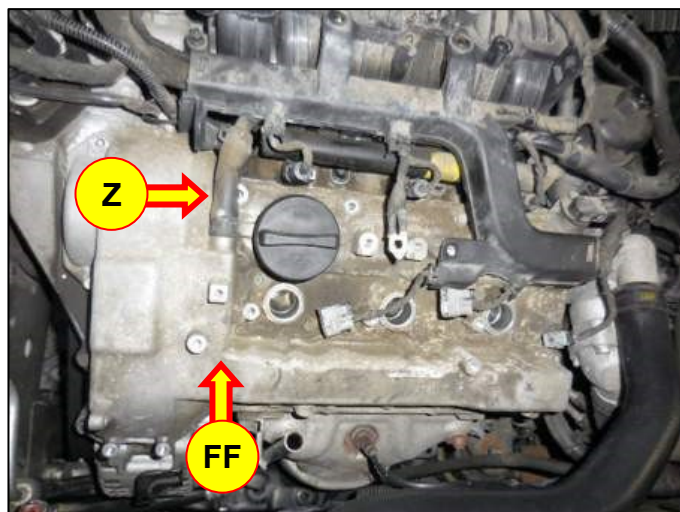
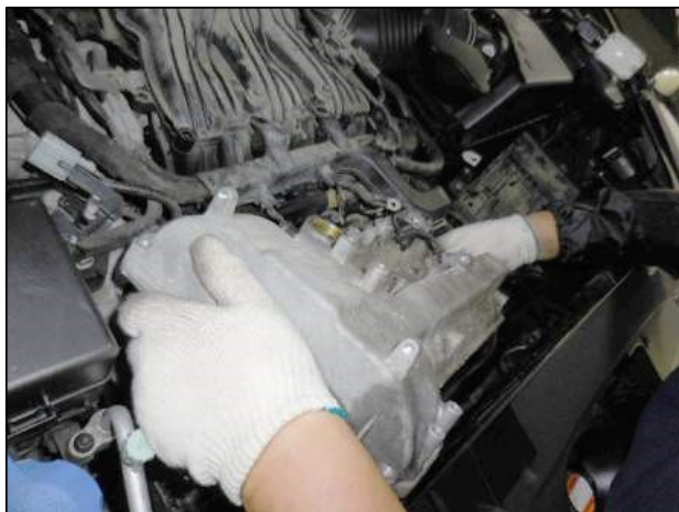
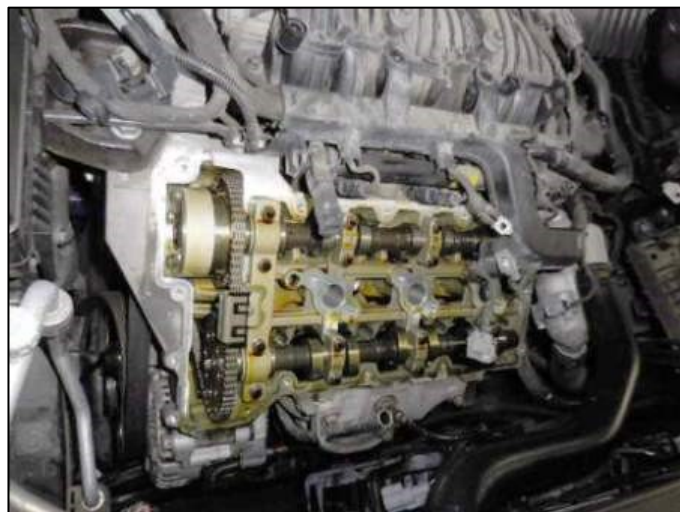
34. Remove the hose (Z).

Remove the bank 2 (LH) cylinder head cover (FF).

**Tightening torque specification:
8.0 lb-ft (96 lb-in, 10.8 Nm)**

Carefully remove the cylinder head cover to avoid any dirt/debris falling into the engine. Debris falling into the cylinder head can result in engine damage.

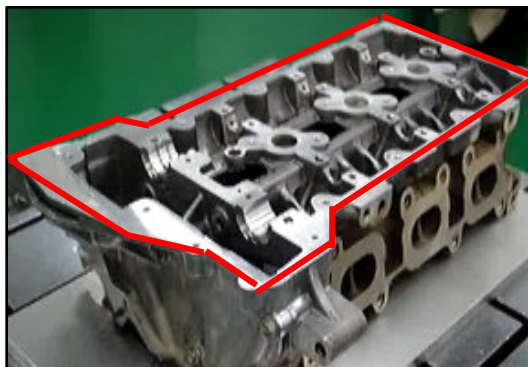
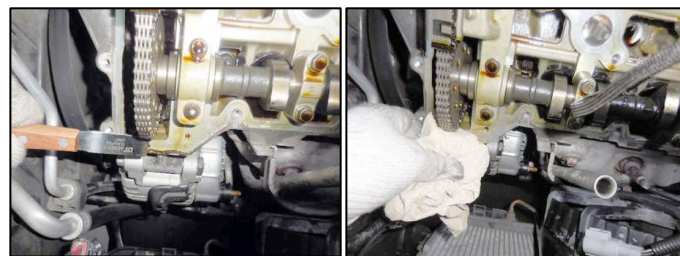
35. Clean the cylinder head and cover with a clean lint-free shop towel, referring to the picture of the cleaning area below (highlighted in red).

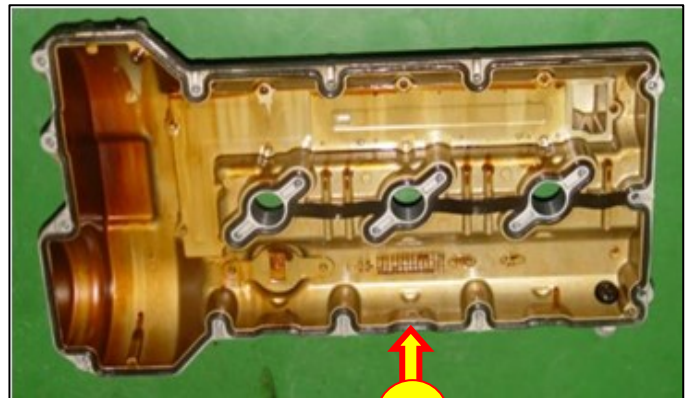
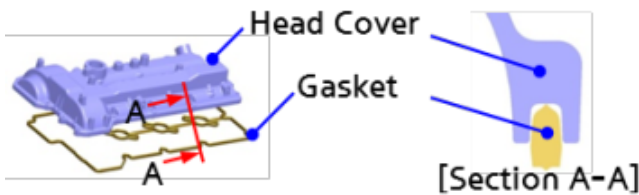
Gasket Installing Groove (Cleaning area)

- 38. Install the new cylinder head cover gasket (II).

Before installing the new gasket (II), clean the gasket installing groove with brake cleaner and a clean lint-free shop towel.

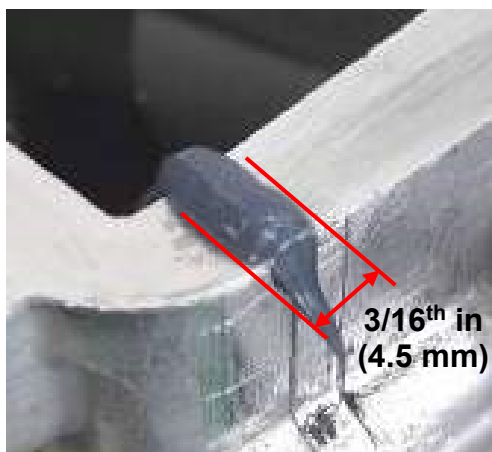
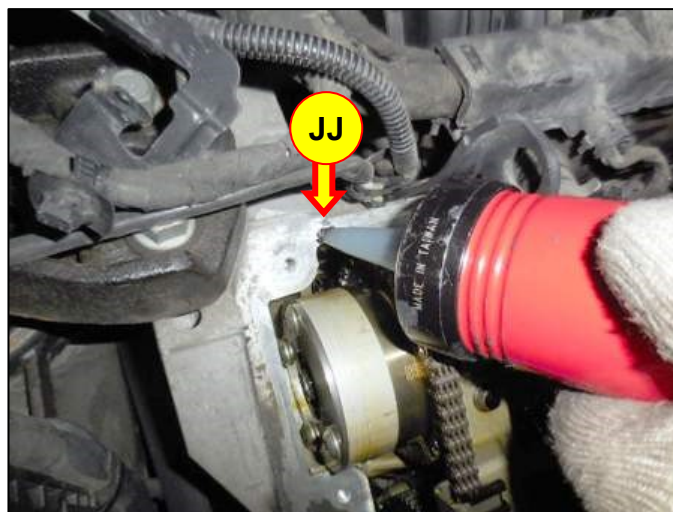
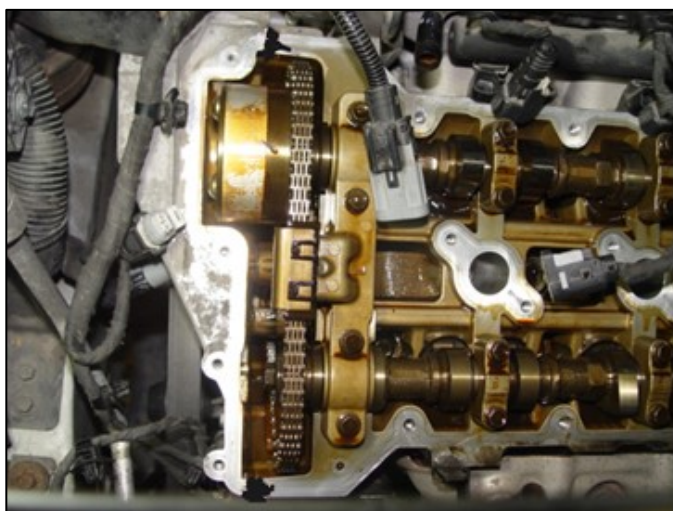
39. Apply liquid RTV gasket onto the “T” joints (JJ), which are the mating points where the front timing chain cover and the cylinder head meet.

When applying the liquid RTV gasket, the applied bead on the surface should be approximately 3/16th in (4.5 mm) wide as shown in the picture below.

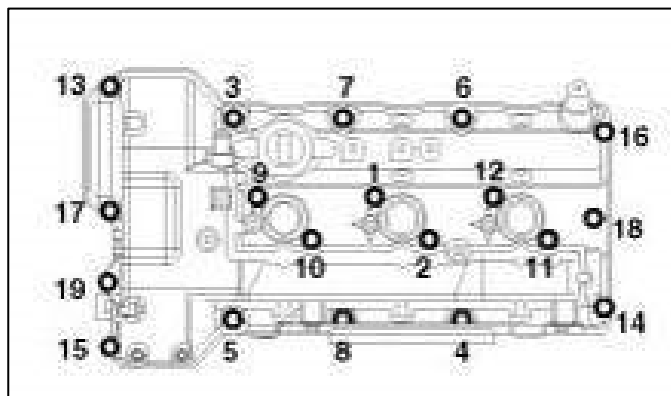
40. Carefully reinstall the cylinder head cover within 5 minutes before the liquid RTV gasket begins to harden.

**Tightening torque specification:
8.0 lb-ft (96 lb-in, 10.8 Nm)**

When reinstalling the cylinder head cover, tighten the bolts in the order as shown in the picture at right.

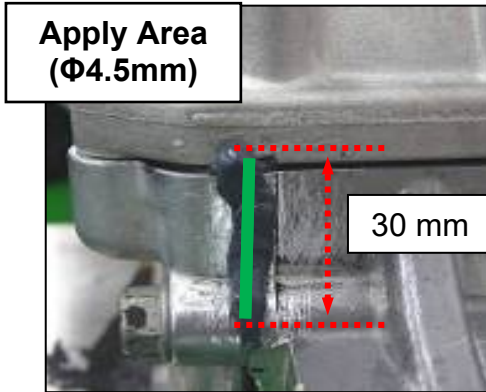
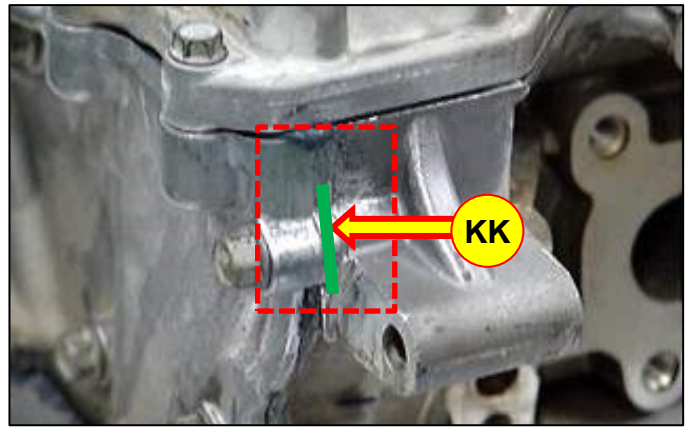
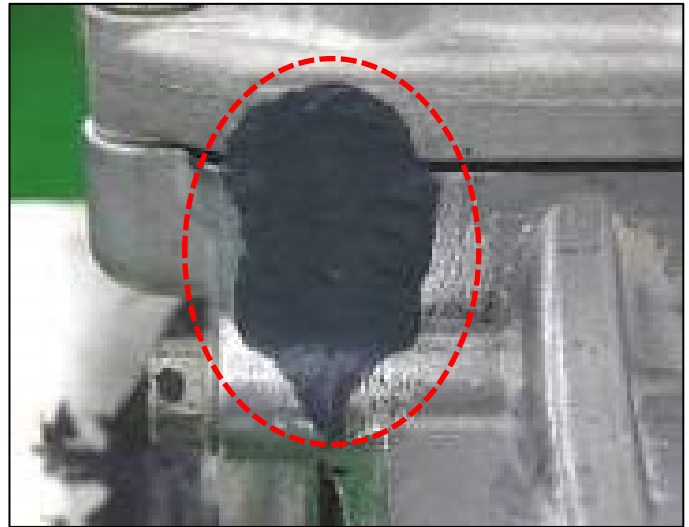
41. Apply liquid RTV gasket onto the outer surface of the “T” joints (KK) of the cylinder head and cover.

- Apply the liquid RTV gasket in a line at least 30 mm long, following the green bold line as shown in the picture on the right and below.

- Within several minutes before the liquid RTV gasket begins to harden, spread the RTV evenly as shown in the picture on the right.

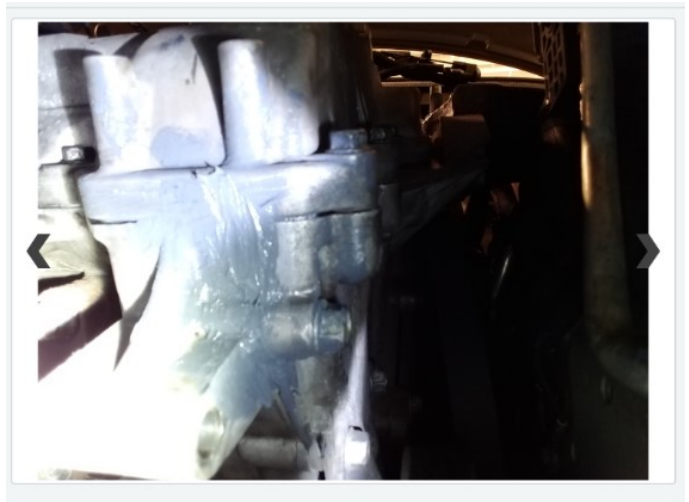
42. Take photo of your work of applying RTV at the T-joint area as shown using GDS tablet STUI camera photo upload function. Save and submit to HMA.

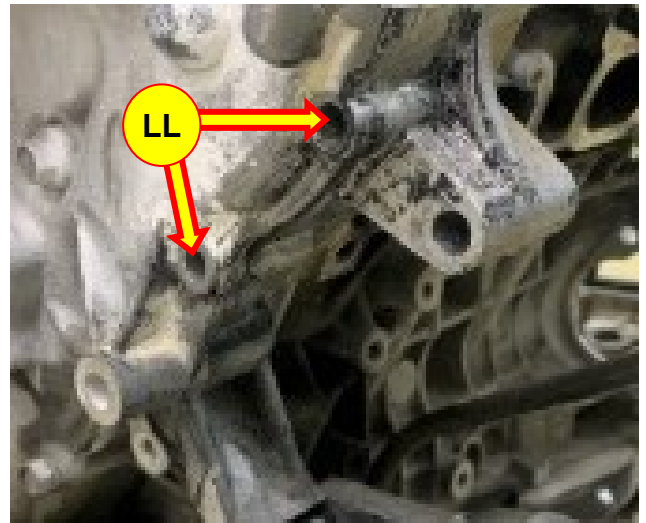
Remove (2) chain cover bolts shown here (LL).

If oil seeps through bolt holes, clean thoroughly with brake cleaner.

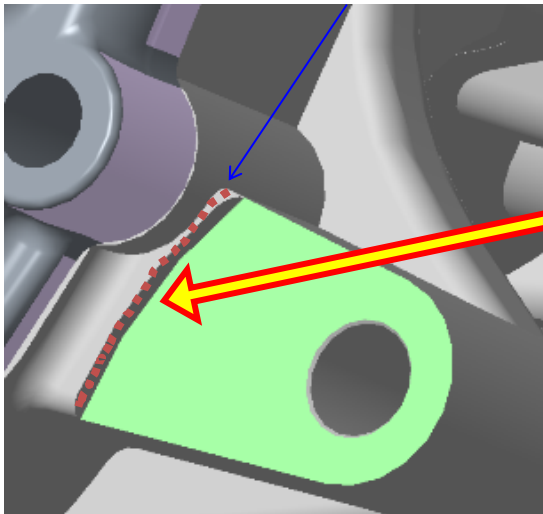
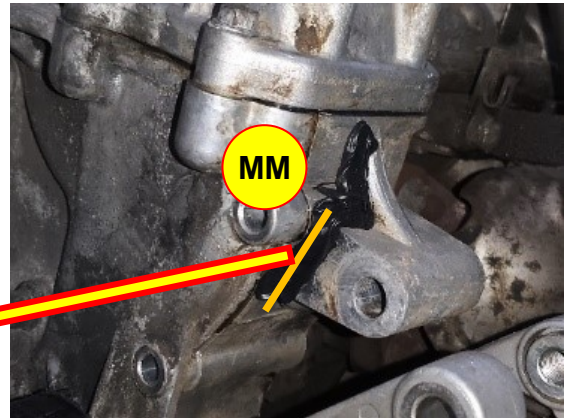
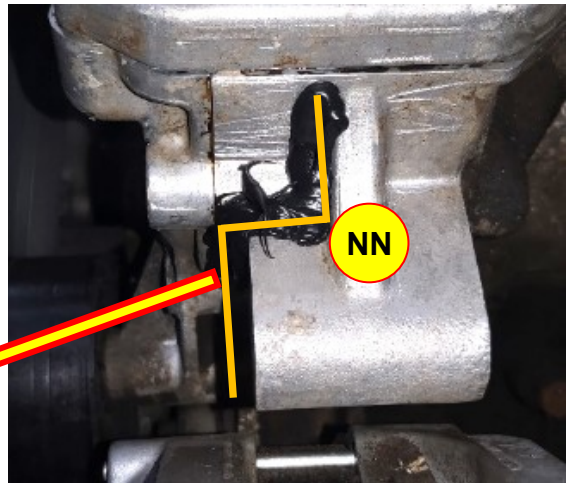
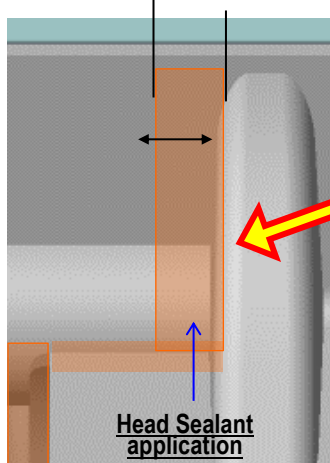
44. Apply RTV sealant onto (MM) and (NN) areas as shown in the photo.

Sealant application along machined edge.

Width: 6mm

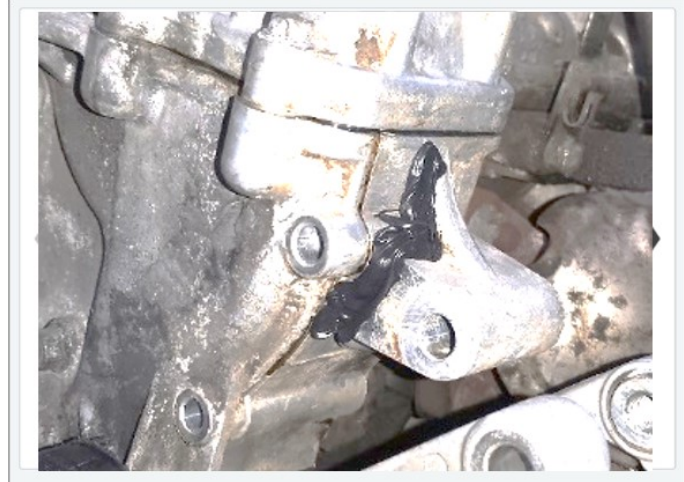
Required STUI camera photo

- 45. Take photo of your work applying the RTV in this area as shown using GDS tablet STUI camera photo upload function. Save and submit to HMA.

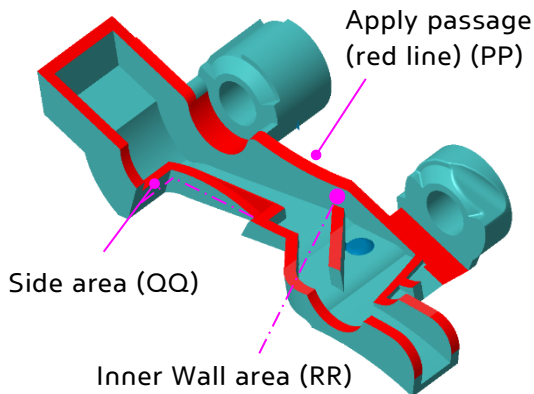
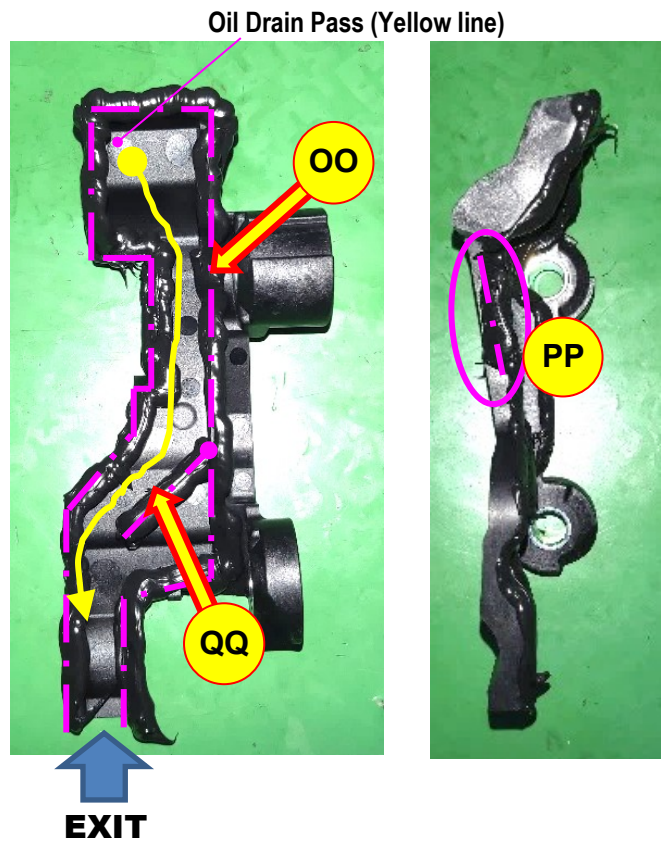
- 46. Apply Sealant onto the oil protector at the indicated areas pictured (OO, PP, QQ).

Be careful not to block the exit. If sealant falls inside the bottom of the oil protector, thoroughly remove sealant and reapply. (To prevent clogging of the oil drain passage)

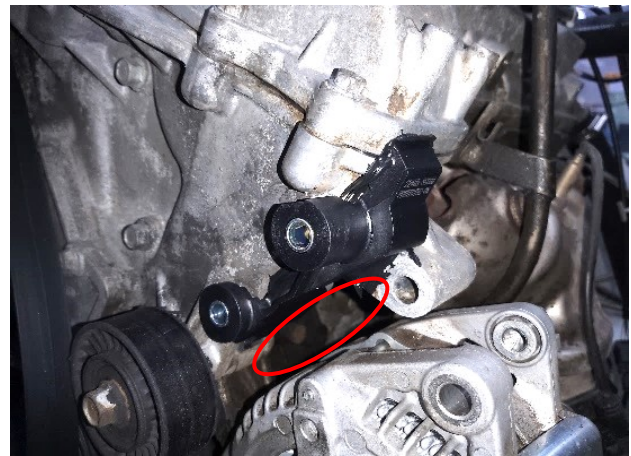
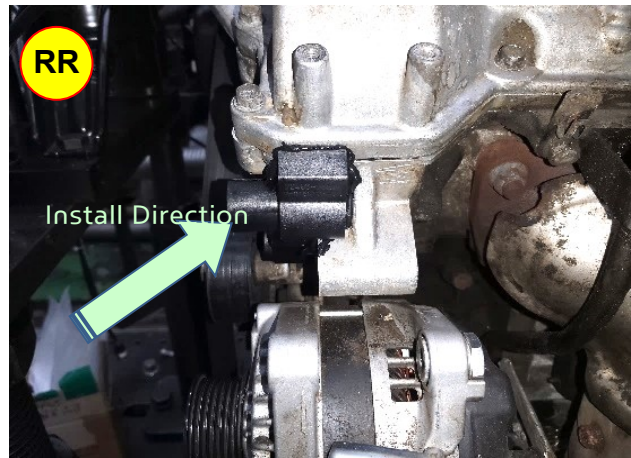
47. Place oil protector in place.
- 1.) Install oil protector to the timing chain cover in the indicated angle pictured in (RR).
 - 2.) Be careful not to contact the surrounding parts.

If the sealant is heavily smeared on the surrounding parts, remove the oil protector, thoroughly clean the sealant from surrounding areas and clean oil protector. Go back to step 44 and repeat.

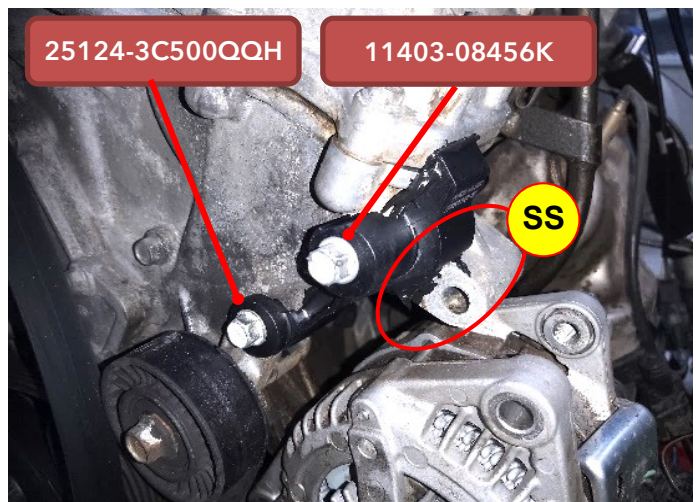
48. Install provided kit bolts into oil protector.
- Bottom bolt: 25124-32C500QQH (M8X35mm)
 - Upper bolt : 11403-08456K (M8X45mm)
 - Check fitment of oil protector.
 - Firmly Press sealing surface by hand.
 - Keep it in loose contact with the engine.

**Tightening torque specification:
15.0 lb-ft (20 Nm)**

NOTE: Do not use original 'chain cover' bolt.

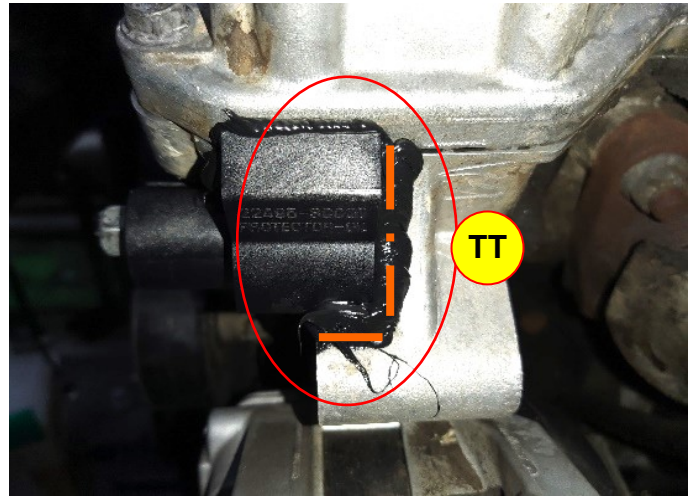
49. Remove sealant from alternator mount (SS).

50. Apply the sealant to the (TT) area to seal oil protector to block.
