Thor Motor Coach Recall Repair Instructions

Recall #	20V-711 2020-554		
Description/Title:	BIM/BIR Replacement Expanded Scope		
Affected Product Line(s):	Certain Model Year 2020/2021 Chateau, Daybreak, Four Winds, Freedom Elite, and Quantum motorhomes built on a Chevy chassis		
Service Campaign # :	RC000206	Released Date:	12/29/2020
Repair Code:	TMCRC80497V	Document Date:	12/29/2020
Time Allowed:	0.75	Document Revision:	A

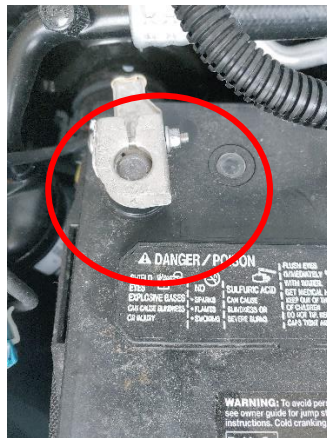
2. Disconnect battery cable from negative post of the chassis battery located under the hood.

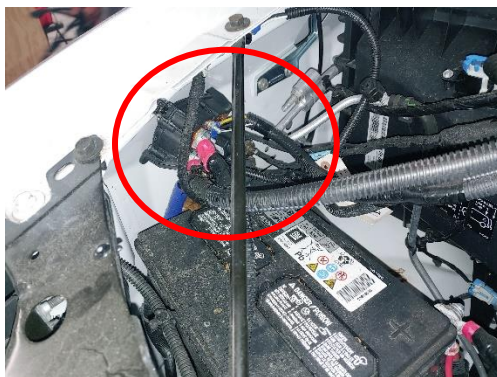
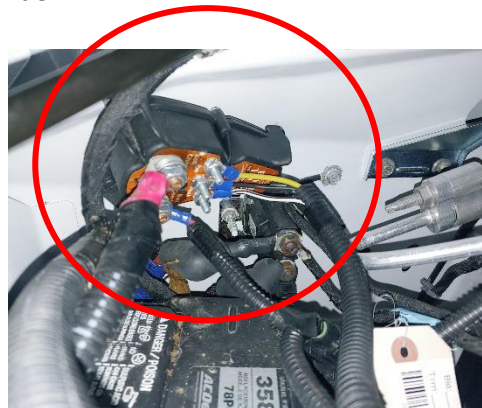
3. Locate BIM/BIR mounted on passenger's side inside fender.

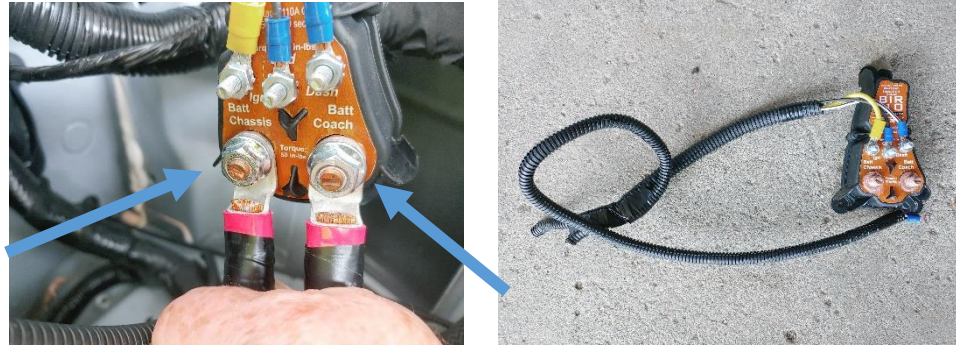
4. Remove the chassis battery cable and the house battery cable from the BIM/BIR and remove BIM/BIR.

Note: The BIM/BIR needs to be returned to Thor Motor Coach for payment of the recall repairs.

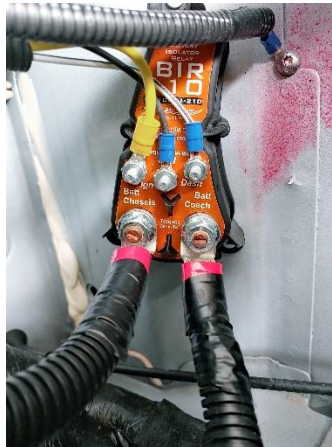
5. Remove the screws holding the BIM/BIR to the inside fender.

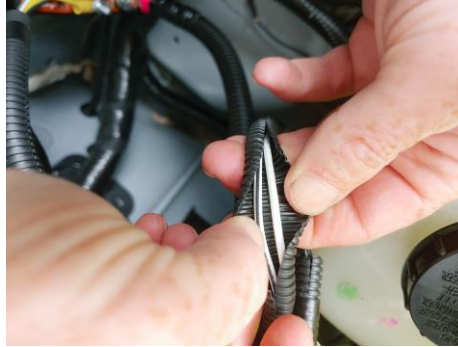
7. Open the loom for the dash switch, locate the white and white with black tracer. Cut both wires.

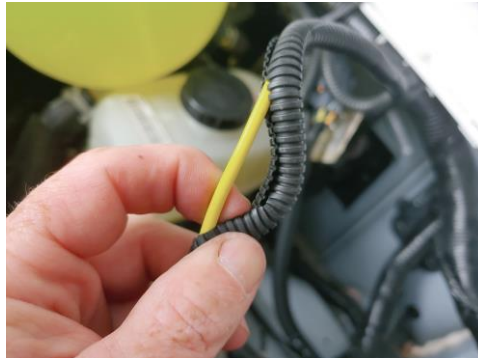
8. Open the loom for the ignition power, locate the yellow wire and cut.

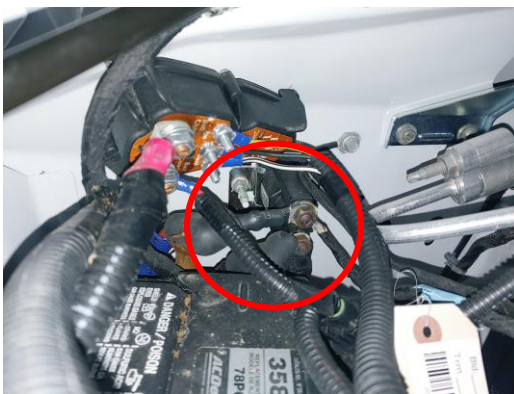
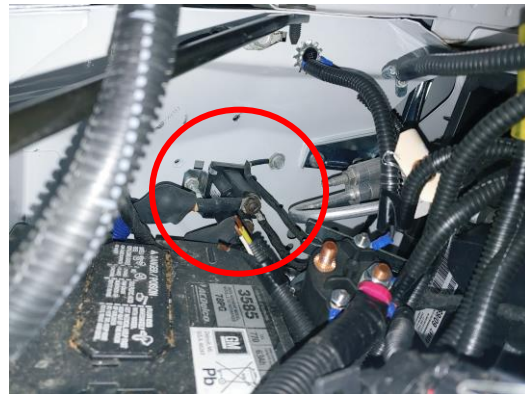
9. Find a good clearance where BIM/BIR was installed to mount the Trombetta solenoid. Make sure it is far away enough from the solenoid installed on fender below where the BIM/BIR was installed to avoid sparking.

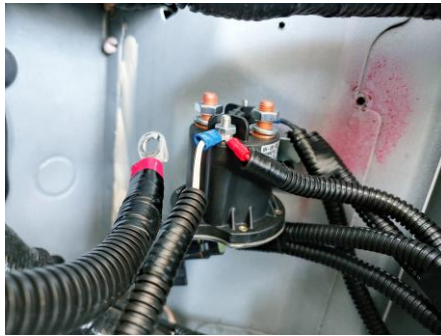
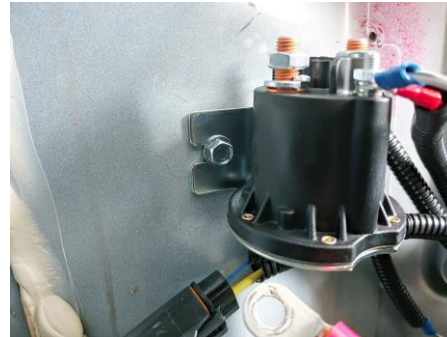
10. Start a ¼" self-tapping hex head screw at the installation mark on the fender wall. Slide Trombetta solenoid bracket into place on the self-tapping hex head screw and secure.

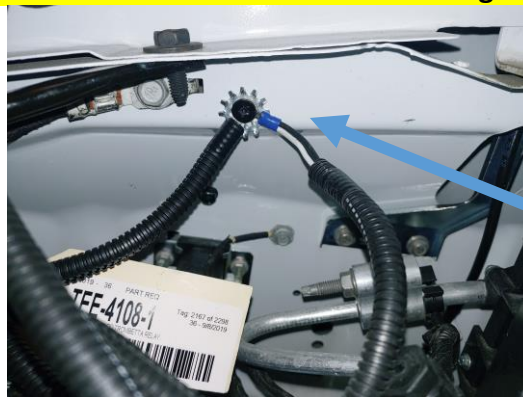
11. Install a 1/4" self-tapping hex head on the other side of the bracket of the Trombetta solenoid.
12. Install ground wire, black wire with ring terminal, above Trombetta solenoid on the inside of the fender by using a 1/4" self-tapping hex head using a 3/8" bit.

NOTE: Must use a star washer between the ring terminal and fender.

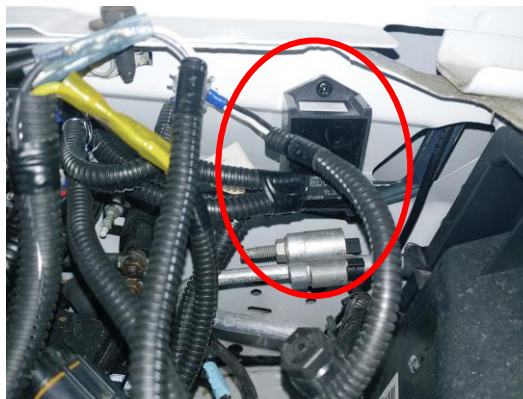
13. Mount the Isolater Relay Delay (IRD) beside the Trombetta solenoid and along the seam of the fender with 1-2 - #8 self-tapping pan head screws.

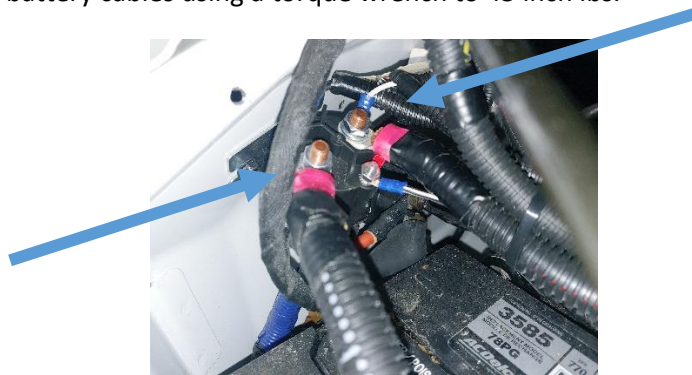
14. Verify which cable is coming from the chassis battery by tracing it back to the chassis battery. Remove the washer and nut from the Trombetta solenoid and secure the chassis battery cable to the large terminal post of the Trombetta solenoid closest to the firewall with the washer and nut.

Note: If either battery cable ring terminal is bent – straighten before securing.

15. Secure the house battery cable to the other large terminal post (towards the front) of the Trombetta solenoid – this house battery is to be secured together with the white wire of the emergency start switch. Put the battery cable on the post first, then place the white wire on top and secure with washer and nut.
16. Tighten nuts on both battery cables using a torque wrench to 45 inch lbs.

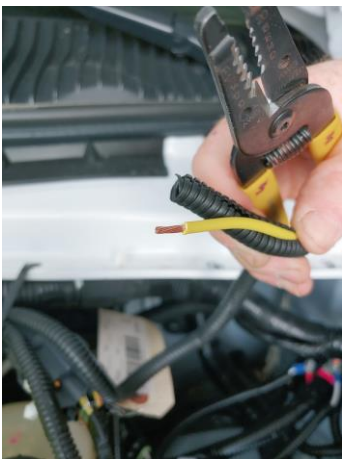
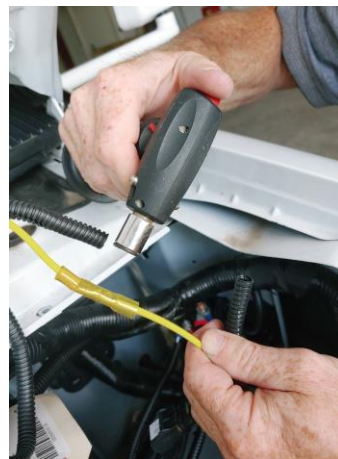
17. Locate and cut yellow ignition power wire, strip back, and connect to yellow wire w/ yellow butt connector from the fuse holder. Crimp and heat shrink using a torch or electric heat gun. Using electrical tape, tape both ends of the yellow wires.

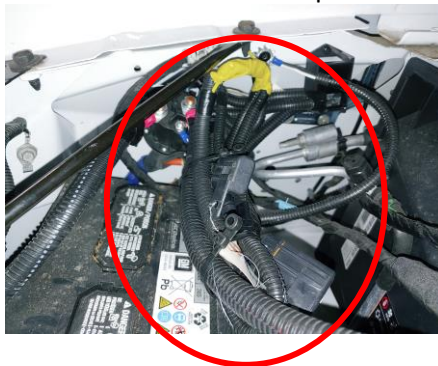
19. Zip tie fuse holders and wires together as shown below to keep secure.
