20PBF

Peterbilt

Model 520 Stability Control Brake Relay Hose Misconnected - NHTSA: 20V739

12/2/2020

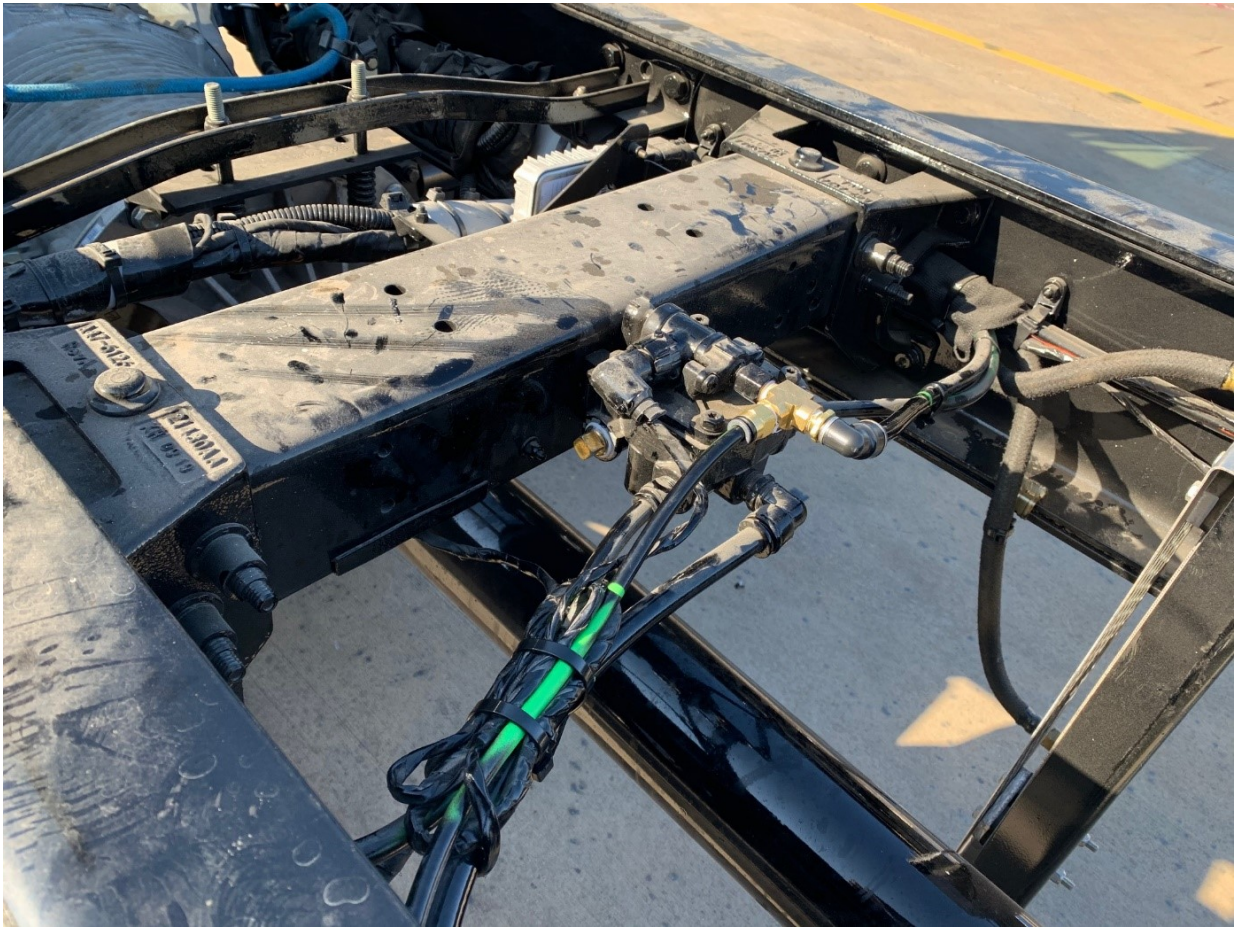
1. Refer to the image below that shows a correctly plumbed relay valve.
2. Inspect the truck to see if the relay valve(s) are plumbed correctly. If plumbed correctly, no further action is required.
3. If the relay valve(s) are not plumbed correctly, refer to the Repair Procedure in the Attachment section to correct the plumbing.

Peterbilt has decided that a condition affecting vehicle stability may exist in certain Model 520 vehicles built from 9/26/2019 through 7/22/2020 with stability control and a spring brake modulator valve (SBM) or lift axle. A stability control event meant to only actuate the ABS controlled wheel ends could actuate lift axle brakes or modulate park brake chambers and could possibly de-stabilize the vehicle, increasing the risk of a crash.
