GROUP  
**Safety Recall  
Campaign**

NUMBER  
**SC200\*\***

DATE  
**January 2021**

**SUBJECT: ENGINE COMPARTMENT FIRE: PREVENTIVE ENGINE INSPECTION AND KSDS SOFTWARE INSTALLATION (SC200\*\*)**

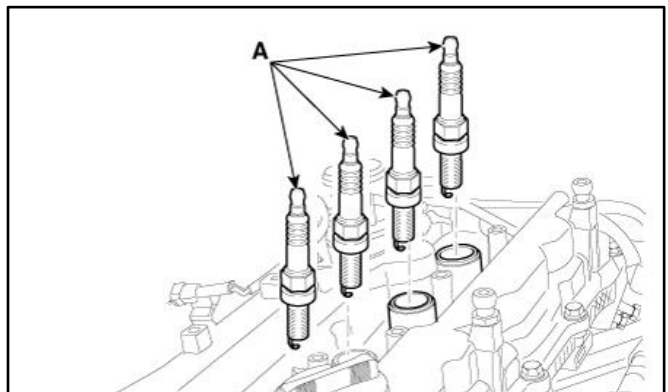
2. Remove the four (4) spark plugs (A) by referring to the “Maintenance → Power Train → Spark Plug → Repair procedures (Replacement)” in the applicable Shop Manual on KGIS.

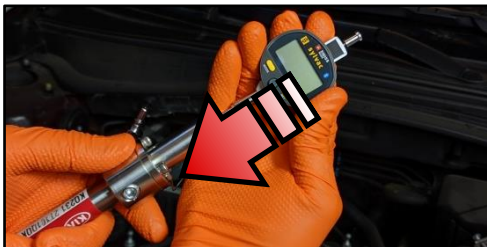
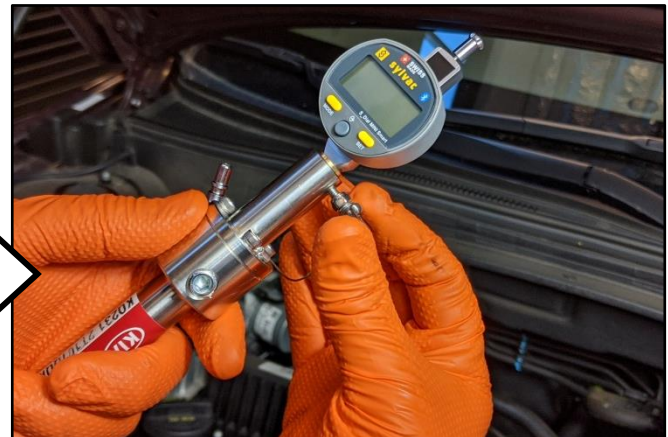
7. Install the Dial Gauge fully into the Probe Rod and secure together by hand tightening the locking wingnut.

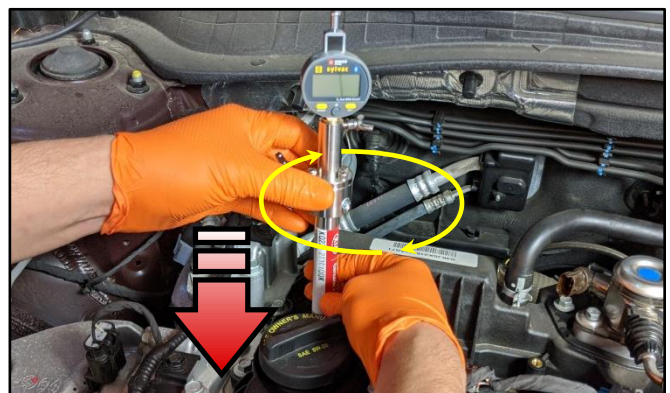
8. **Carefully**, insert the assembled SST Probe Rod and Dial Gauge into the Cylinder 1 spark plug hole and **carefully** turn the SST Crankshaft Rotator **by hand** clockwise until hand tight.

**Damage to cylinder head can occur if spark plug hole is cross-threaded. DO NOT use a wrench to tighten the SST rod.**

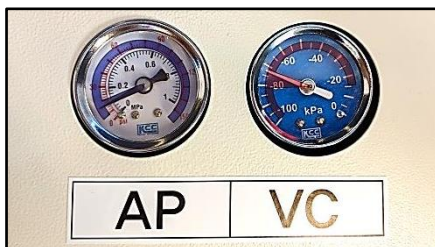
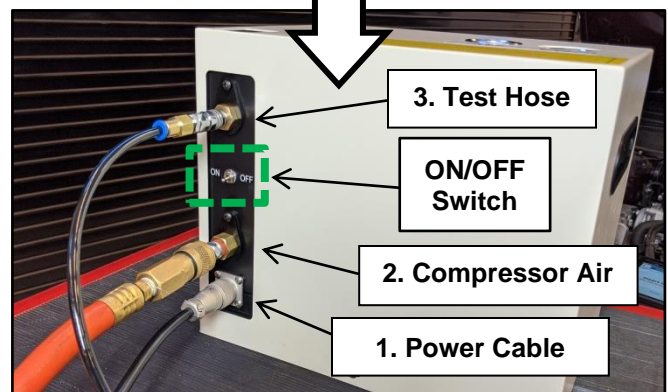
18. Turn the Bearing Clearance Tester power switch to the 'ON' position. Gauges should read as follow:

**AP (Pressure) Gauge: (0.1 ~ 0.11MPa)**  
**VC (Vacuum) Gauge: (-73 ~ -83kPa)**

**If the gauges do not read within specification, calibration of the SST box is required. Refer to [TSB SST067](#) for details.**

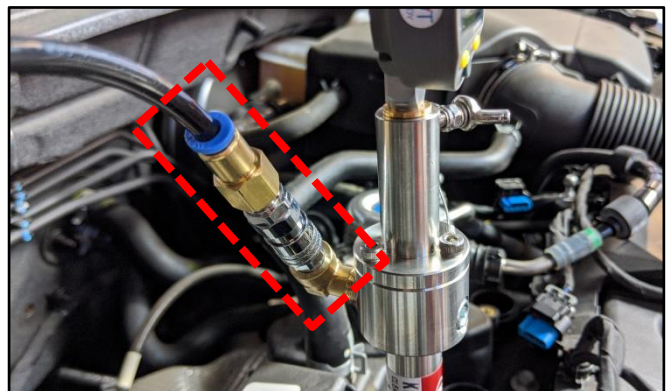
19. Carefully, insert and connect the other end of the Test Hose to the Probe Rod fitting.

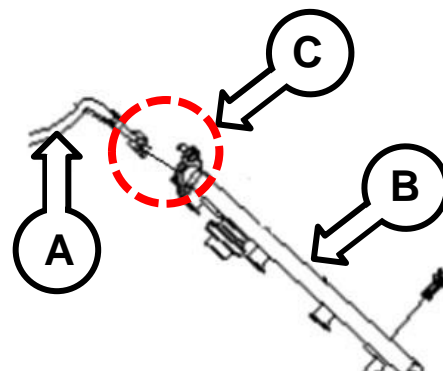
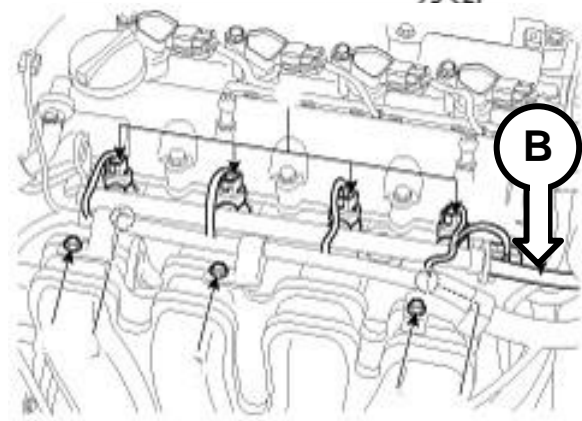
NG: Fuel Leakage	OK: No Leakage

1. Open the hood and remove the engine cover.
2. Inspect for fuel leakage according to the steps below.
  - 2a. Start the engine 'ON'.
  - 2b. Press gas pedal to the floor for 5 seconds, repeat 3 times. Then follow the steps below (2c, 2d) maintaining a steady idling condition.
  - 2c. **Theta 2.4L MPI Engine**  
(XMa, SL, TD, TF HEV):
    - Inspect the fuel feed line (A) and delivery pipe (B) connection (C) for fuel leaks using one sheet of test paper (see diagram below).
    - If fuel leakage is found, refer to KGIS for the fuel line connector torque specification to retighten.
    - If fuel is still leaking, open a Techline case online.
    - If no leak is found, proceed to oil pan leak inspection, step 3.

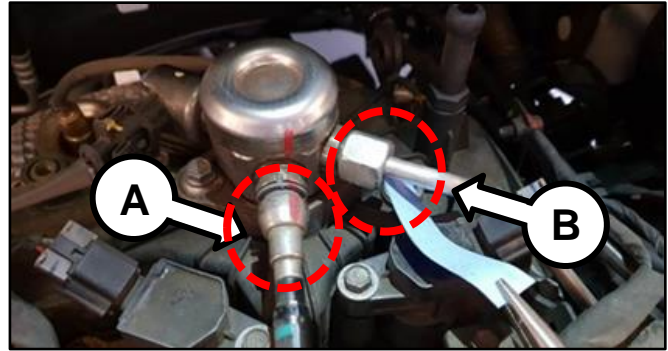
NG: Fuel Leakage	OK: No Leakage

- Inspect the low pressure line (A) and the two (2) high pressure fuel line connections (B) & (C) for fuel leak(s) using an oil test paper (see diagram below).
- If a fuel leak is found, **replace** the affected fuel line and/or pipe by referring to the “Engine Control/Fuel System → Fuel Delivery System → Delivery Pipe → Repair procedures” chapter in the applicable shop manual. Ensure the removed part cannot be reused.
- If **no leak** is found, proceed to oil pan leak inspection, step 3.

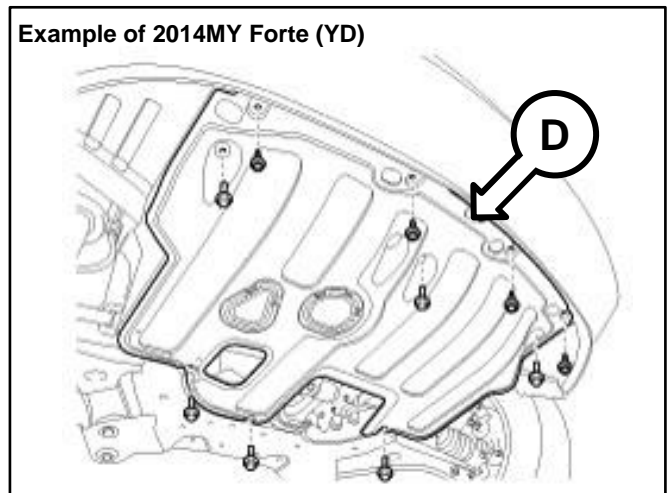
3. Raise the vehicle on a hoist and remove the undercover(s) (D).

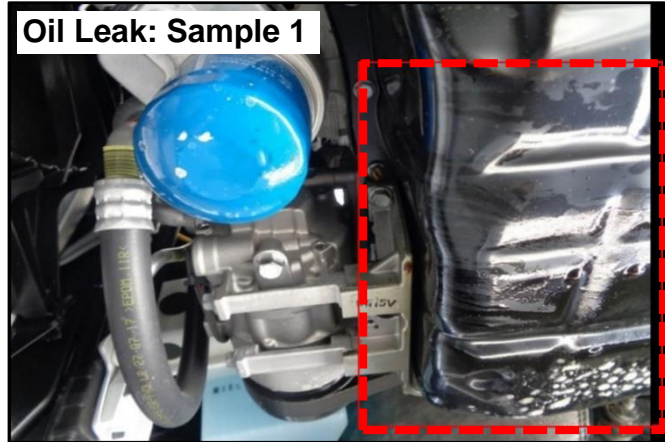
**Oil Leak: Sample 1**

- 4a. Visually inspect for oil leaking from the oil pan seal area.
- 4b. **If oil leakage is found**, (refer to sample images shown), replace the oil pan by referring to the “Engine Mechanical System → Lubrication System → Oil Pan → Repair procedures” chapter in the applicable Shop Manual on KGIS.
- 4c. Open a Techline case and submit PWA.

For this Oil Leak Inspection, replace Oil Pan ONLY with a PWA’s confirmation of an apparent visible oil pan leak.

- Be sure to tighten bolts to specifications found on KGIS within 5 minutes of sealant application.
- Wait at least 30 minutes after assembling the oil pan, to allow sealant to dry completely and refill engine oil.
