TO: Mercedes-Benz Dealer Principals, General Managers, Sales Managers, Service Managers, Parts Managers	FROM: Gregory Gunther, Department Manager, Vehicle Compliance and Analysis, Engineering Services
RE: Recall Campaign Launch Notification Retrofit Information Labels MY2019 177 (A-Class)	Date: March 20, 2021

Campaign No. 2021020019, March 2021

SUBJECT: **Model A-Class vehicles (177 platform)**
Model Year 2019
Check identification plate and various information labels

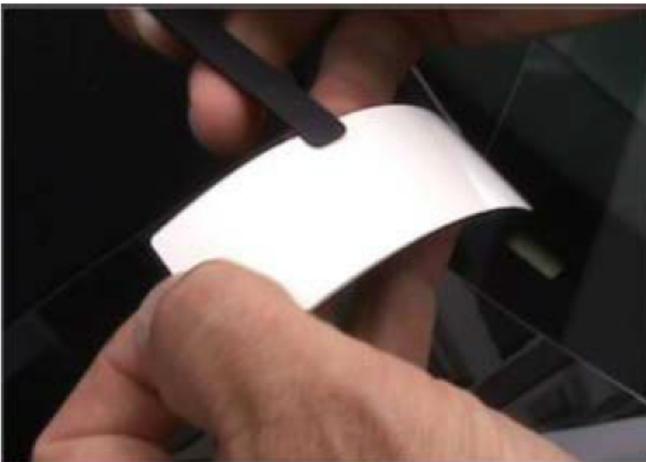
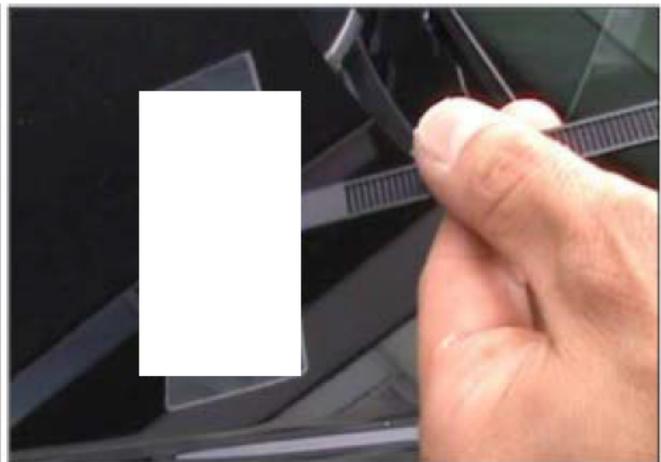
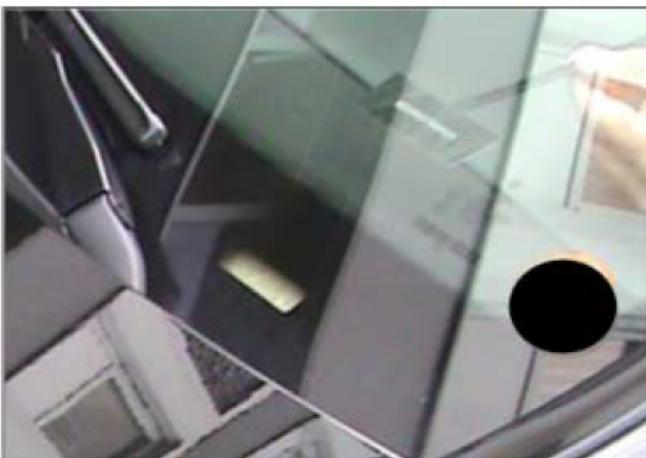
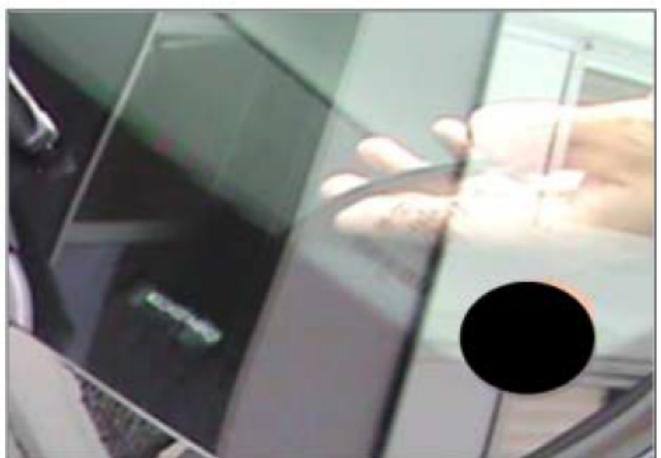
- i** To attach identification plate. Insert identification label using a cable tie between the windshield and instrument panel and attach using aid on the cross-member (**figures 3–6**).

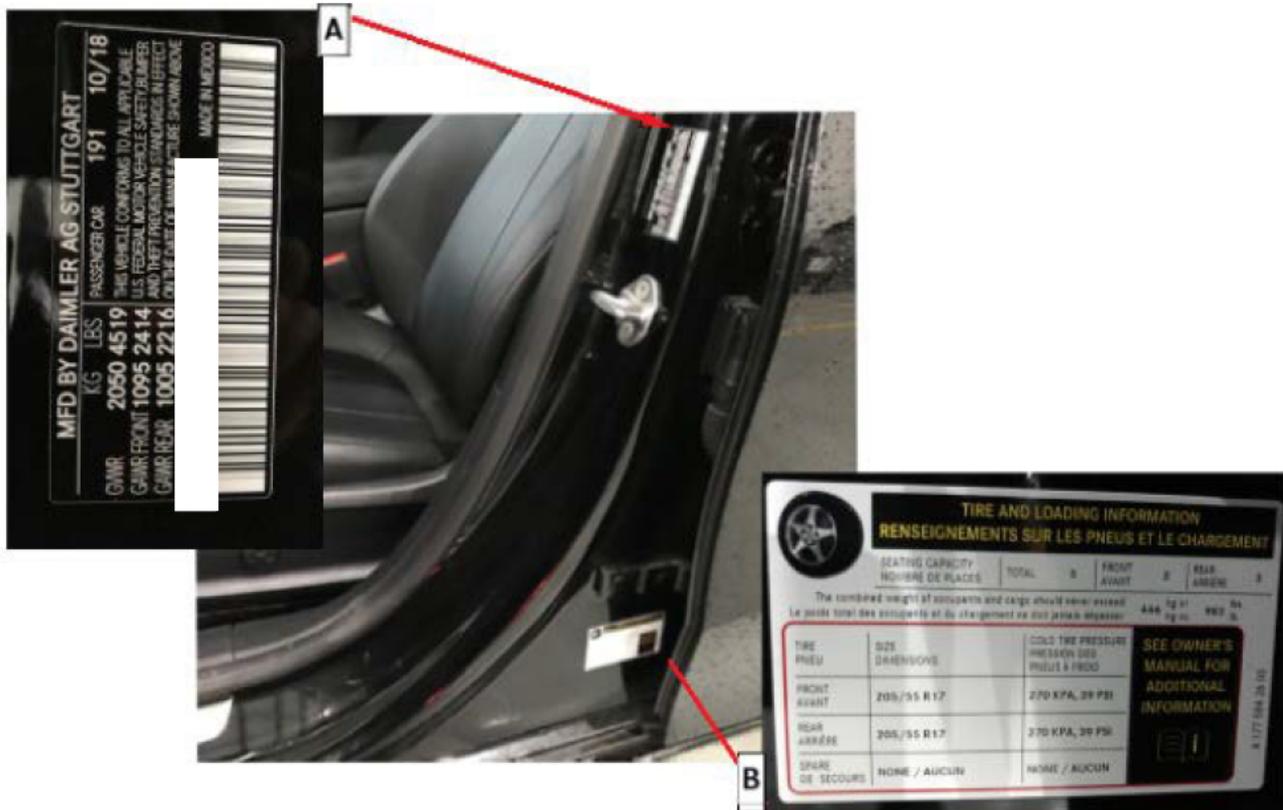
Figure 7

2. Check on the driver side B-pillar (**Figure 7**) for the VIN identification information label (**Figure 7**)(A) and the tire and load information label (**Figure 7**)(B) If a label is missing apply new label in the location shown in (**Figure 7**).

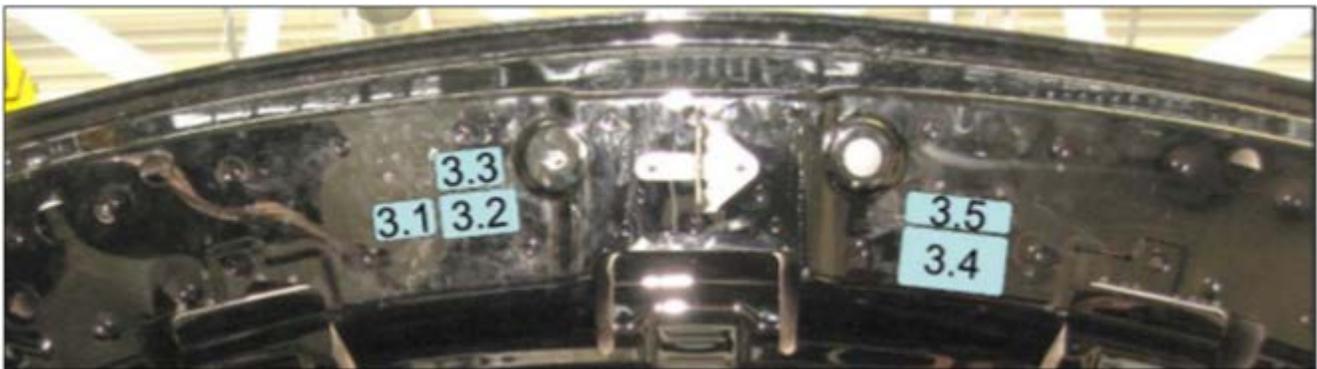
Figure 8

3. Check on the front underside of the hood (**Figure 8**)(3.1) for the equipment information label in the engine compartment (**Figure 9**) If the label is missing apply new label in the location shown in (**Figure 8**)(3.1).
4. Check on the front underside of the hood (**Figure 8**)(3.2) for the air conditioning system label (R-134a) (**Figure 10**) If the label is missing apply new label in the location shown in (**Figure 8**)(3.2).
5. Check on the front underside of the hood (**Figure 8**)(3.4) for the USA emission control information label (**Figure 11**) If the label is missing apply new label in the location shown in (**Figure 8**)(3.4).
6. Check on the front underside of the hood (**Figure 8**)(3.5) for the 4MATIC information label (**Figure 12**) If the label is missing apply new label in the location shown in (**Figure 8**)(3.5).

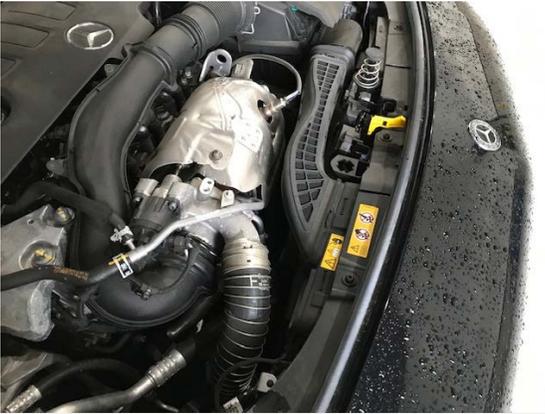
Figure 13

7. Check under the hood in the front of the engine compartment (**Figure 13**) for the radiator fan run-on information labels (**Figure 14**). If a label is missing apply new label in the location shown in (**Figure 13**).

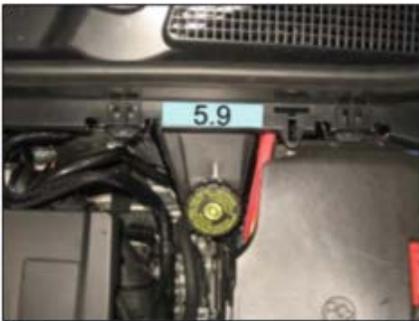
Figure 15

8. Check the rear of engine compartment near the brake reservoir fill (**Figure 15**)(5.9) for the brake fluid reservoir label (**Figure 16**). If the label is missing apply new labels in the location shown in (**Figure 15**)(5.9).

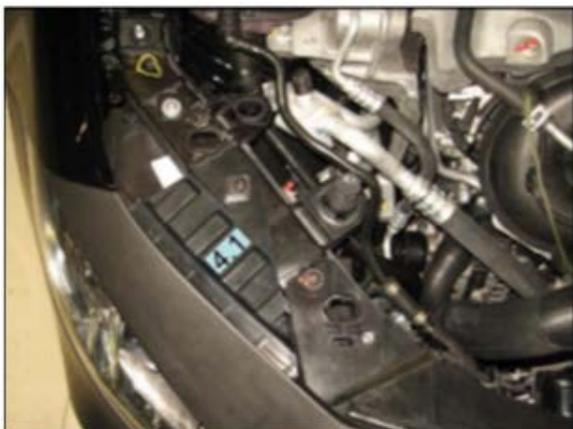
Figure 17

9. Check the front of the engine compartment (**Figure 17**)(4.1) for the LED headlamp information label (**Figure 18**). If the label is missing apply new labels in the location shown in (**Figure 17**)(4.1).

i Only on vehicles with option, code 640 LED headlamps.

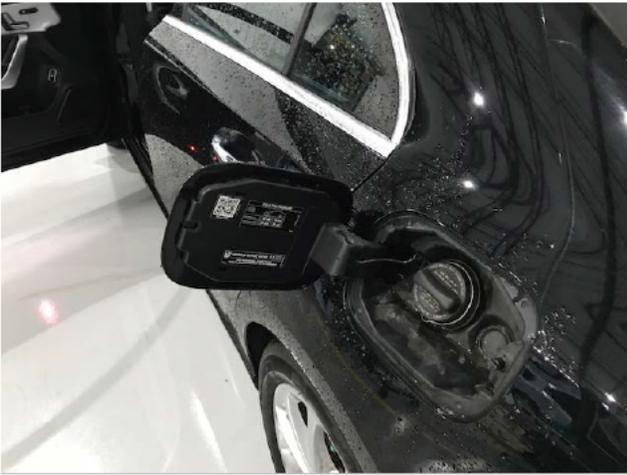
Figure 19

10. Check on the inside of the fuel filler flap (Figure 19) for the rescue data QR code label 1 (Figure 20) (A), tire pressure label (Figure 20) (B), and fueling label (Figure 20) (C). If a label is missing apply new labels in the location shown in (Figure 19 and 20).

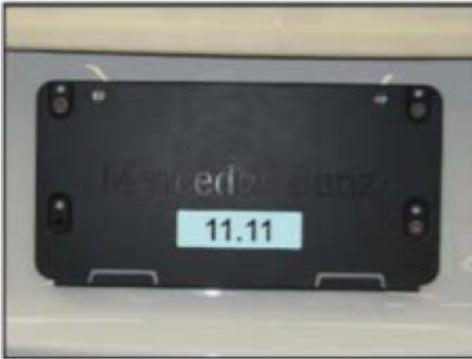
Figure 21

11. Check on the rear license plate mount (Figure 21)(11.11) for the VIN label (Figure 22). If the label is missing apply new label in the location shown in (Figure 21)(11.11).

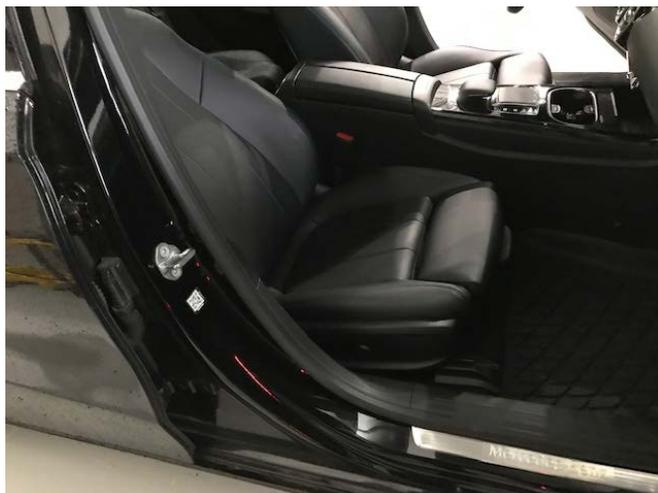
Figure 25

13. A Check on the passenger's side B-pillar (**Figure 25**) for the rescue data QR code label 2 (**Figure 26**) If the label is missing apply new label in the location shown in (**Figure 25**).
