Safety Recall: 2013-15 Accord (CVT only) Driveshaft Inspection

Supersedes 20-125, dated March 11, 2021, to revise the information highlighted in **yellow**

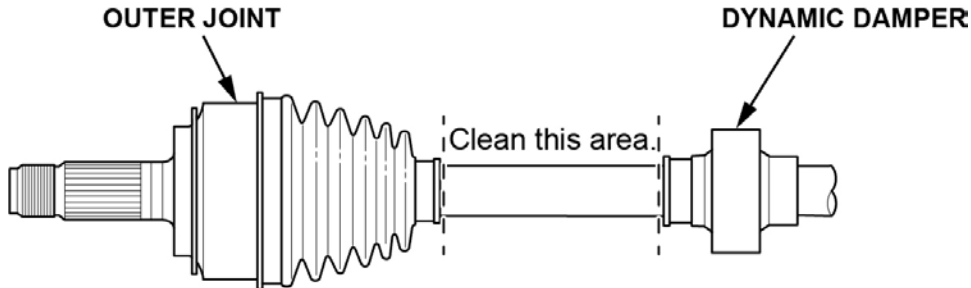
1. Raise and support the vehicle.
2. Use a clean shop towel to wipe any excess dirt and debris from the driveshafts between the outer joint and the dynamic damper.

NOTE: Paint chips may be sharp and could cut bare hands. Use gloves when wiping the driveshaft.

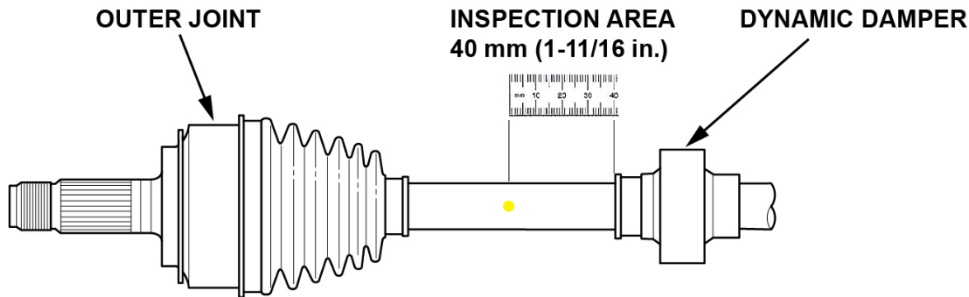
3. Using a ruler and yellow paint marker, measure **40 mm (1-11/16 in)** away from the dynamic damper, and mark the driveshaft with a dot. Click [HERE](#) to view the video on how to do the inspection procedure.

NOTE: Do not scribe or damage the painted surface of the driveshaft. Any replaced driveshafts may be called in for inspection.

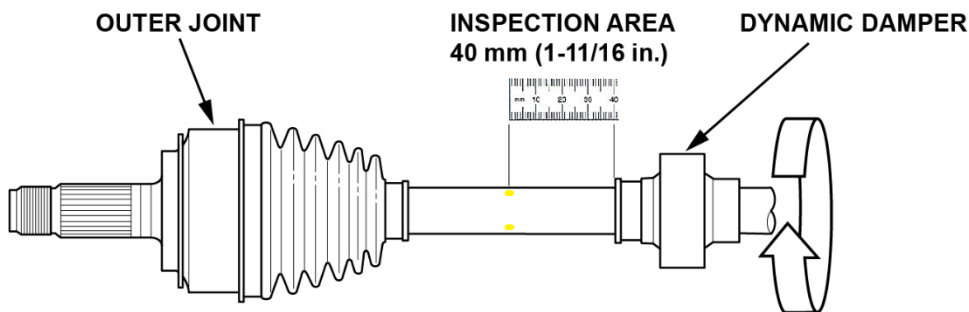
4. Rotate the axle 1/4 turn and repeat the above step **3 times** until there are 4 paint dots on the axle.

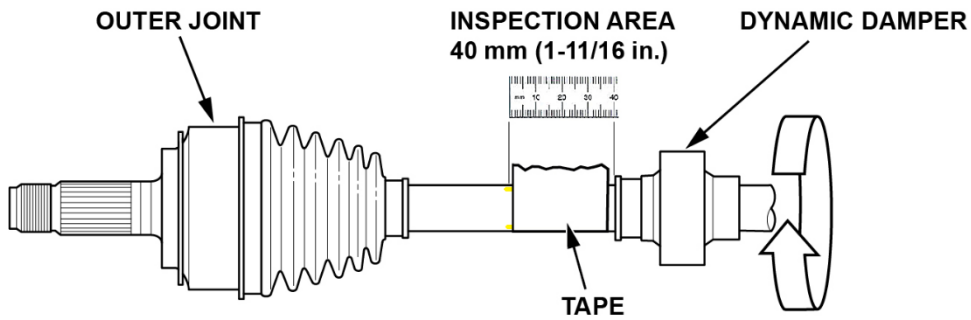
5. Connect the 4 painted dots around the axle using masking tape.

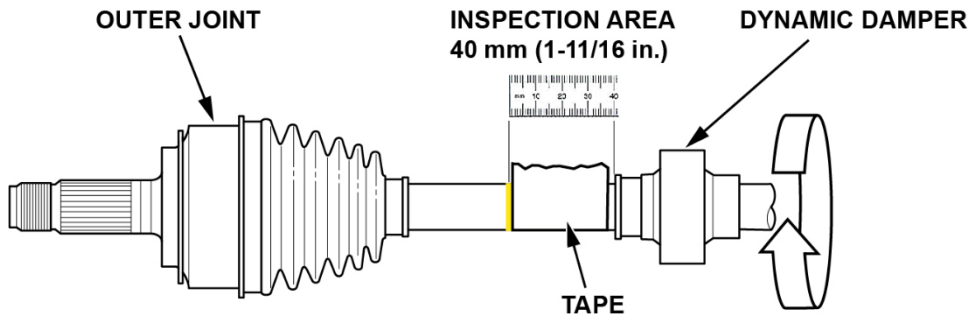
6. Using the masking tape as a guide, trace a line all around the axle using the yellow paint marker.

NOTE: Marking the line accurately is important, especially if there is damage close to or inside the 40 mm line.

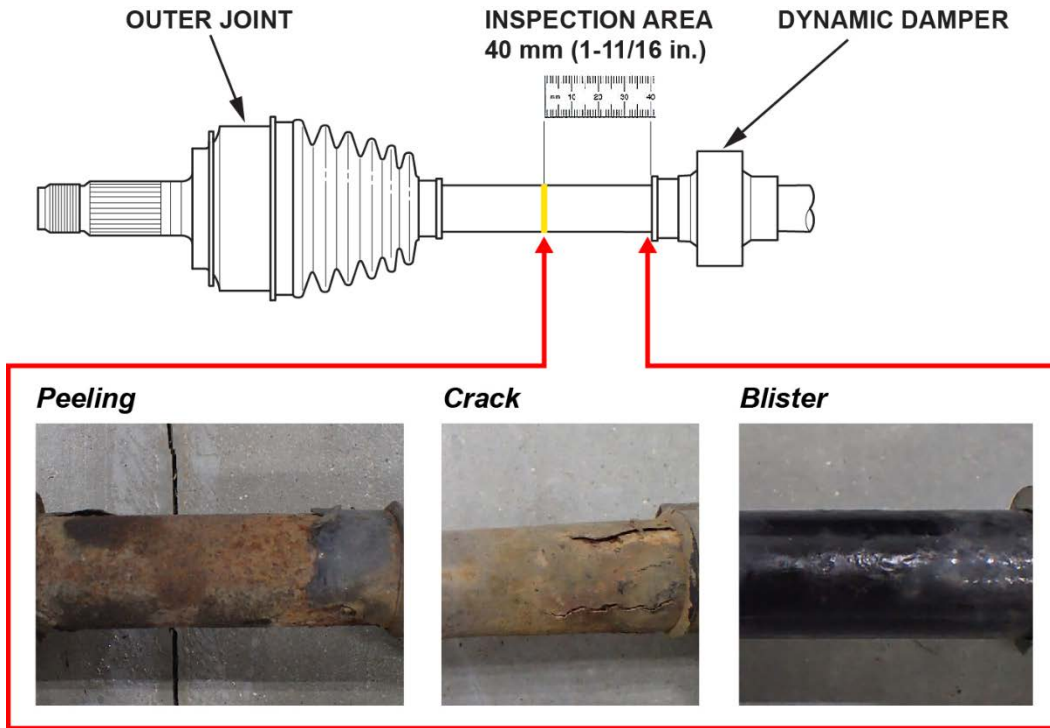
8. Inspect the driveshaft surface between the dynamic damper and the line for peeling paint, cracks, or blisters.

NOTE: Corrosion or paint defects between the outer joint and the yellow line are OK.

Is there peeling paint, cracks, or blisters on either driveshaft within **40 mm (1-11/16 in)** of the dynamic damper?

- Yes. Go to the REPAIR PROCEDURE.
- No. The driveshafts are OK. Return the vehicle to the customer.

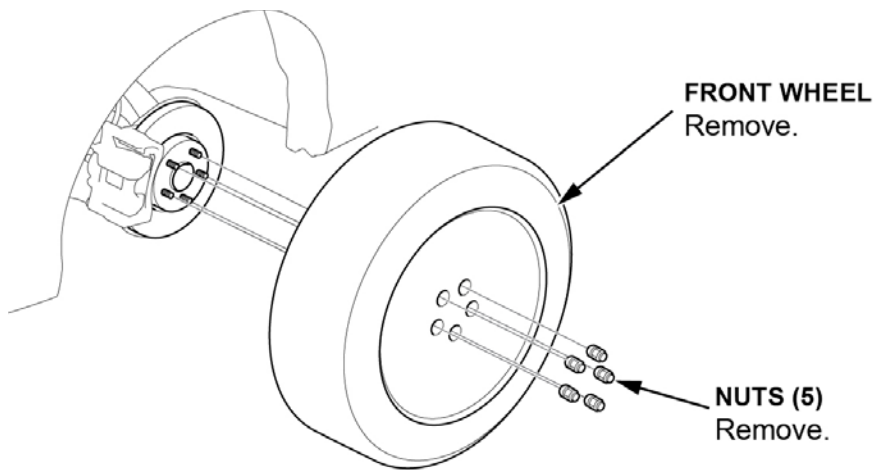
1. Remove both front wheels.

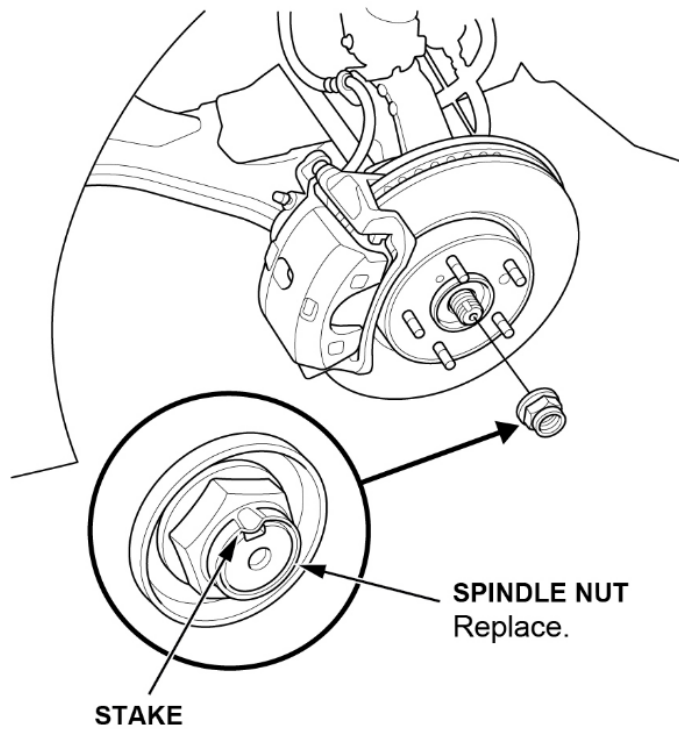
2. Pry up the stake on both spindle nuts and remove them.

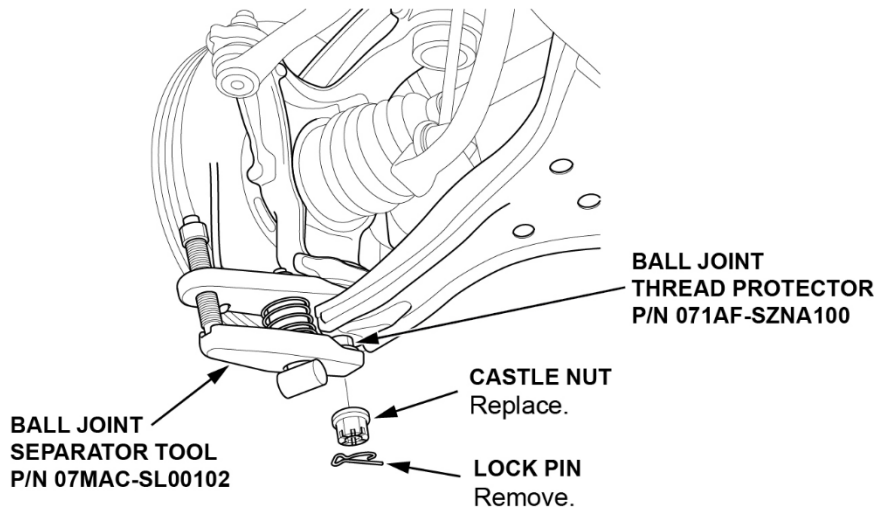
3. Disconnect both lower ball joints.

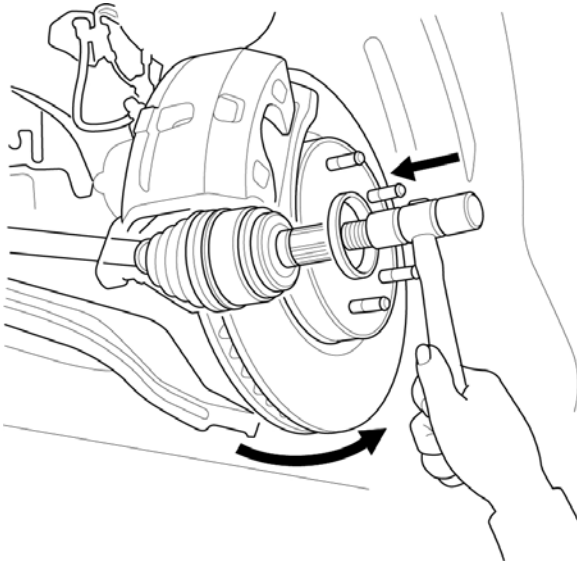
4. Use a soft-face hammer to separate the outboard joints from the steering knuckles.

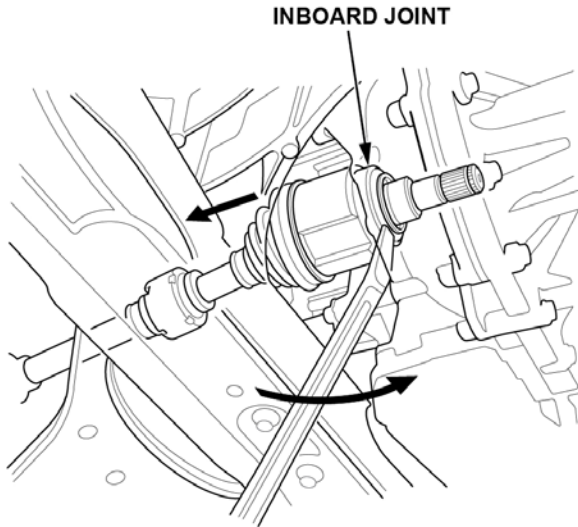
5. Use a pry bar to pry the inboard joint of the left driveshaft from the transmission.

NOTE: Be careful not to damage the transmission oil seal with the pry bar.

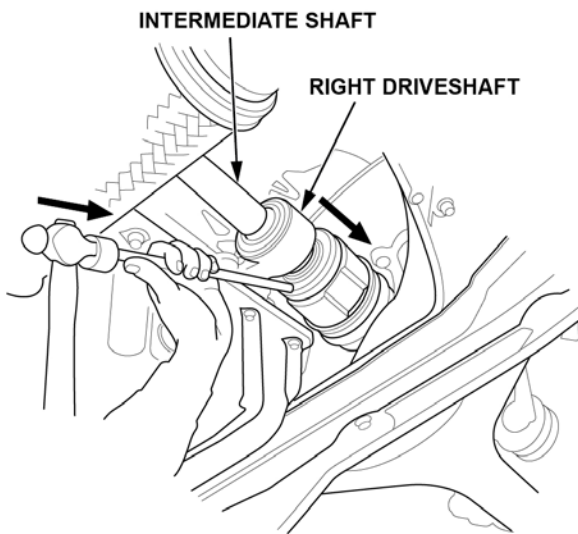
7. Use a drift punch and a hammer to remove the right driveshaft from the intermediate shaft.

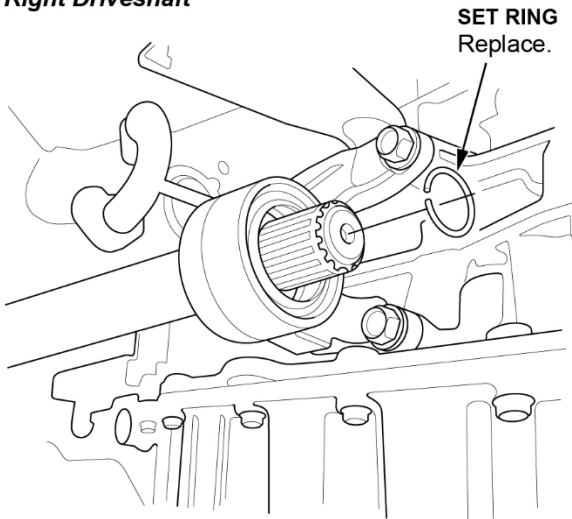
Right Driveshaft

9. Replace the set ring on the intermediate shaft with the one provided in the hardware kit.

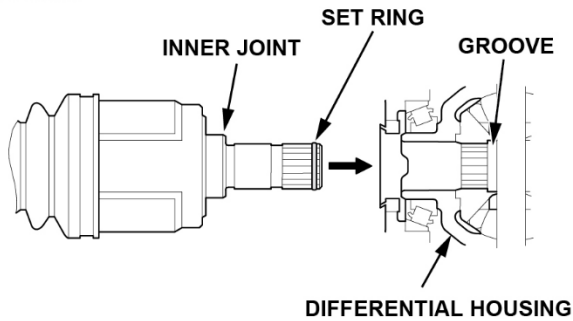
Left Driveshaft

10. Make sure the mating surfaces are clean, then install the new driveshafts. Insert them until the set rings lock in the grooves.

NOTE: Insert the left driveshaft straight in to avoid damaging the transmission oil seal.

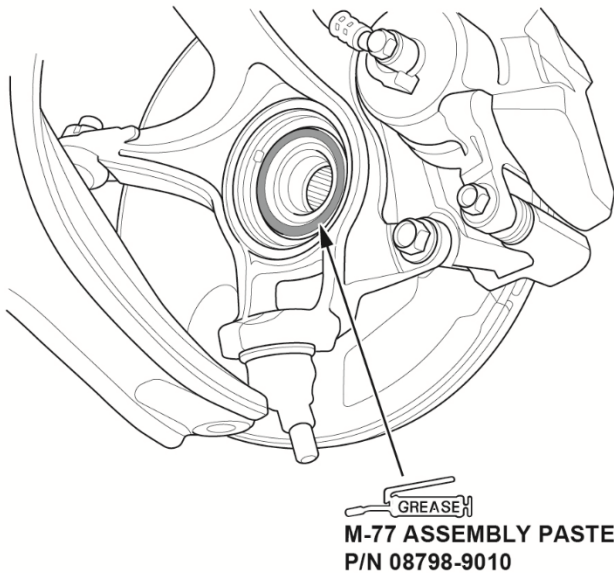
11. Make sure the bearing and spindle are clean of any debris or rust particles using a shop towel and/or compressed air. Then, apply about **3 g (0.11 oz)** of M-77 Assembly Paste (P/N 08798-9010) to the contact area of the outboard joint and the front wheel bearings.

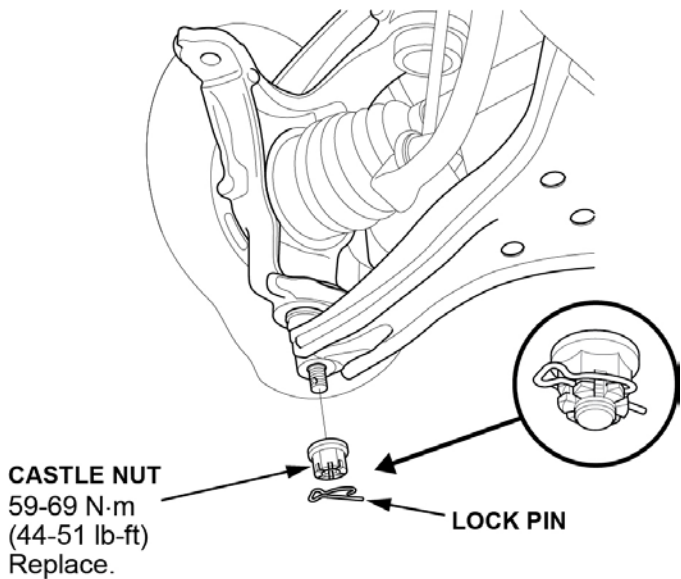
12. Pull the steering knuckles outwards and insert the outer driveshaft joints into the hub.
13. Connect the lower ball joints to the lower control arm. Use new castle nuts provided in the hardware kit.

NOTE: Torque the castle nuts to the lower torque specification, then tighten them only far enough to align the slot with the ball joint pin hole. Do not align the castle nuts by loosening them. When aligned, install the lock pin through the hole.

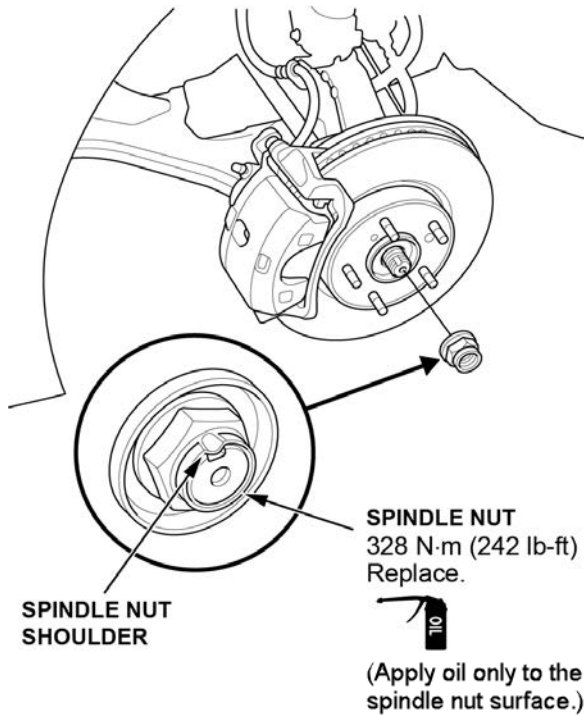
14. Install the new spindle nut provided in the hardware kit, and torque it to **328 N·m (242 lb-ft)** using a torque wrench. If you are going to use an air or battery powered impact gun to install the nut, make sure to turn down the air or power so you do not overtighten it, then torque it to specification using a torque wrench.

NOTE: Apply oil or lube to the spindle nut surface only. Do not apply any to the threads of the spindle or nut.

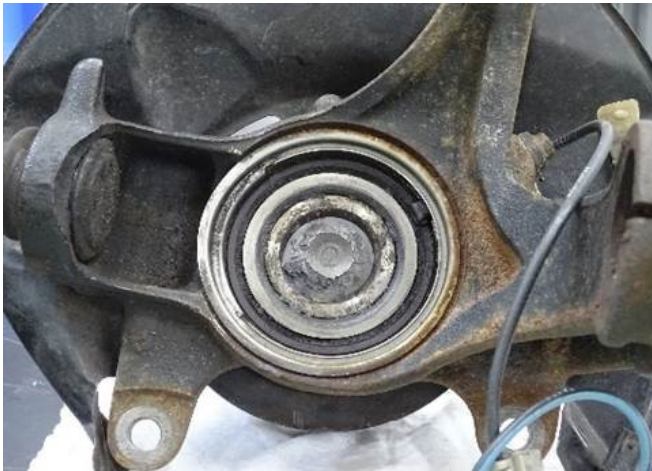
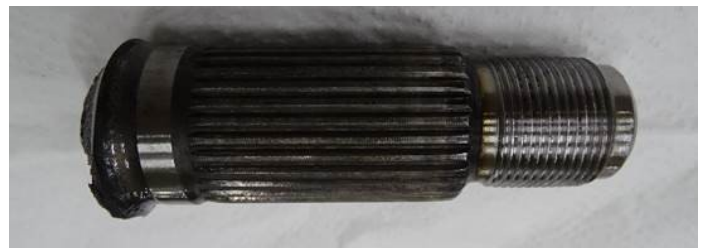
NOTE: It is important to know that many air and battery powered impact guns can achieve 2 or 3 times the axle nuts torque specification. If you severely over-torque an axle nut, it is possible to break a driveshaft as shown below:

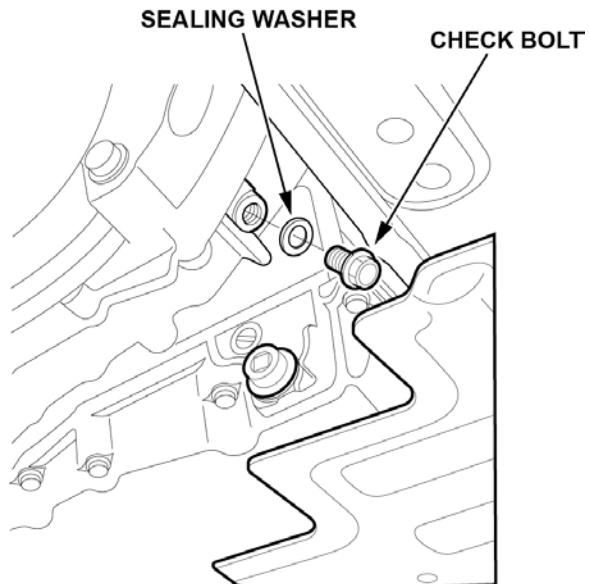
20. Remove the check bolt and sealing washer.

- When checking the transmission fluid level at the check bolt, it is not uncommon to find the fluid at the upper or lower level.
- Do the transmission fluid level check immediately after the shift lever operation.
- The check bolt and the transmission fluid may be hot.

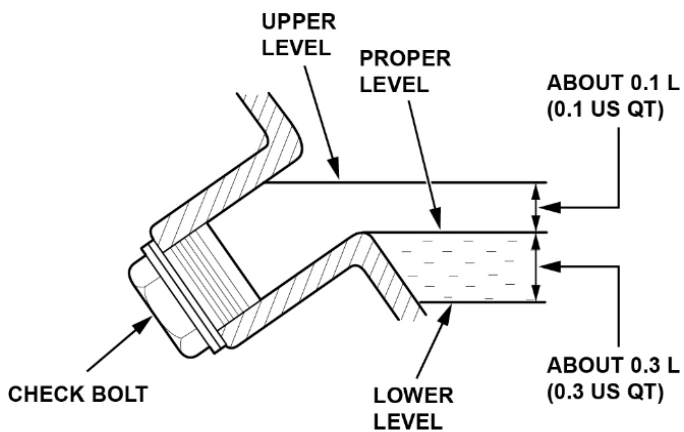
The transmission is at the proper level if the fluid is dripping from the hole gradually.

- *If the transmission fluid is flowing out of the check hole, wait for until it is dripping from the hole gradually. Then, go to step 24.*
- *If the transmission fluid is dripleess from the check hole, loosely install the check bolt and go to the next step.*

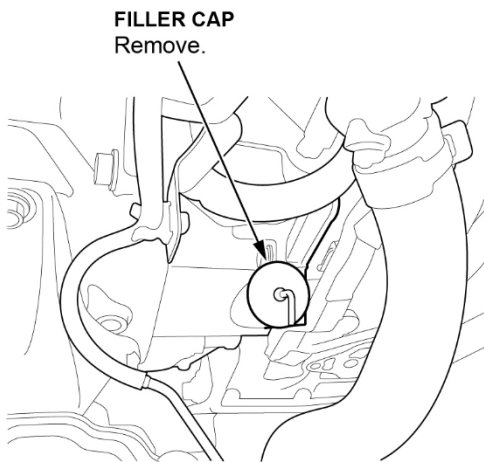
21. Remove the filler cap.

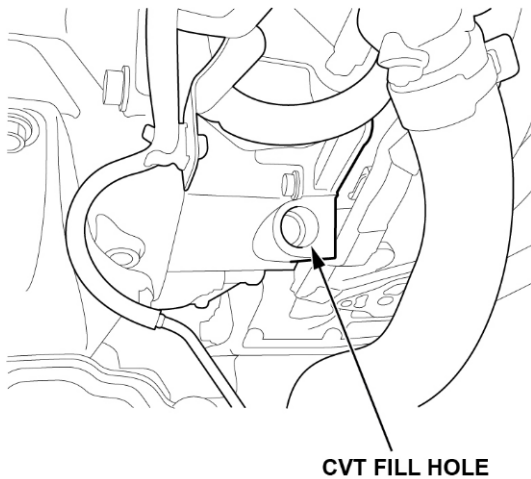
22. Fill the transmission with a suitable amount of HCF-2 CVT Fluid.

NOTE: Using the wrong type of fluid will damage the transmission.

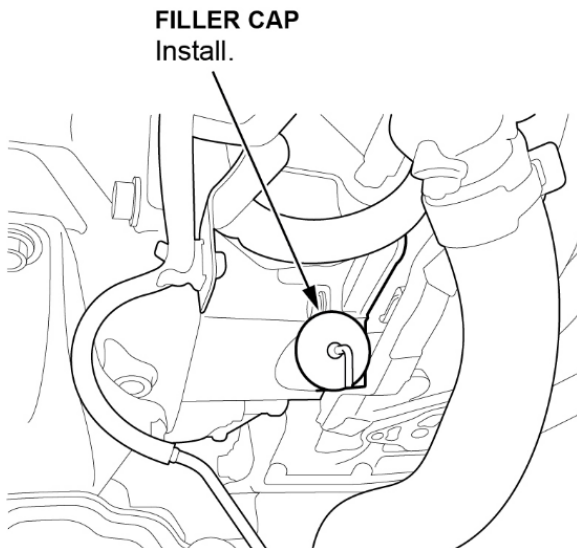
23. Install the filler cap in the direction shown and restart the procedure at step 17.

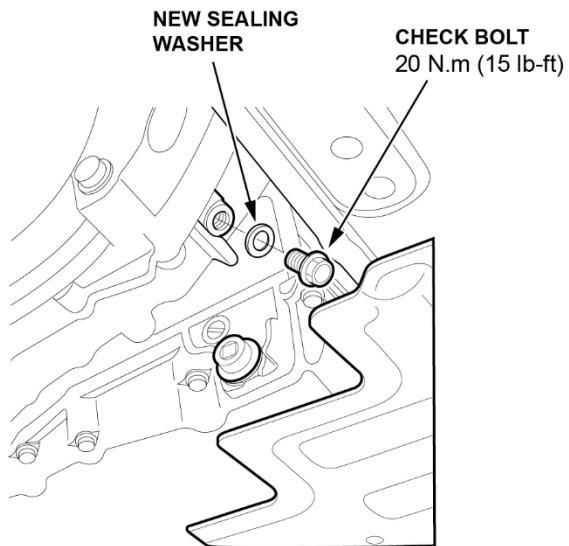
24. Install the original check bolt with a new sealing washer.
