Safety Recall: 2007-08 Fit Driveshaft Inspection

Supersedes 21-042, dated April 2, 2021, to revise the information highlighted in **yellow**

Due to improper manufacturing, the paint on the driveshaft near the dynamic damper may peel and chip over time, exposing the bare metal and potentially causing it to corrode under the dynamic damper. A corroded driveshaft may break during high torque conditions, rendering the vehicle without propulsion, or allowing the vehicle to roll while in Park, which can increase the potential of a crash or injury.

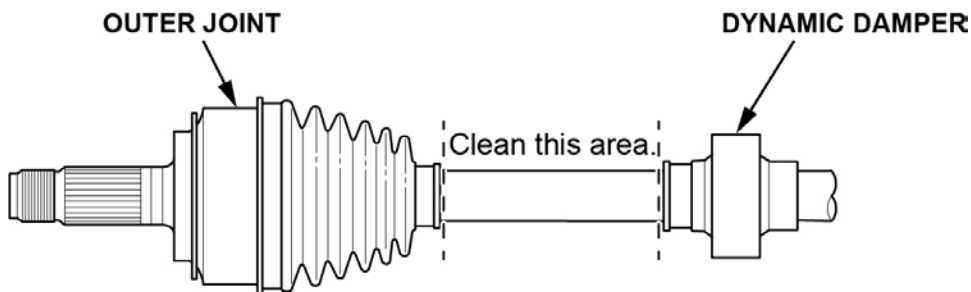
1. Raise and support the vehicle.
2. Use a clean shop towel to wipe any excess dirt and debris from the driveshafts between the outer joint and the dynamic damper.

NOTE: Paint chips may be sharp and could cut bare hands. Use gloves when wiping the driveshaft.

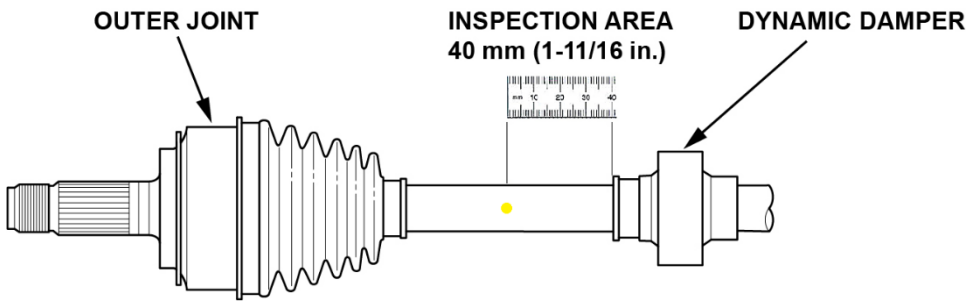
3. Using a ruler and yellow paint marker, measure **40 mm (1-11/16 in)** away from the dynamic damper, and mark the driveshaft with a dot. Click [HERE](#) to view a video on how to do the inspection procedure.

NOTE: Do not scribe or damage the painted surface of the driveshaft. Any replaced driveshafts may be called in for inspection.

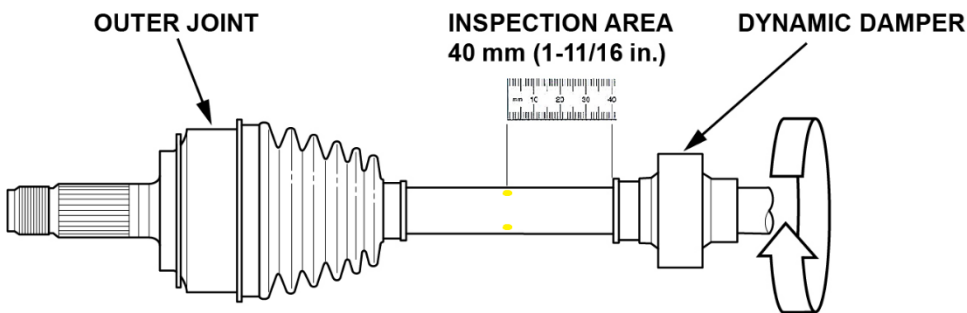
4. Rotate the axle 1/4 turn and repeat the step above **three times** until there are four paint dots on the axle.

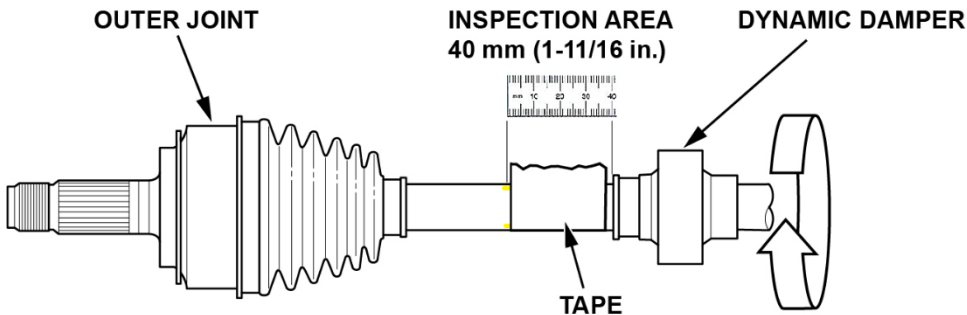
5. Connect the four painted dots around the axle using masking tape.

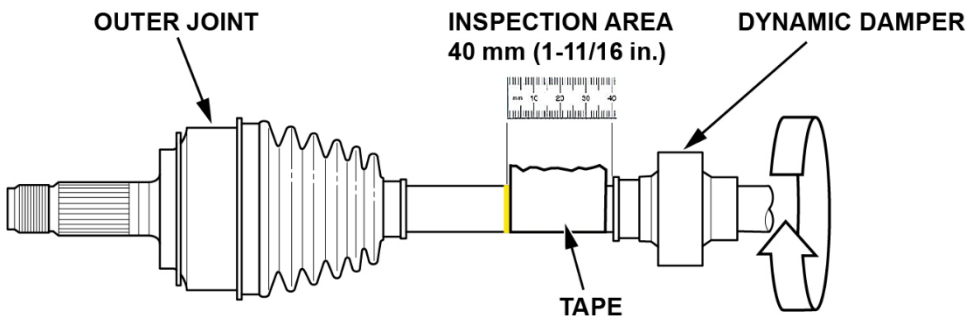
6. Using the masking tape as a guide, trace a line all around the axle using the yellow paint marker. Marking the line accurately is important, especially if there is damage close to or inside the 40 mm line.

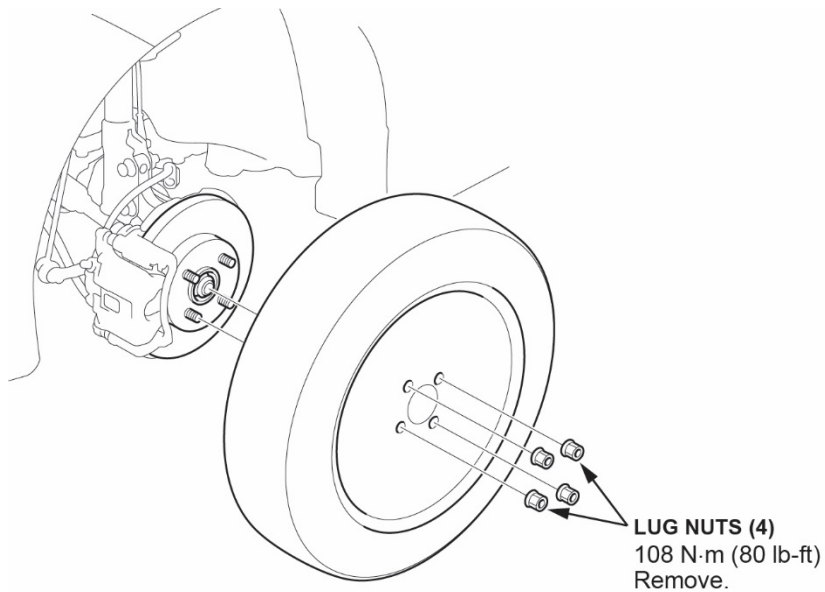
1. Remove the front wheel of the driveshaft you are replacing.

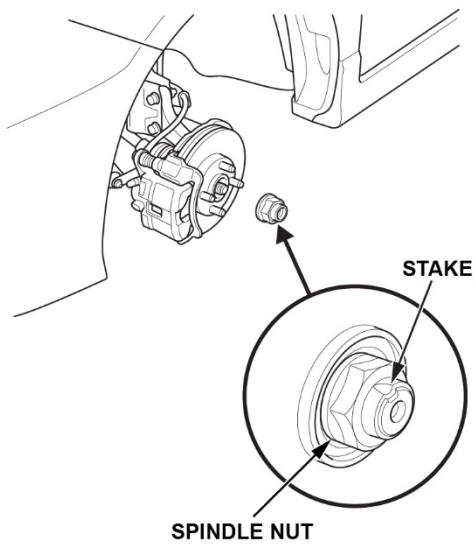
2. Pry up the stake on the spindle nut, then remove it.

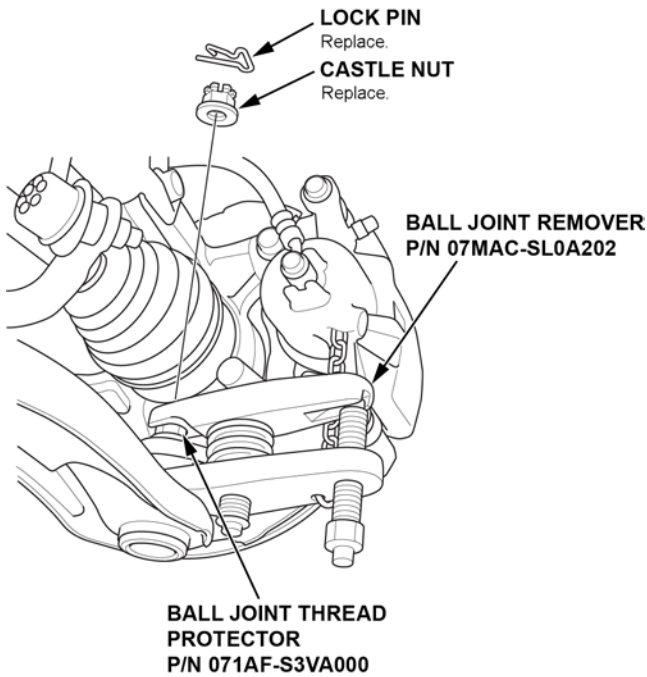
3. Remove the lock pin from the lower arm ball joint, then remove the castle nut.

4. Separate the ball joint from the knuckle using the Ball Joint Thread Protector (T/N: 07AAF-SDAA100) and Ball Joint Remover (T/N: 07MAC-SL0A202). Grease the threads and tip of the pressure bolt on the ball joint remover, and make sure the pivot bolt is not parallel to the ball joint remover arms. For additional information on how to use the tools, refer to the service information.

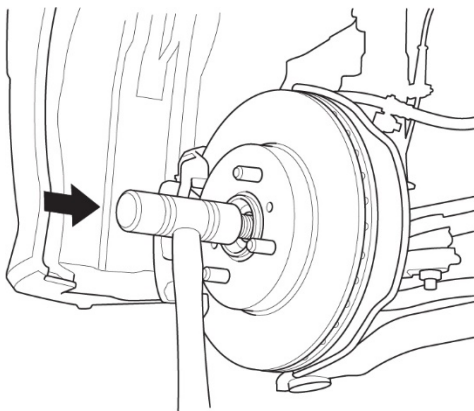
5. Use a soft-face hammer to separate the outboard joint from the front hub.

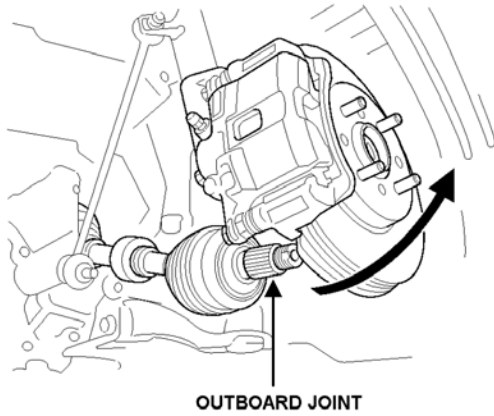
6. Pull the knuckle outward to separate the outboard joint from the front wheel hub.

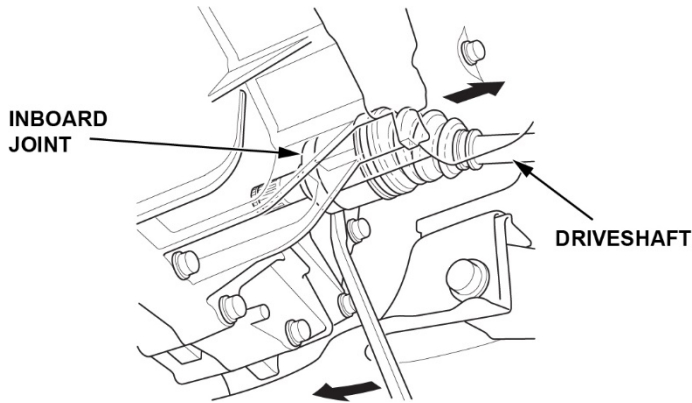
7. *Driver's side driveshaft only:* Use a pry bar to pry the inboard joint from the transmission housing. Then, remove the driveshaft as an assembly.

- Do not pull on the driveshaft, or the inboard joint may come apart.
- Pull the inboard joint straight out to avoid damaging the oil seal.
- Be careful not to damage the transmission oil seal with the pry bar.

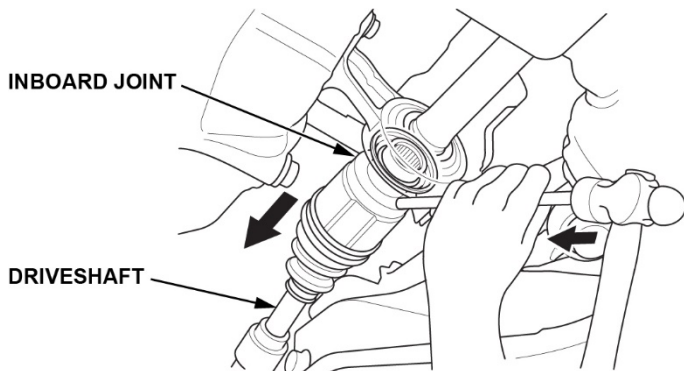
8. *Passenger's side driveshaft only:* Using a punch and hammer, drive the inboard joint off of the intermediate shaft. Then, remove the driveshaft as an assembly.

- Do not pull the assembly by the driveshaft, the inboard joint may come apart.
- Be careful not to damage the transmission oil seal with the pry bar.

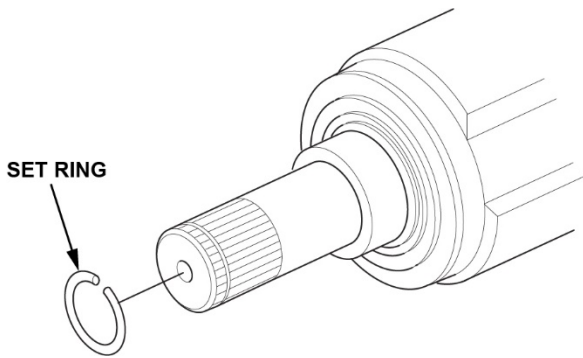
9. *Driver's side driveshaft only:* Replace the set ring on the inboard joint.

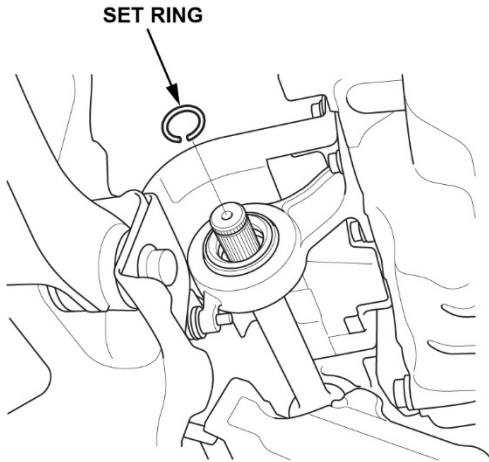
10. *Passenger's side driveshaft only:* Replace the set ring on the intermediate shaft.

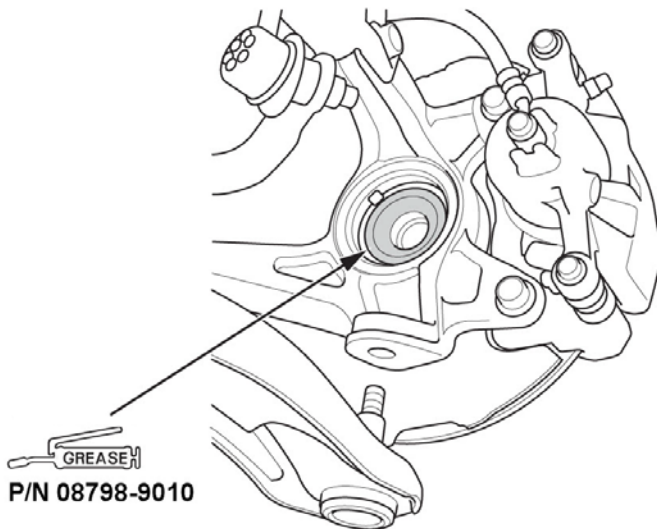
12. Apply about **5 g (0.18 oz)** of M-77 Assembly Paste (P/N 08798-9010) to the contact area of the outboard joint and front wheel bearing.

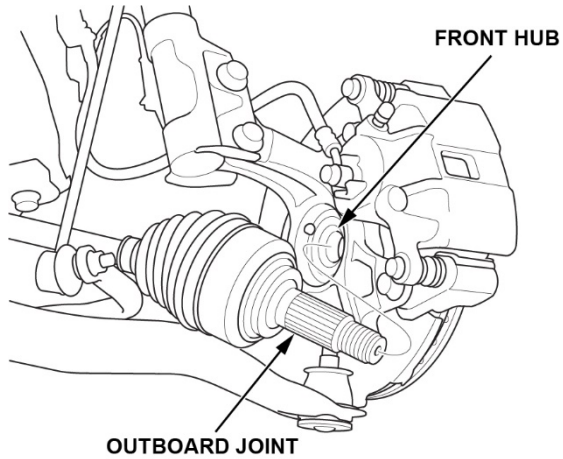
14. Install the outboard joint into the front hub on the knuckle.

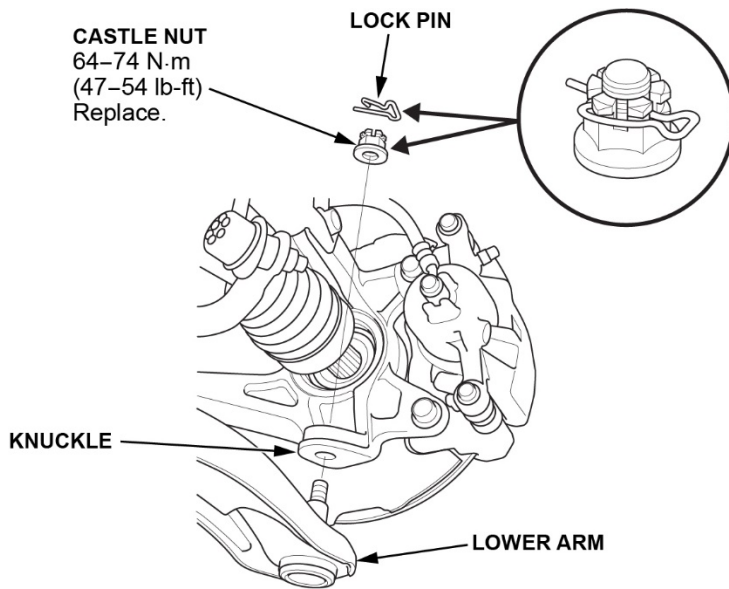
15. Wipe off any grease contamination from the tapered ball joint section and threads, then install the knuckle onto the lower arm. Make sure not to damage the ball joint boot.

16. Install the new castle nut, and torque it to the lower torque specification. Then, tighten it until the slot on the castle nut aligns with the ball joint pin hole. Install the lock pin into the pin hole as shown.

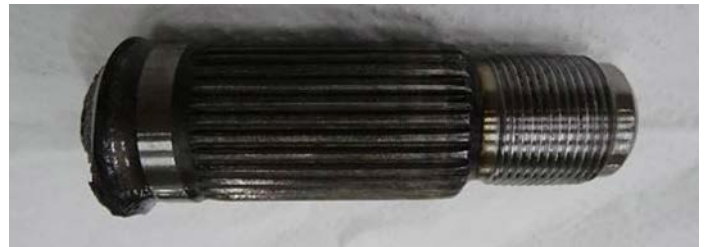
NOTE: It is important to know that many air and battery powered impact guns can achieve 2 or 3 times the axle nuts torque specification. If you severely over-torque an axle nut, it is possible to break a driveshaft as shown below:
