Safety Recall: 2012 Civic Hybrid Driveshaft Inspection**Supersedes 21-043, dated April 15, 2021, to revise the information highlighted in yellow****AFFECTED VEHICLES**

REVISION SUMMARY**Under REPAIR PROCEDURE step 18, a note and images were added.****BACKGROUND**

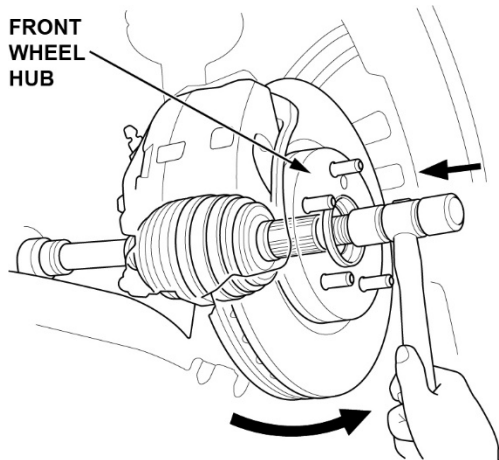
5. Pull the knuckle outward and separate the outboard joint from the front wheel hub using a plastic hammer.

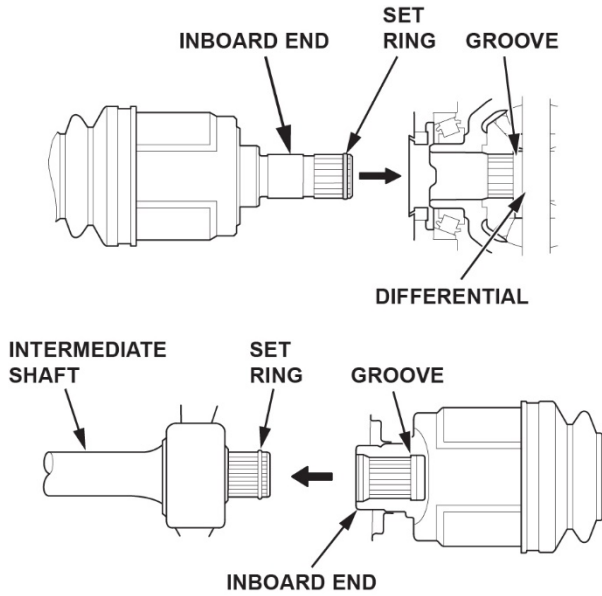
12. Insert the inboard end of the driveshaft into the differential or the intermediate shaft until the set ring locks in the groove.

NOTE: Insert the driveshaft horizontally to prevent damaging the oil seal.

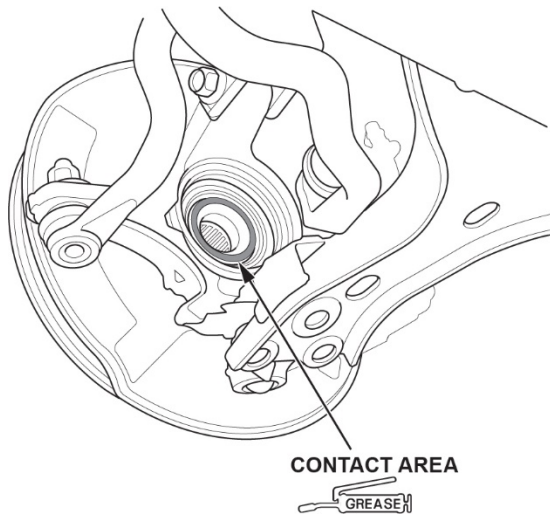
13. Make sure the connecting surfaces of the joint and splined section are clean of any debris or rust particles using a shop towel and/or compressed air before starting installation. Apply about 5 g (0.18 oz) M-77 Assembly Paste (P/N 08798-9010) to the contact area of the outboard joint and the front wheel bearing.

NOTE: The paste helps to prevent noise and vibration.

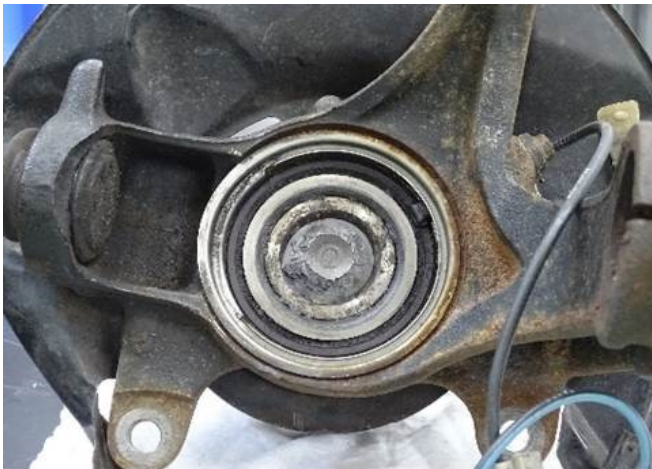
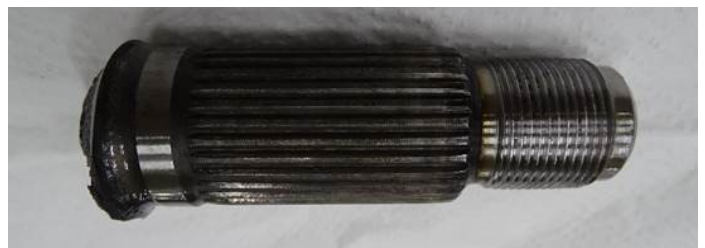
NOTE: It is important to know that many air and battery powered impact guns can achieve 2 or 3 times the axle nuts torque specification. If you severely over-torque an axle nut, it is possible to break a driveshaft as shown below:
