July 14, 2021

Version 3

**Safety Recall: 2012 Civic Hybrid Driveshaft Inspection**Supersedes 21-043, dated June 8, 2021, to revise the information highlighted in **yellow****AFFECTED VEHICLES**

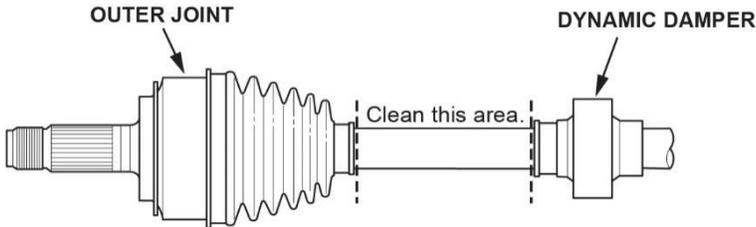
1. Raise and support the vehicle.
2. Use a clean shop towel to wipe any excess dirt and debris from the driveshaft between the outer joint and the dynamic damper.

Note: Paint chips may be sharp and could cut bare hands. Use gloves when wiping the driveshaft.

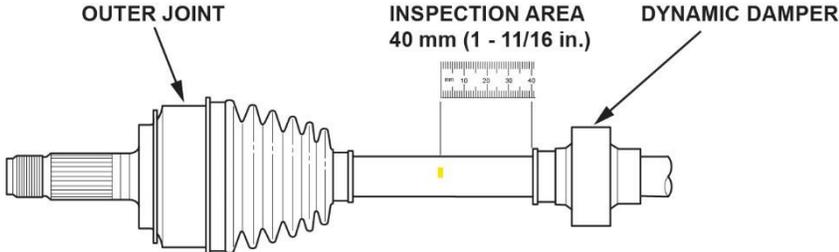
3. Using a ruler and yellow paint marker, measure **40 mm (1-11/16 in.)** away from the dynamic damper and mark the driveshaft with a dot. [Click HERE](#) to view video on how to do the inspection procedure.

Note: Do not Scribe or damage the painted surface of the driveshaft. Any replaced axle may be called in for inspection.

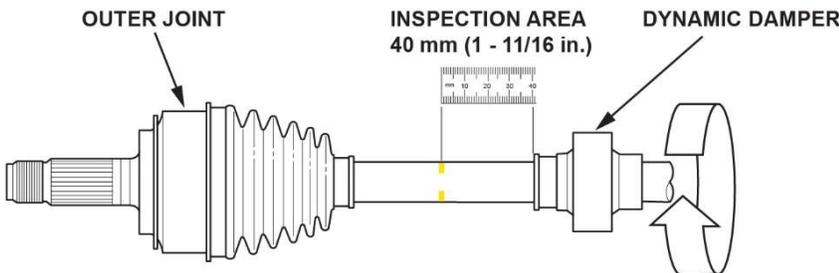
4. Rotate the axle 1/4 turn and repeat the above step **3 times** until there are 4 paint dots on the axle.

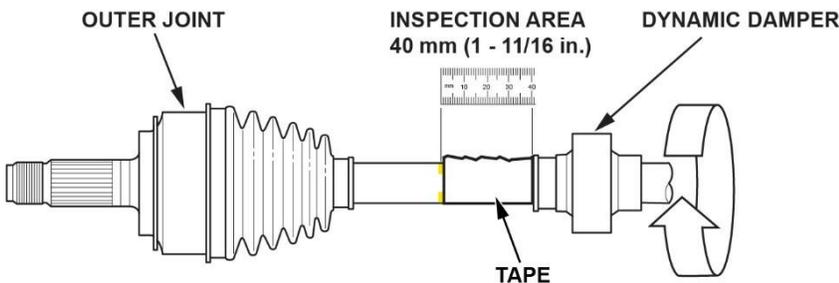
5. Connect the 4 painted dots around the axle using masking tape.

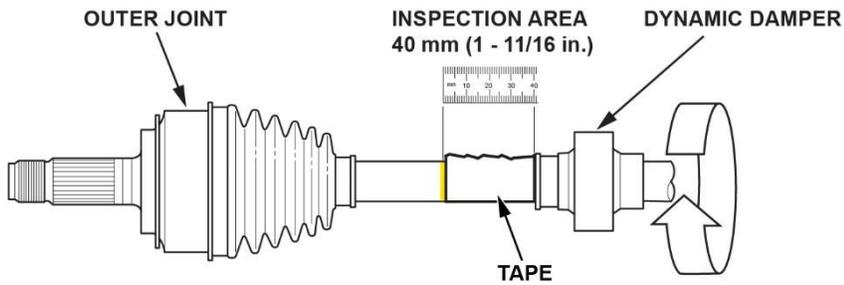
6. Using the masking tape as a guide, trace a line all around the axle using the yellow paint marker.

**NOTE:** Marking the line accurately is important, especially if there is damage close to or inside the 40 mm line.

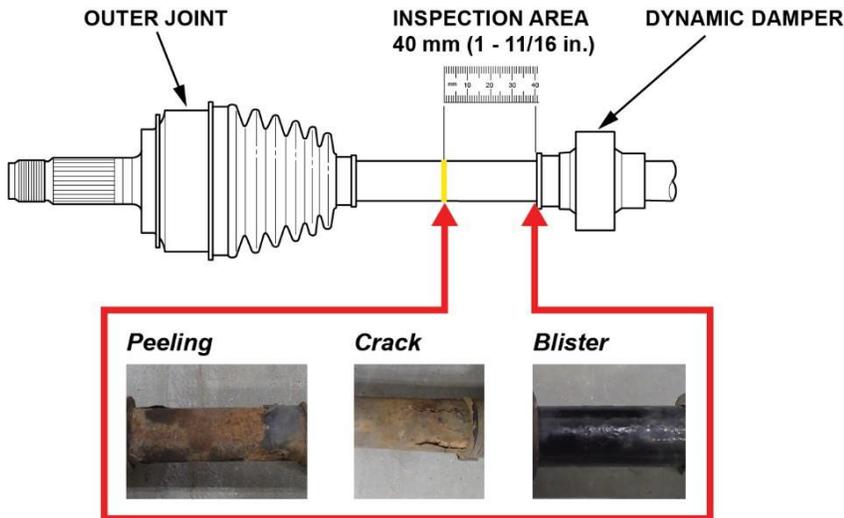
8. Inspect the driveshaft surface between the dynamic damper and the line for peeling paint, cracks, or blisters. Corrosion or paint defects between the outer joint and the yellow line are OK.

Is there peeling paint, cracks, or blisters on the driveshaft within **40 mm (1-11/16in)** of the dynamic damper?

- Yes. Go to REPAIR PROCEDURE
- No. The driveshaft is OK. Repeat the inspection on the other driveshaft if it also has a dynamic damper. Otherwise, return the vehicle to the customer.

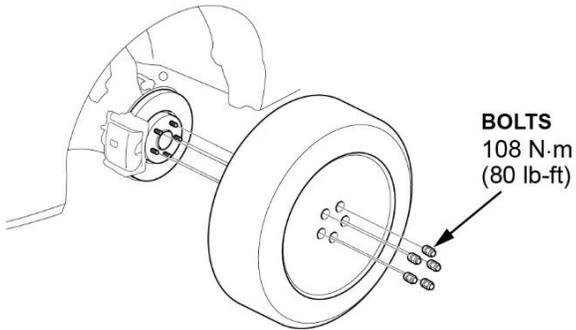
1. Remove the front wheel(s).

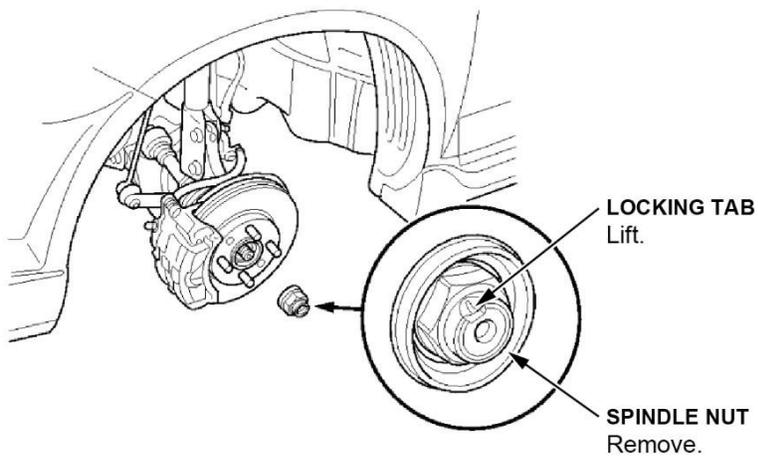
2. Remove the front spindle nuts by lifting up the locking tab on the nuts, then remove the nut.

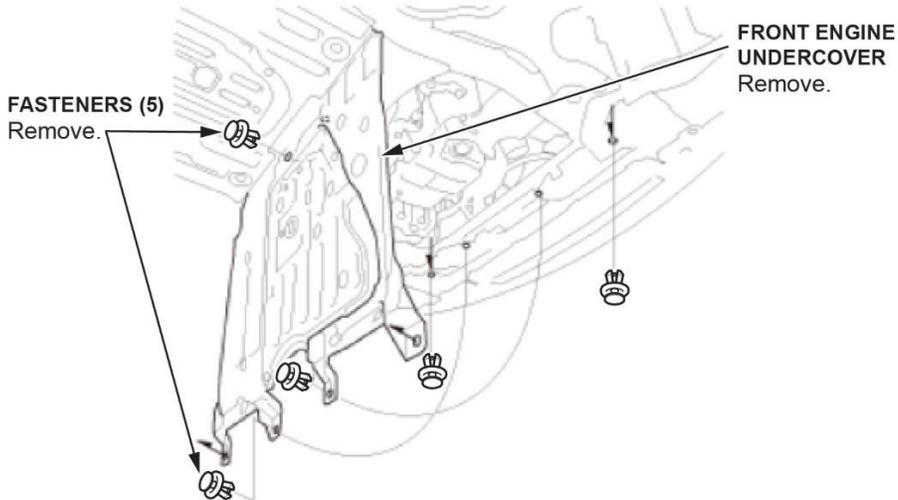
3. Remove the front engine undercover as needed.

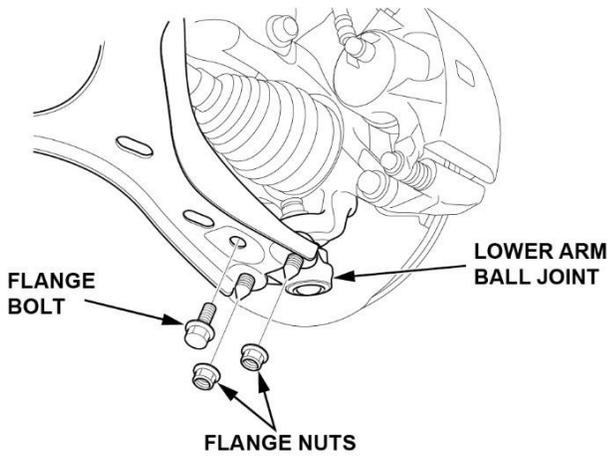
4. Remove the flange bolt, remove the flange nuts, and disconnect the lower arm ball joint from the lower arm.

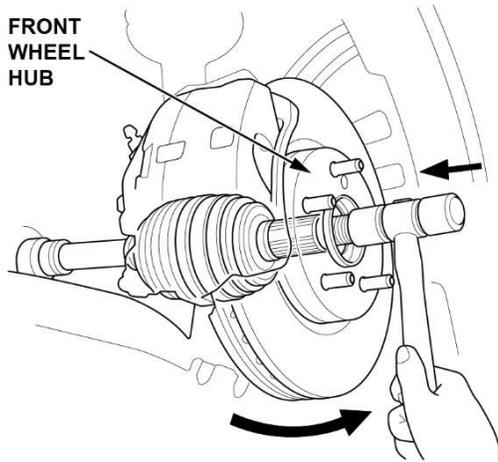
5. Pull the knuckle outward and separate the outboard joint from the front wheel hub using a plastic hammer.

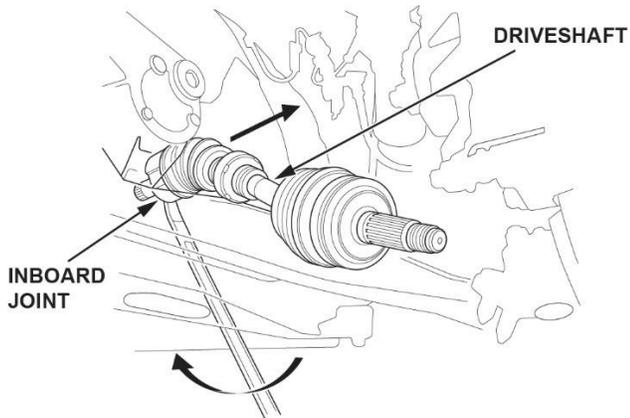
6. Left driveshaft: Pry the inboard joint using a pry bar. Remove the driveshaft as an assembly.  
NOTE: Be careful not to damage the oil seal or the end of the inboard joint with the pry bar.

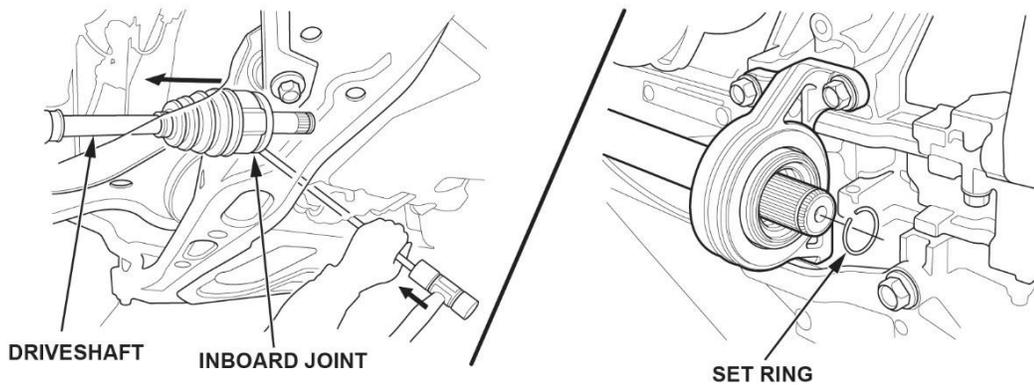
**RIGHT DRIVESHAFT**

7. Drive the inboard joint off of the intermediate shaft using a drift punch and a hammer. Remove the driveshaft as an assembly.

NOTE: Do not pull on the driveshaft, or the inboard joint may come apart. Pull the inboard joint straight out.

8. Remove the set ring from the intermediate shaft.

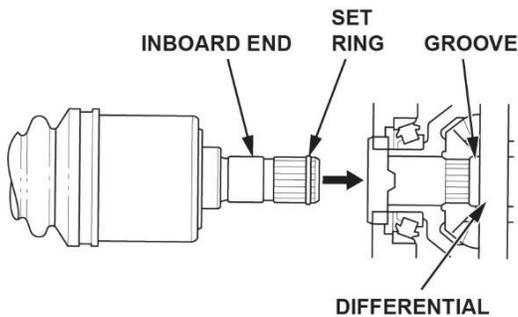
9. Insert the inboard end of the driveshaft into the differential until the set ring locks in the groove.

NOTE: Insert the driveshaft horizontally to prevent damaging the oil seal.

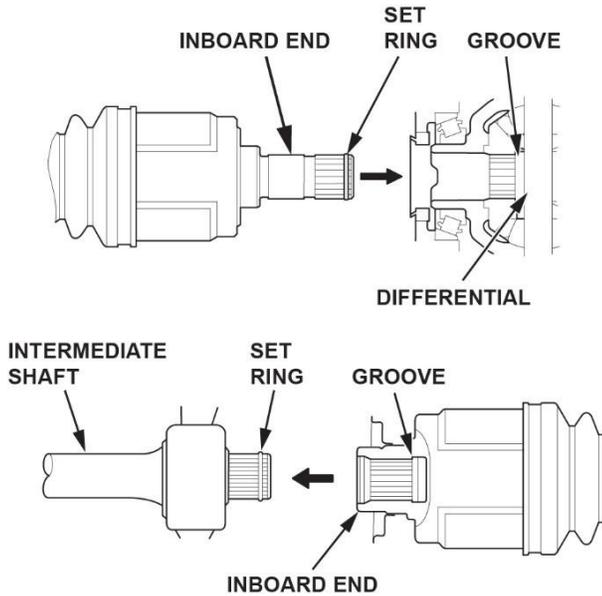
12. Insert the inboard end of the driveshaft into the differential or the intermediate shaft until the set ring locks in the groove.

NOTE: Insert the driveshaft horizontally to prevent damaging the oil seal.

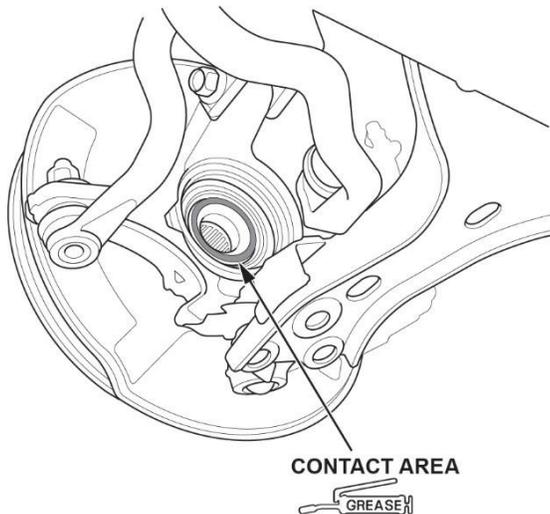
13. Make sure the connecting surfaces of the joint and splined section are clean of any debris or rust particles using a shop towel and/or compressed air before starting installation. Apply about 5 g (0.18 oz) M-77 Assembly Paste (P/N 08798-9010) to the contact area of the outboard joint and the front wheel bearing.

NOTE: The paste helps to prevent noise and vibration.

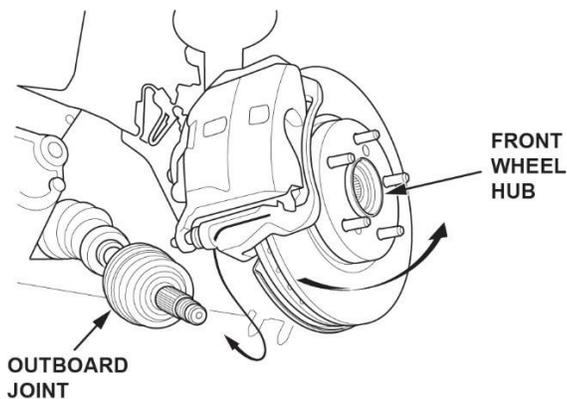
14. Install the outboard joint into the front wheel hub.

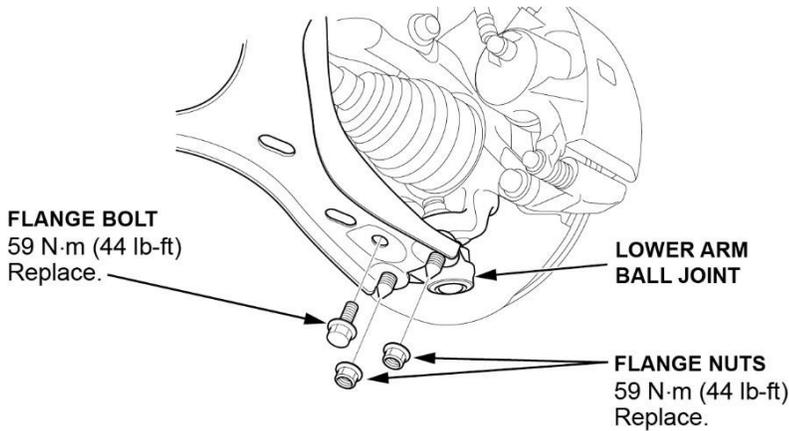
15. Connect the lower arm ball joint to the lower arm.
16. Loosely install the new flange nuts and the new flange bolt.
17. Tighten the flange nuts and the flange bolt in the sequence shown.

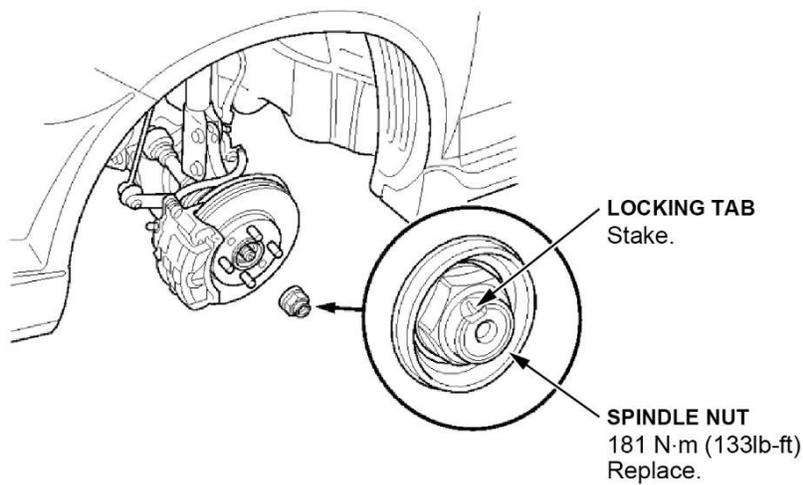
18. Apply a small amount of engine oil to the seating surface of the new spindle nut. Then, install and torque the spindle nut. After torquing it, use a drift punch to stake the spindle nut shoulder against the driveshaft.

**NOTE:** If you are going to use an air or battery powered impact gun to install the nut, make sure to turn down the air or power so you do not overtighten it, then torque it to specification using a torque wrench.

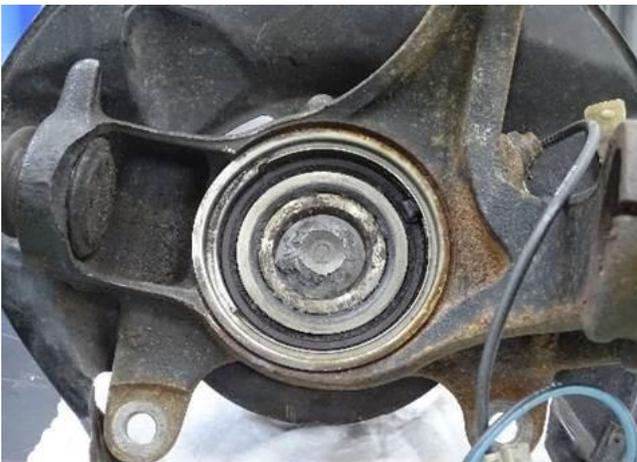
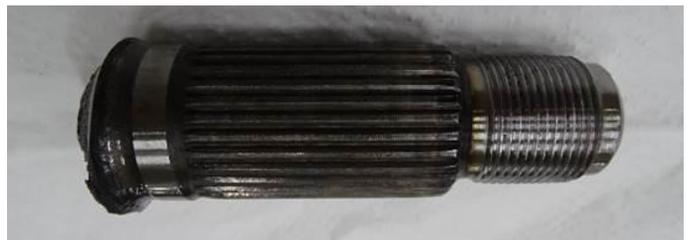
**NOTE:** It is important to know that many air and battery powered impact guns can achieve 2 or 3 times the axle nuts torque specification. If you severely over-torque an axle nut, it is possible to break a driveshaft as shown below:

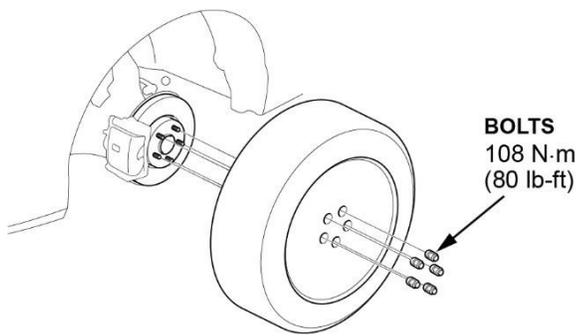
19. Install the front wheel(s).

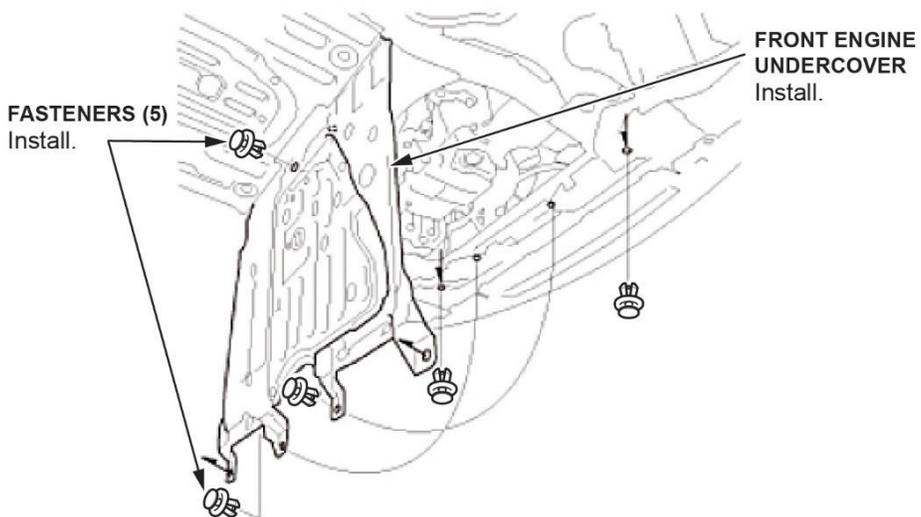
20. Install the engine undercover.
