Campaign No. 2021010006, March 2021

SUBJECT: **Model GLC-Class (253 platform)**
Model Year 2018
Check Starter Harness

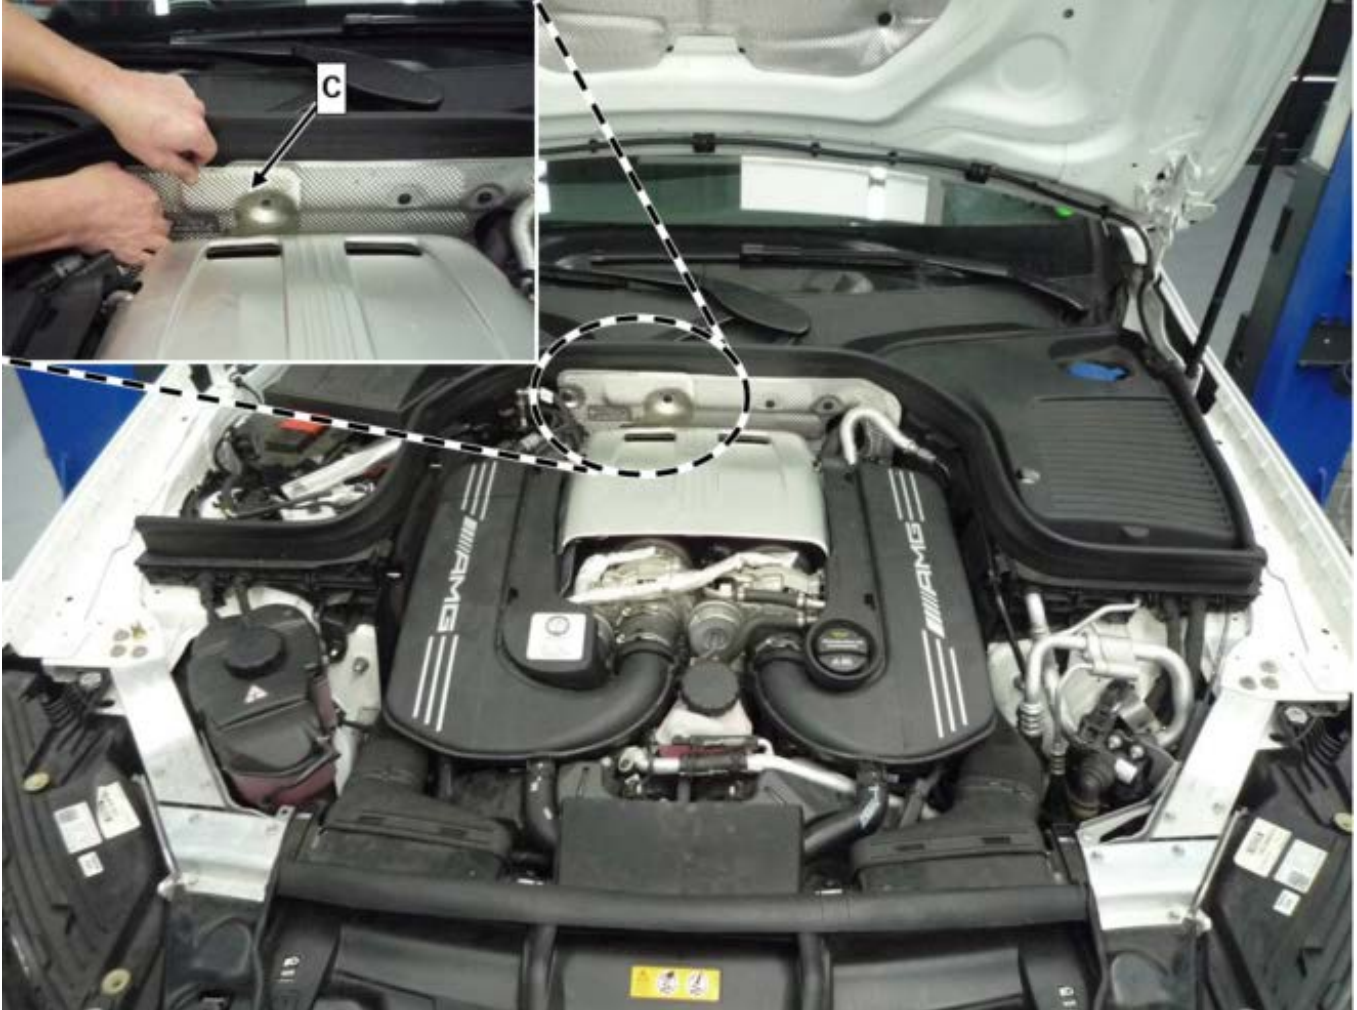
**Figure 2**

1. Remove heat shield (C, Figure 2) above busbar.

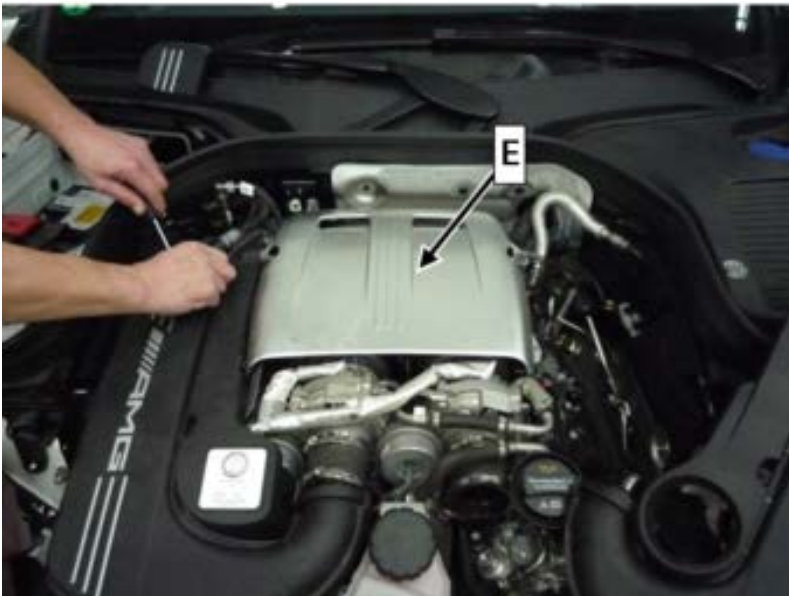
Figure 4

3. Remove heat shield (**E, Figure 4**).

i For basic data, see **AR09.40-P-6026MNG**. Do not drain coolant.

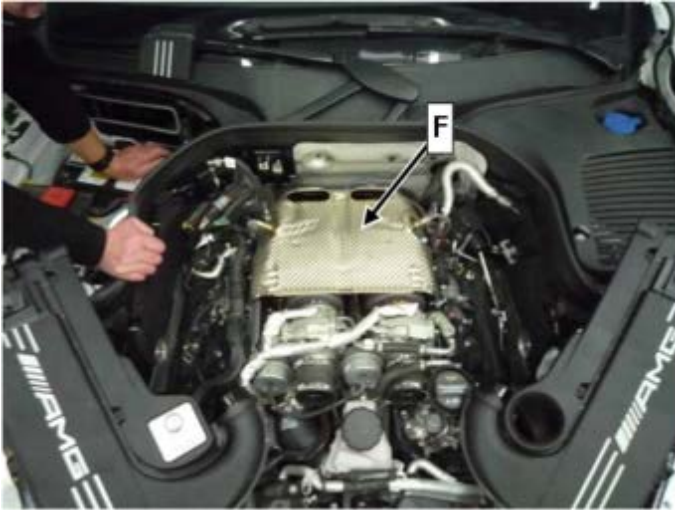
4. Remove heat shields (F, Figure 5 and G, Figure 6).

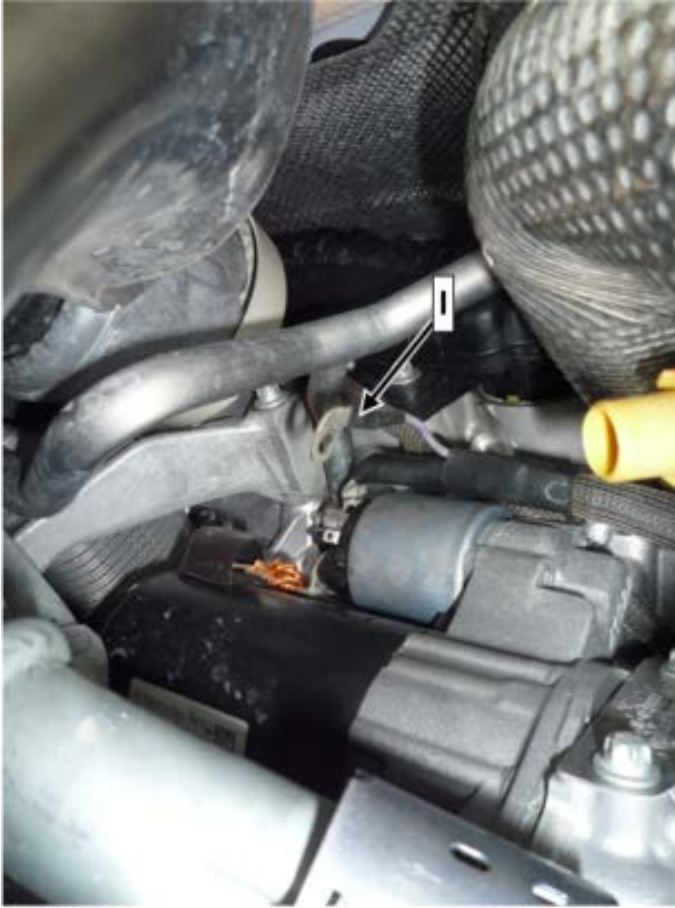
Figure 8

6. Release circuit 50 (I, Figure 8) at starter.
