Product Safety Recall

N202314670 Front Center Seat Belt May Not Be Attached

Release Date: December 2020

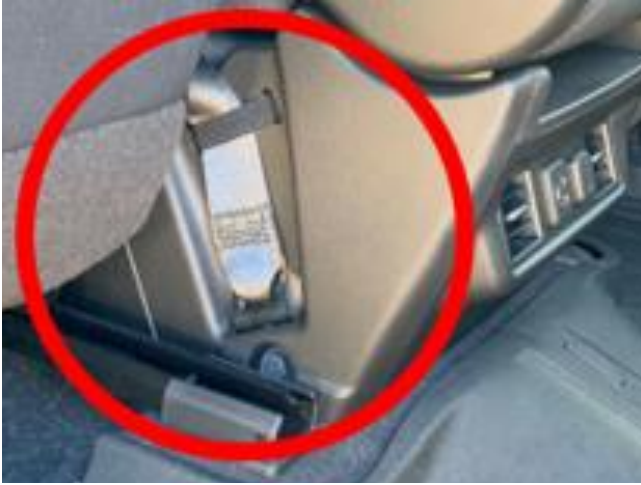
5695741

1. Move the left and right front seats to the full forward position. Position the seat backs in the full upright position.

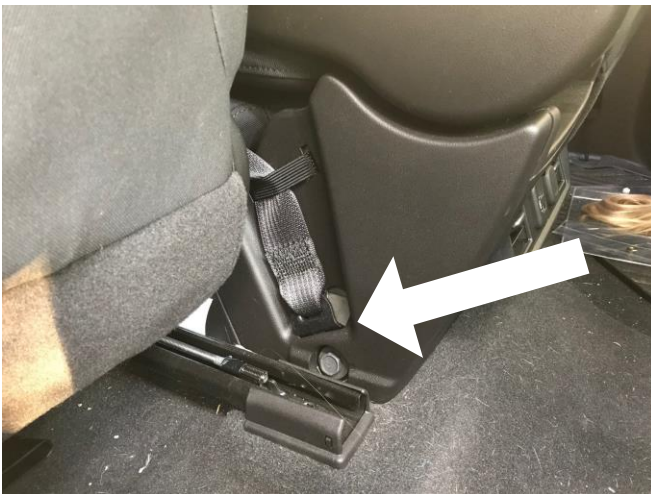
5695743

2. Access the left and right attachment locations for the center seat belt buckle and retractor belt.
3. Visually verify the left and right seat-belt attachment brackets are positioned in the seat base correctly and secured by the bolt.

Seat-Belt Bracket Positioned Correctly, Securing Bolt Through Hole in Belt Bracket.

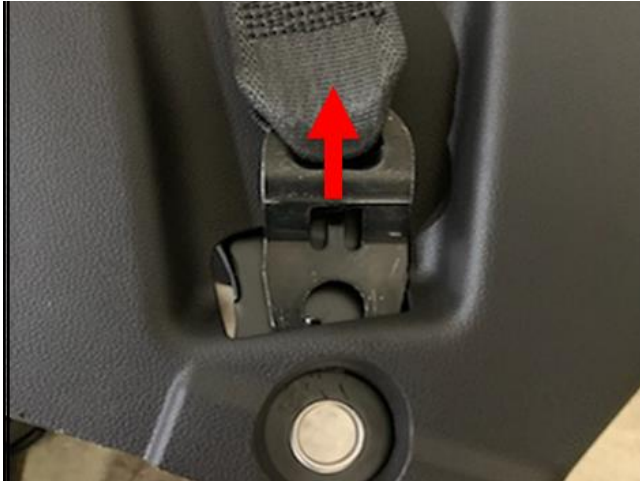
5695744

Seat-Belt Bracket Positioned Too High, Securing Bolt Not Through Hole in Bracket.

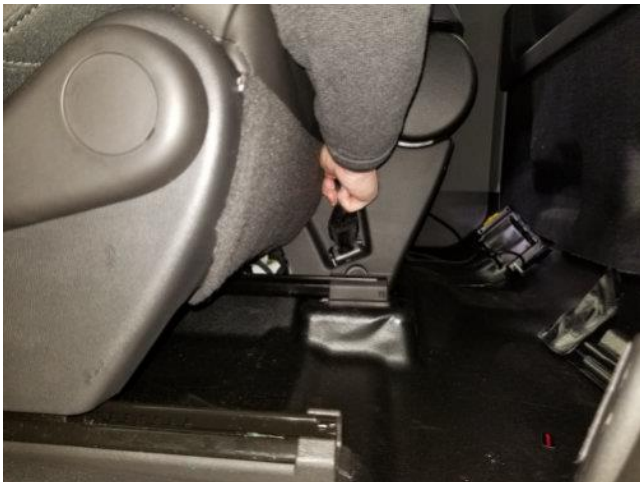
5695745

4. Further verify the seat belt attachments by firmly pulling outward (toward the door opening) on the belt in the area between the elastic band and the mounting bolt. Look for any movement of the seat-belt bracket at the seat base. Repeat this action three times.
5. **If both seat belts are attached correctly**, no further action is required.
6. **If a seat belt is not secured correctly**, perform the following steps:
 - Remove the four seat mounting bolts. Refer to *Front Seat Removal and Installation* in SI. DO NOT remove the seat assembly.
 - Carefully shift the seat assembly forward in the vehicle enough to allow access to the seat belt mounting bolt.
 - Remove the seat belt mounting bolt.
