Product Safety Recall

N202322233 Seat Belt May Not Be Properly Attached

Release Date: January 2021

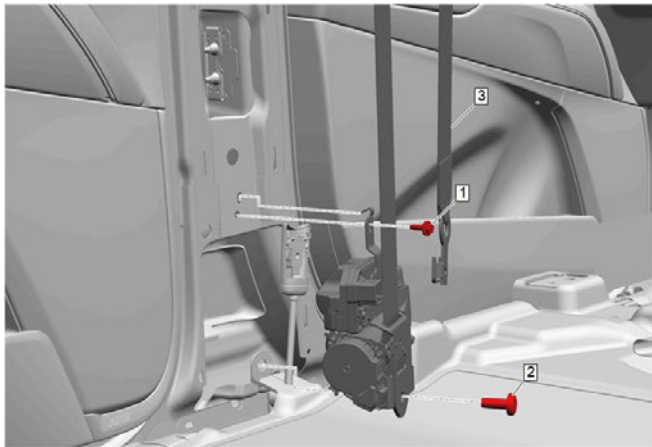
5618244

Service Procedure for First Row Outer Seatbelt Retractor Mounting Bolt

2. Remove and discard the lower retractor bolt (2).
3. Install the new retractor mounting bolt. Refer to the note above for installation details. Tighten the new service bolt to 45 N.m (33 lb. ft).
4. Reinstall the center pillar lower trim panel. Refer to *Center Pillar Lower Trim Panel Replacement* in SI.

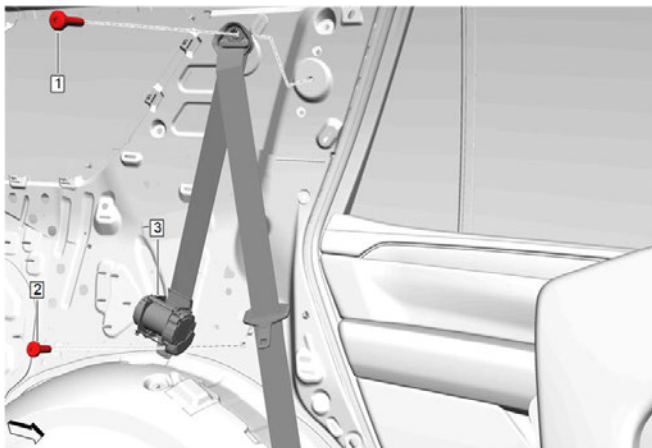
5607363

Second Row Retractor Mounting bolt (2)

3. Remove the second or third row seat belt retractor bolt as required. Discard the bolt.
4. Install the new retractor mounting bolt. Refer to the note above for installation details. Tighten the new service bolt to 45 N.m (33 lb. ft).
5. Reinstall the quarter lower rear trim panel. Refer to *Quarter Lower Rear Trim Panel Replacement* in SI.
6. Reinstall the rear compartment floor stowage compartment. Refer to *Rear Compartment Floor Stowage Trim Compartment Replacement* in SI.

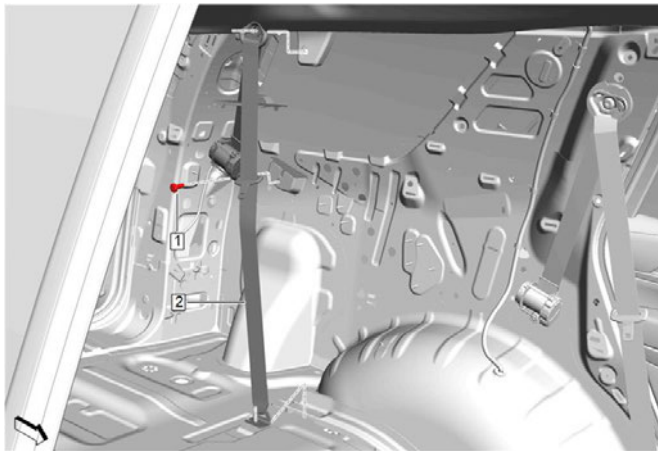
5634145

Third Row Retractor Mounting Bolt (1)

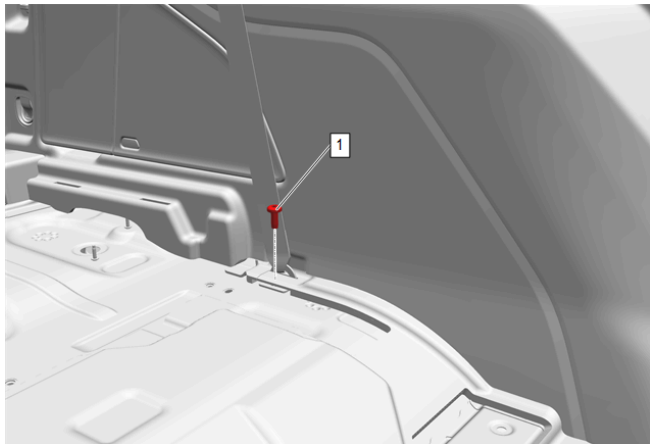
5612585

Third Row Seat Belt Anchor Bolt Replacement

2. Locate the third-row seat belt anchor bolt (1). Remove and discard the bolt.
3. Install the new seat belt anchor bolt. Refer to the note above for installation details. Tighten the new service bolt to 45 N.m (33 lb. ft).
4. Reinstall the third-row seat. Refer to *3rd Row Seat Removal and Installation* in SI.
