Safety Recall

Code: 20Z8

Subject	Fuel Pump Flange
Release Date	July 03, 2017
Revision Summary	Repair available for Audi Q5.
Affected Vehicles	U.S.A. & CANADA: Certain 2013-2017 MY Audi Q5 and 2013-2015 Audi Q7 <i>Check Campaigns/Actions screen in Elsa on the day of repair to verify that a VIN qualifies for repair under this action. Elsa is the <u>only</u> valid campaign inquiry & verification source.</i> <ul style="list-style-type: none">✓ Campaign status must show "open."✓ If Elsa shows other open action(s), inform your customer so that the work can also be completed at the same time the vehicle is in the workshop for this campaign.
Problem Description	On certain vehicles, the fuel pump flange may develop fine cracks or fissures, which could result in a fuel leak. Leaking fuel, in the presence of an ignition source, could lead to a fire causing injury and/or damage to property.
Corrective Action	If cracks, leaks, and/or yellow discoloration are present, the fuel pump flange will be replaced and a protective film installed onto the fuel pump flange. If no cracks, leaks, and/or yellow discoloration are present, a protective film will be installed onto the fuel pump flange.

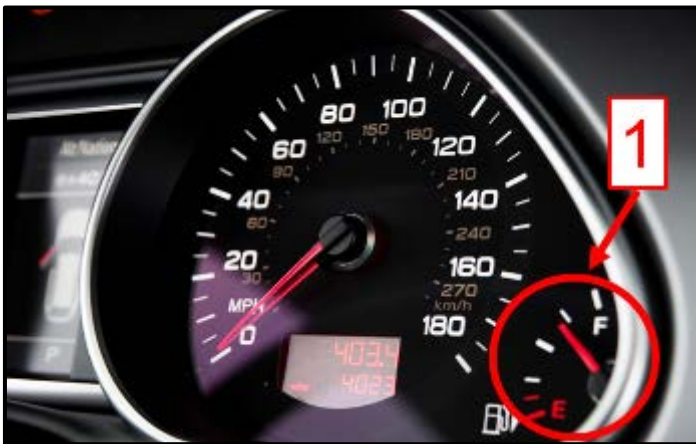
- Check the vehicle fuel level displayed on the instrument cluster <1>.
- Record the vehicle fuel level on the repair order.

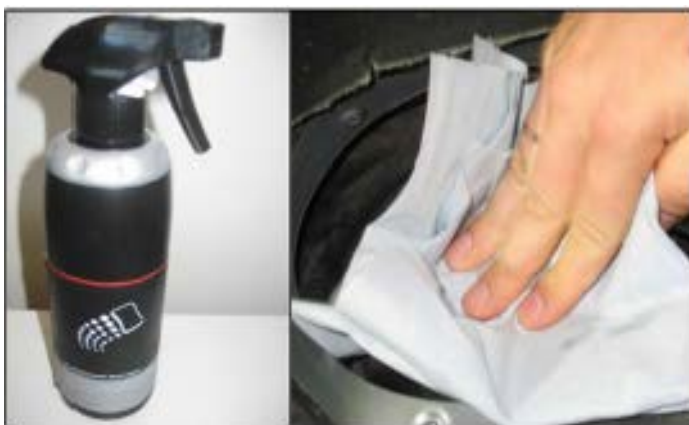
- Clean top of fuel filter with suitable plastic cleaner.

! NOTE
 Use a suitable cloth to apply the plastic cleaner; do not spray the plastic cleaner directly onto the flange.

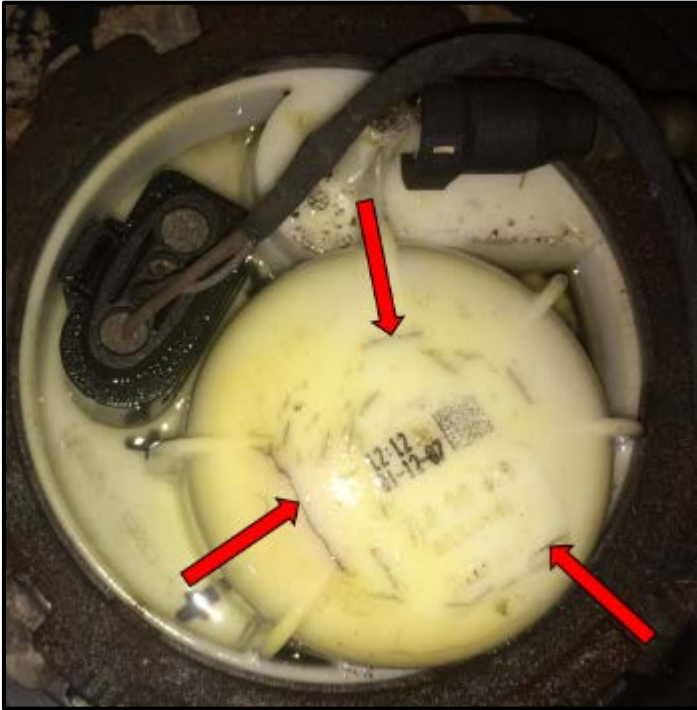
- If there is a visible presence of leaking fuel;
 - **Continue to Section D and Replace the Fuel Filter Flange and install the protective film.**
 - **All others continue to the next step.**

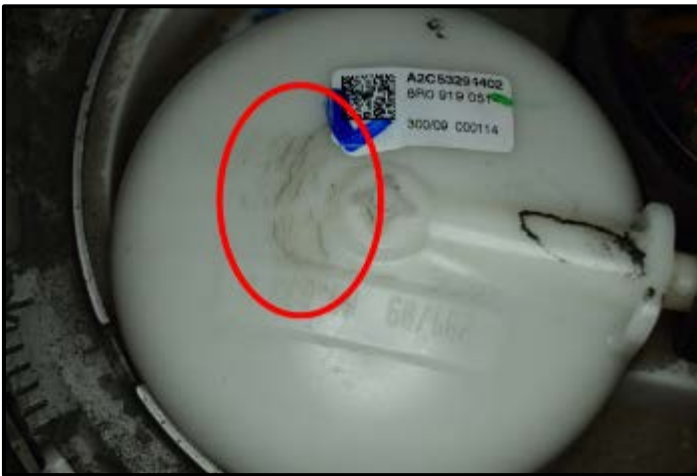
- If there are no signs of leaking present, but there **ARE** cracks <circle> and/or yellow discoloration present;
 - **Continue to Section D and Replace the Fuel Filter Flange and install the protective film.**
 - **All others continue to the next step.**

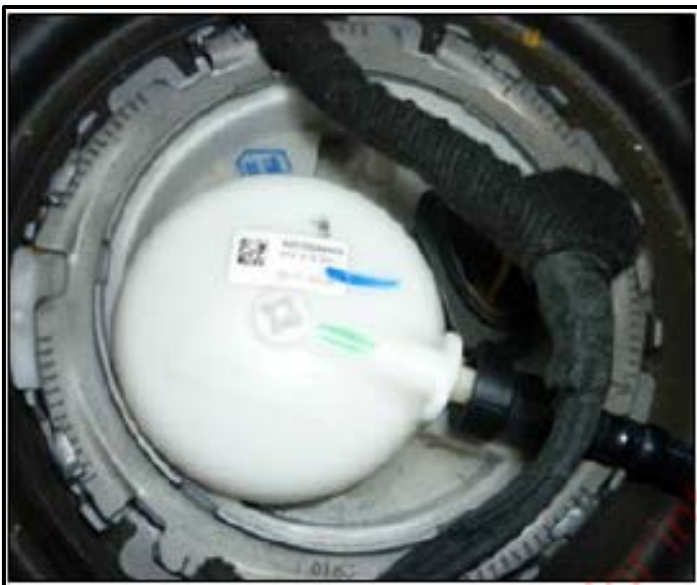
- If there are **NO** cracks, leaks, and/or yellow discoloration present;
 - **Continue to Section C and install the protective film and reinstall the seat frame.**

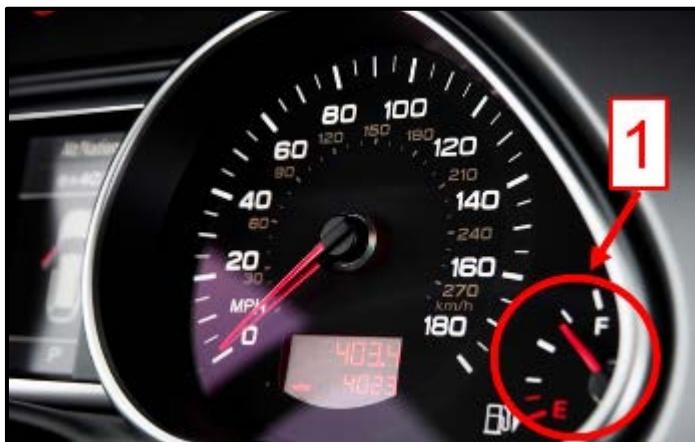
- Turn on the ignition.
- Cycle the ignition four to five times to prime the fuel system and verify there are no DTC's present and no warning lamps illuminated.
- Start the vehicle to verify fuel system functionality. Make sure to check for any fuel leaks before delivering the vehicle to the customer.
- Check the vehicle fuel level displayed on the instrument cluster <1>.
- Refer to the vehicle fuel level on the repair order and verify the proper operation of the fuel level sensor.
- Reset customer convenience basic settings (i.e. one touch windows, instrument cluster clock, etc.).
- Repair Complete - **Proceed to section H.**

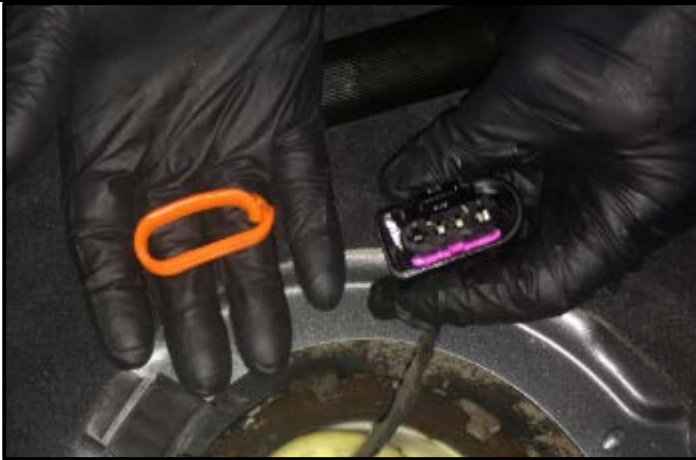
- If the fuel filter flange was leaking fuel, inspect the wiring harness connector carefully for damage due to fuel wicking into the weather pack seals.
- If damage to the weather pack seal and/or wiring harness is discovered, be sure to order the appropriate wiring and connector to correctly repair the damaged harness.

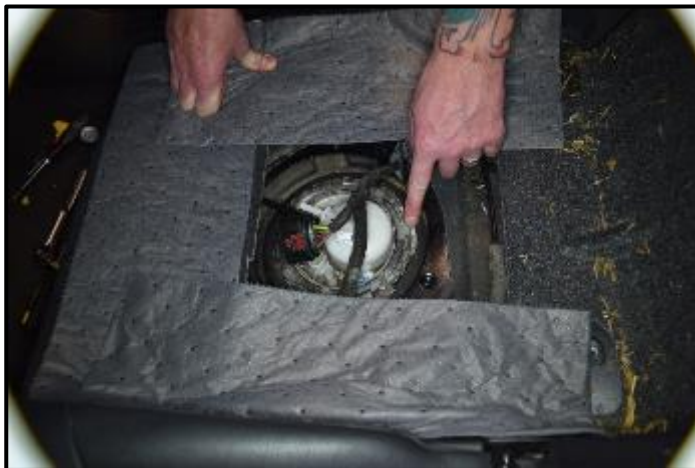
WARNING

There is a risk of fuel leaking out from the filled fuel filter flange. Lay cloths, rags, or other absorbent material below to catch the leaking fuel.

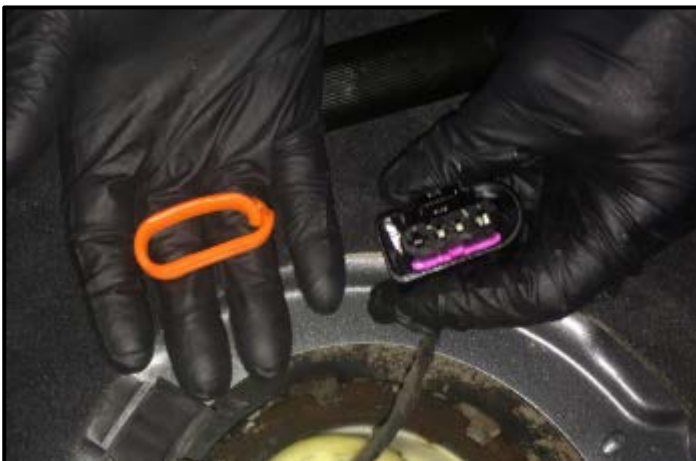
- If required, repair the wiring harness connector, wiring, and weather pack seals before reconnecting the connector to the fuel filter flange.

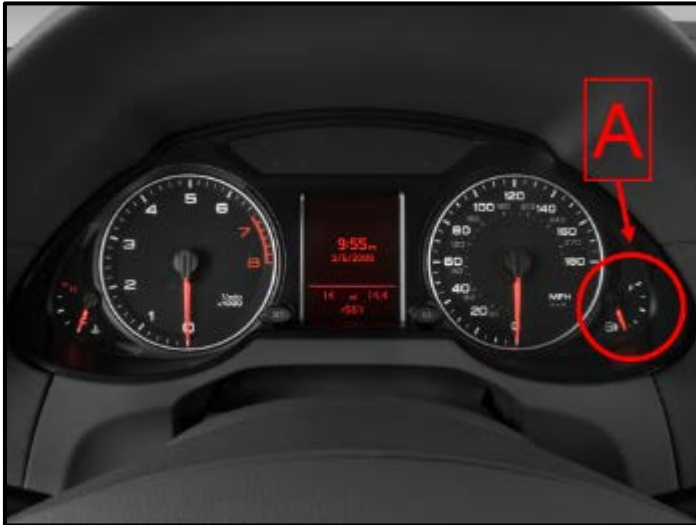
- Check the vehicle fuel level displayed on the instrument cluster <A>.
- Record the vehicle fuel level on the repair order.

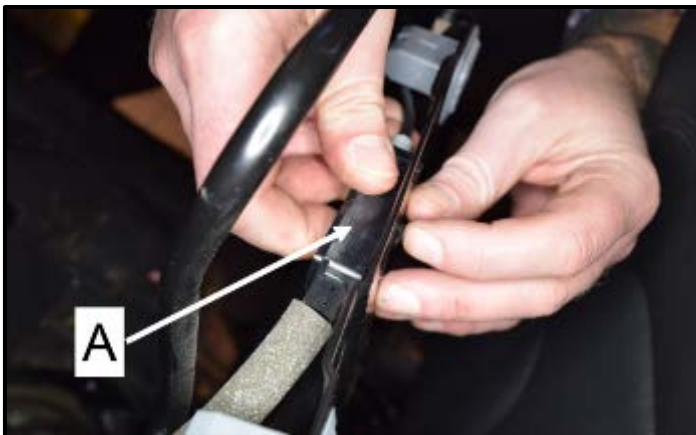
- Flip the seat frame up to gain access to the seat frame adjustment cable connector.
- Unclip the seat frame adjustment cable connector <A> from the seat frame (if equipped).

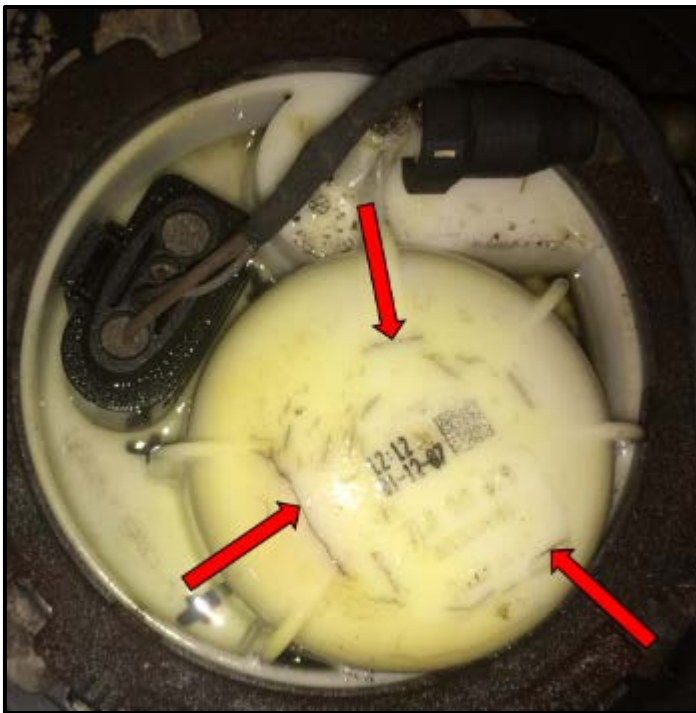
- If there is a visible presence of leaking fuel;
 - **Take photos of the flange clearly showing the leak to attach to the ATA WEB Ticket.**
 - **Continue to Section G and Replace the Fuel Filter Flange and install the protective film.**
 - **All others continue to the next step.**

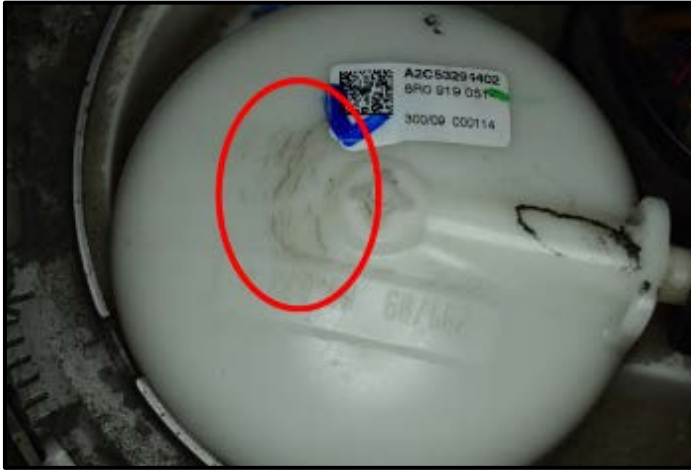
- If there are no signs of leaking present, but there **ARE** cracks <circle> and/or yellow discoloration present;
 - **Take photos of the flange clearly showing the cracks to attach to the ATA WEB Ticket.**
 - **Continue to Section G and Replace the Fuel Filter Flange and install the protective film.**
 - **All others continue to the next step.**

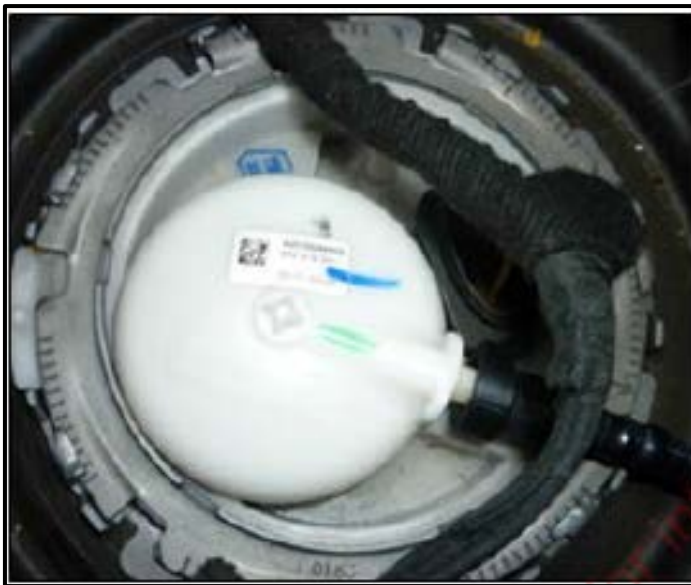
- If there are **NO** cracks, leaks, and/or yellow discoloration present;
 - **Continue to Section F and install the protective film and reinstall the seat frame.**

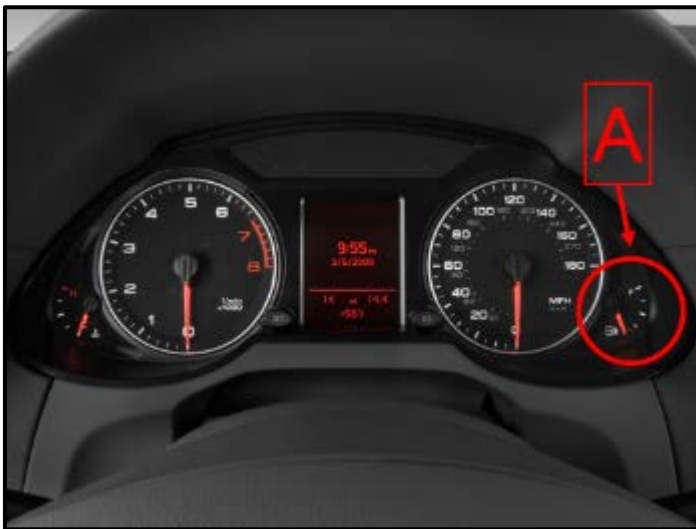
- Turn on the ignition.
- Cycle the ignition four to five times to prime the fuel system and verify there are no DTCs present and no warning lamps illuminated.
- Start the vehicle to verify fuel system functionality. Make sure to check for any fuel leaks before delivering the vehicle to the customer.
- Check the vehicle fuel level displayed on the instrument cluster <A>.
- Refer to the vehicle fuel level on the repair order and verify the proper operation of the fuel level sensor, and that the correct amount of fuel has been returned to the vehicle from the Fuel Extracting Device -VAS5190A- (if removed).
- Reset customer convenience basic settings (i.e. one touch windows, instrument cluster clock, etc.).
- Repair Complete - **Proceed to Section H.**

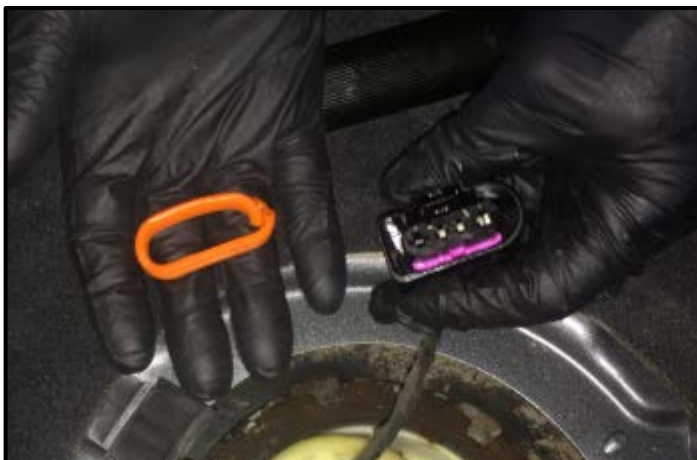
- If the fuel filter flange was leaking fuel, inspect the wiring harness connector carefully for damage due to fuel wicking into the weather pack seals.
- If damage to the weather pack seal and/or wiring harness is discovered, be sure to order the appropriate wiring and connector to correctly repair the damaged harness.

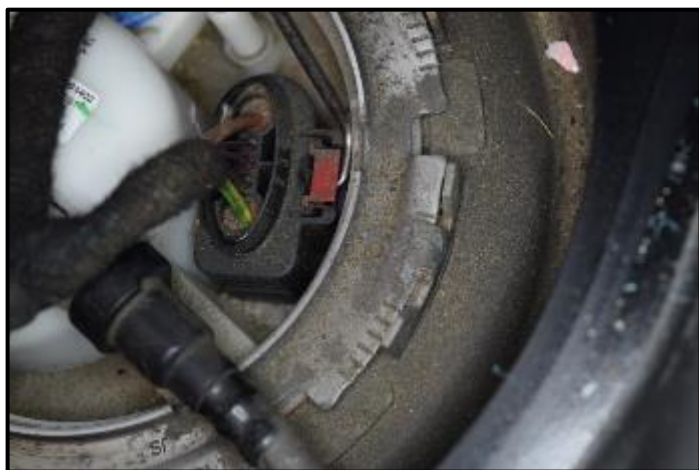
! NOTE

Due to clearance issues between the locking tab and the body of flange, a small pick tool can be used to aid in removal of the connector.

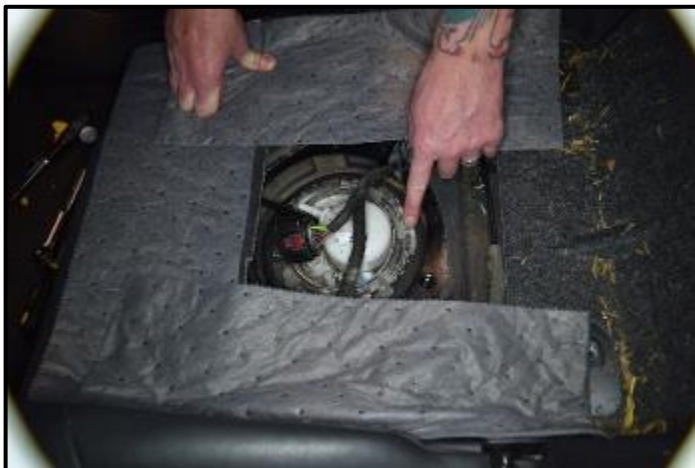
WARNING

There is a risk of fuel leaking out from the filled fuel filter flange. Lay cloths, rags, or other absorbent material around the fuel filter flange opening to catch the leaking fuel.

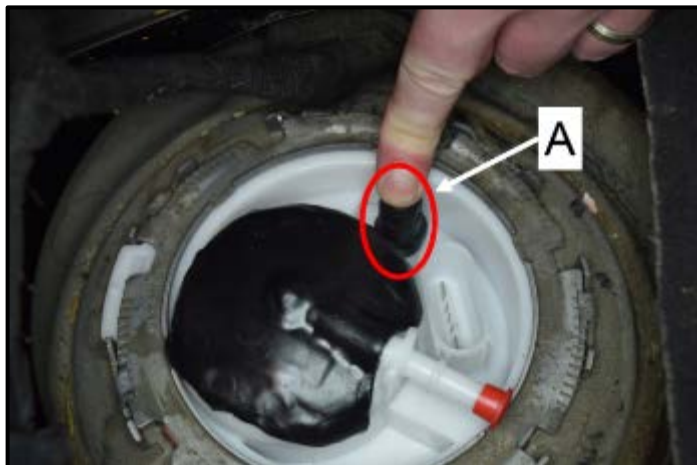
- Install the Quick coupling piece cap <A> to the top of the fuel filter flange until you hear an audible click.
- Pull gently on the Quick coupling piece cap <A> to verify connection to the fuel filter flange.

Part Number	Part Description
8E0201263A	Quick coupling piece cap

WARNING
There is a risk of fuel leaking out of the fuel line heater connection <A> if the Quick coupling piece cap is not installed. Verify that the Quick coupling piece cap is connected or the vehicle may leak fuel from the fuel line heater nipple.

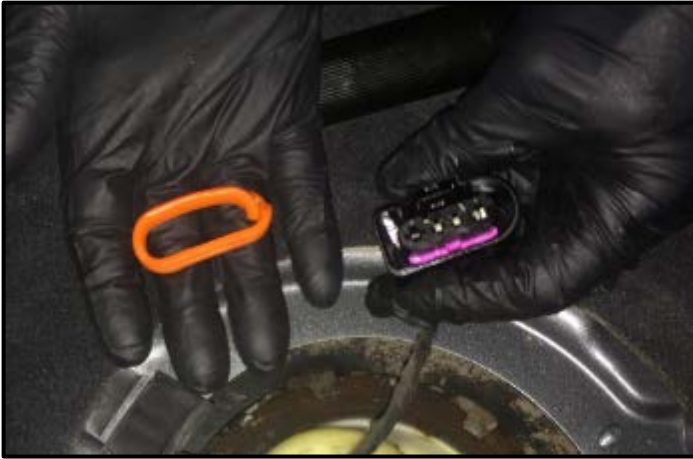
- If required, repair the wiring harness connector, wiring, and weather pack seals before reconnecting the connector to the fuel filter flange.
