Product Safety Recall

N212328760 Front Passenger Airbag Takata Inflator

– Priority Group 6

Revision: 03

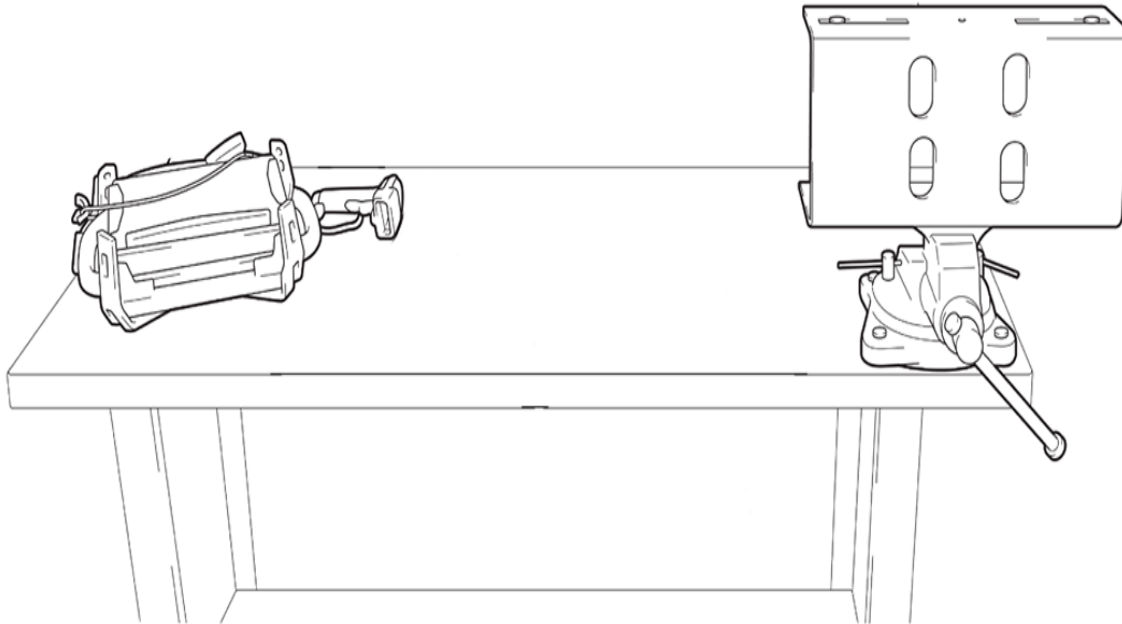
3607819

Danger: To avoid personal injury or death, it is critical to use an airbag module bracket when replacing an inflator module. Carefully read and follow the instructions below:

1. Confirm the bracket assembly is installed securely in the vise.
2. Confirm there are no loose objects or people exposed to the back side of the bracket for safety in the unlikely event of airbag deployment due to improper work procedures. The airbag is NOT being replaced due to an inadvertent deployment concern.
3. Confirm that no objects, tools or people are within 3 feet (1 meter) of the back side of the bracket.
4. Confirm that no objects, tools or people are within 2 feet (0.6 meters) of the sides of the bracket.
5. BEFORE starting work and periodically while working on the airbag module, touch a metallic part of the work bench to discharge static electricity in the body.

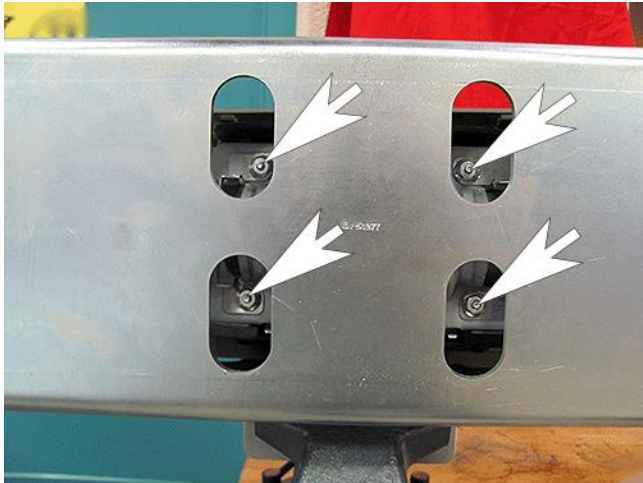
4664049

- Position the airbag assembly so that all four stopper plate nuts can be removed through the access holes.

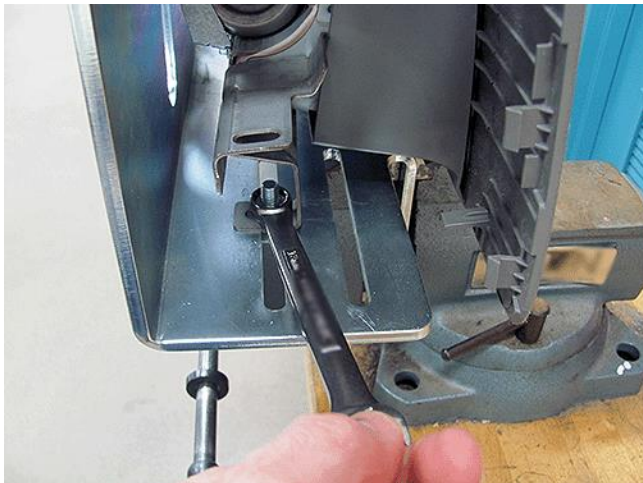
4664050

- Tighten the two fasteners that attach the airbag assembly to the module bracket.
- Confirm the following steps have been completed BEFORE proceeding to the next step:
 - The mounting bracket is secure in the vise.

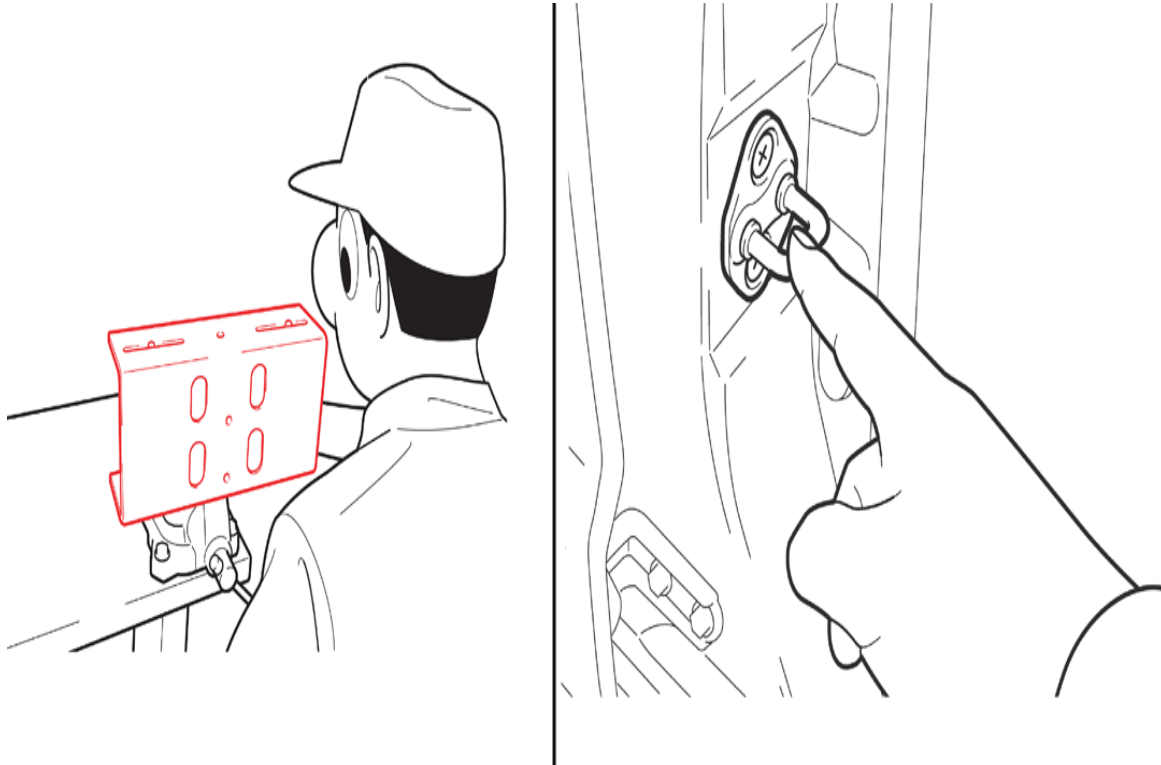
3607909

Danger: To avoid personal injury, *ALWAYS* keep as much of your body as possible in front of the bracket when working on the airbag assembly. Remember to periodically touch a metallic part of the vehicle or work bench to discharge static electricity in the body. **DO NOT** use power tools when performing the inflator removal/reinstallation steps.

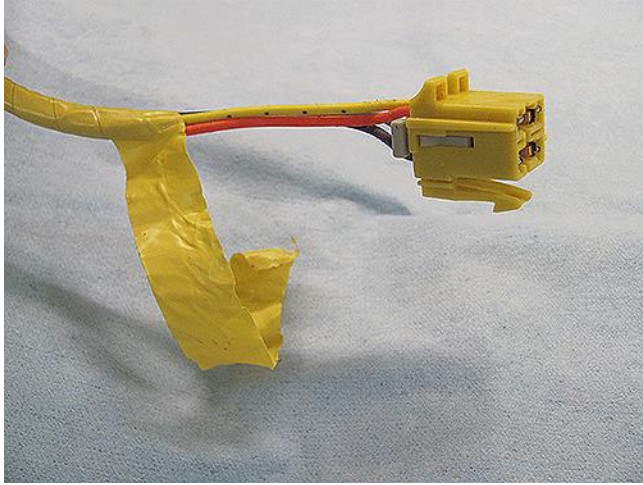
5680363

1. Peel the yellow tape off of the wire harness near the connector. **DO NOT** use a knife or sharp tool to remove the yellow tape.

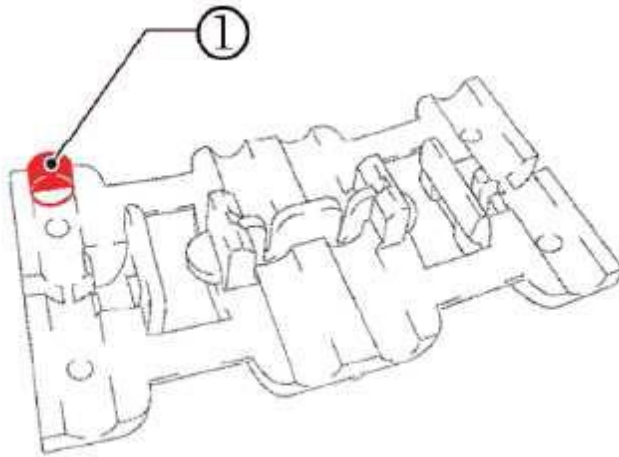
5680722

2. Locate the red plastic "Electro Tap" from the service kit. If required, remove the small tab from the electro tap as shown (1).

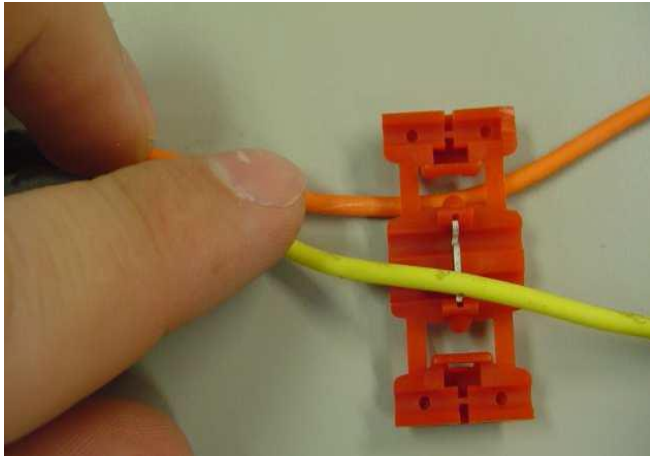
5680660

3. Locate the yellow wire and place it in the electro tap.

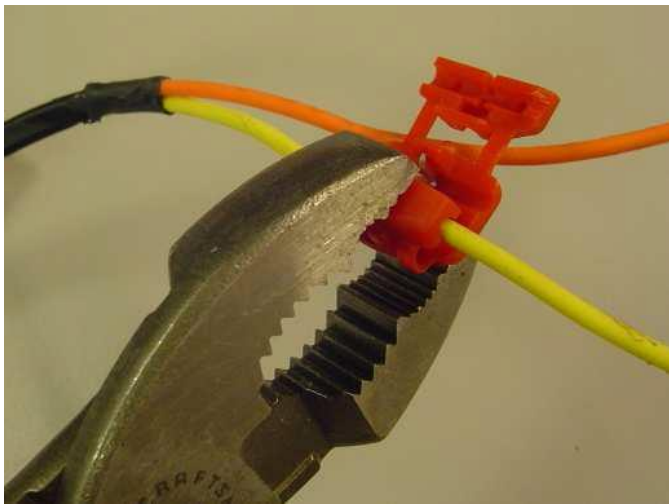
5680663

4. Use pliers to firmly close the electro tap on the **yellow wire** until an audible “click” is heard confirming the installation.

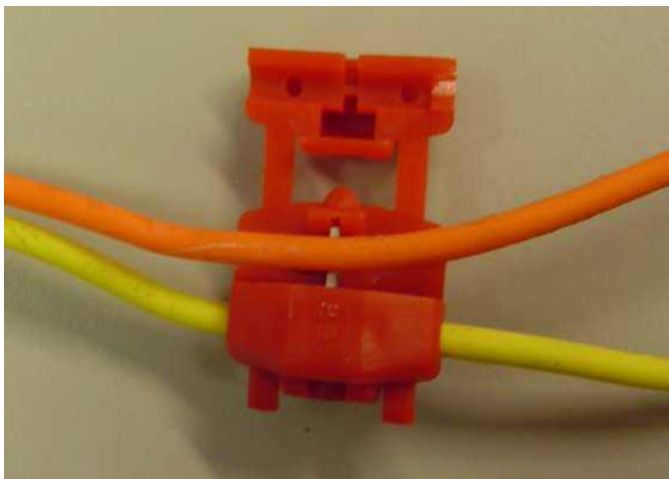
5680664

5. Locate the orange wire and place it in the electro tap.
6. Use pliers to firmly close the electro tap on the **orange wire** until an audible “click” is heard confirming the installation.

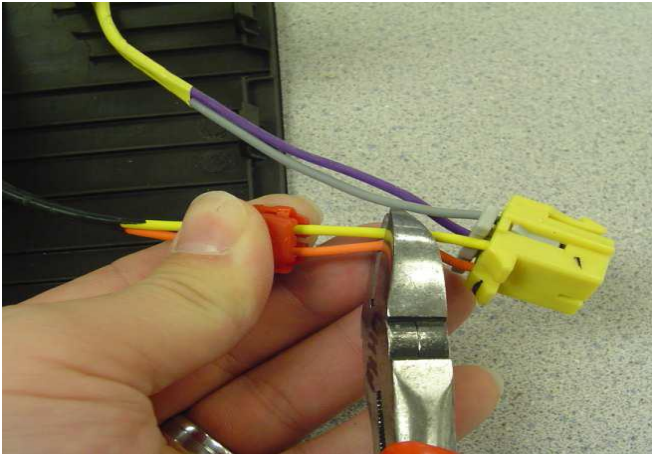
5680666

7. Place wire cutters on the connector side of the electro tap and cut the wires as shown.

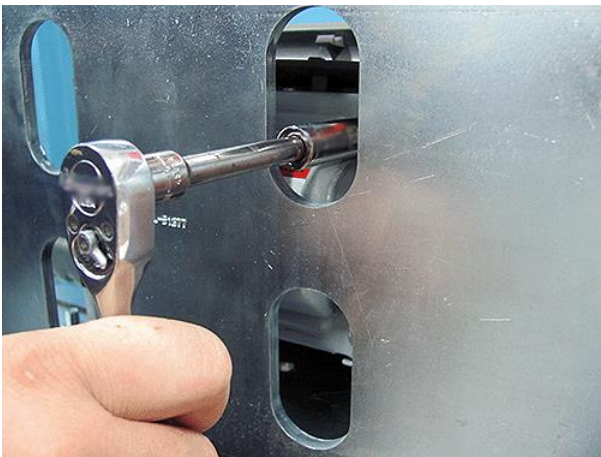
4664052

8. Use the access holes in the bracket to loosen and remove the four self-locking nuts, **do not use power tools to remove the nuts**. Discard the nuts, they will not be reused.

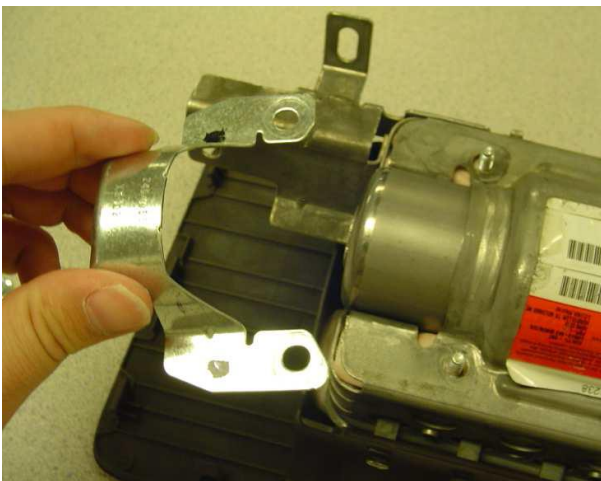
5680667

9. Remove the stopper plate (bracket).

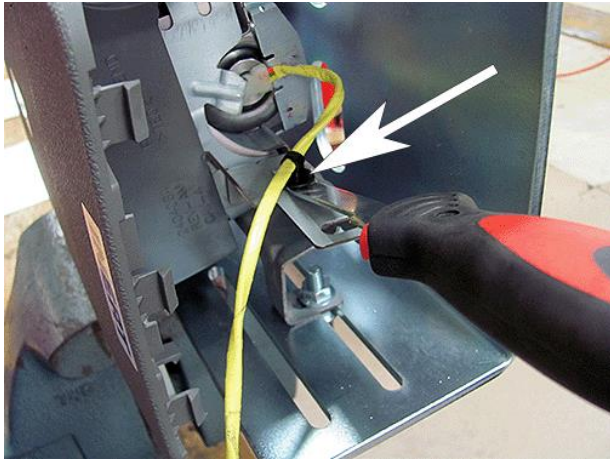
4664053

10. Disengage the wire harness locator from the housing.

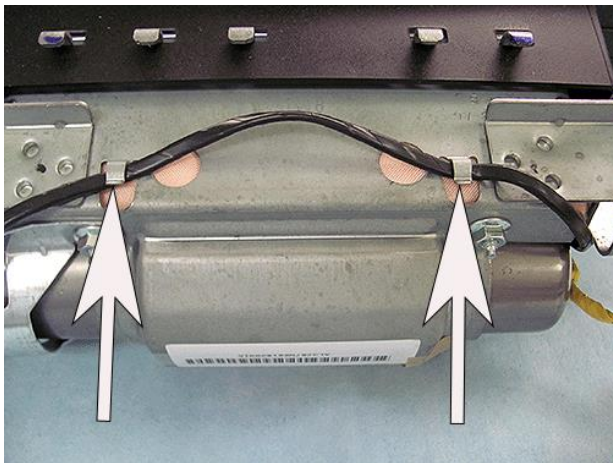
5680364

11. Remove the black taped wire from the housing tabs. The wire harness is now fully disconnected from the housing.

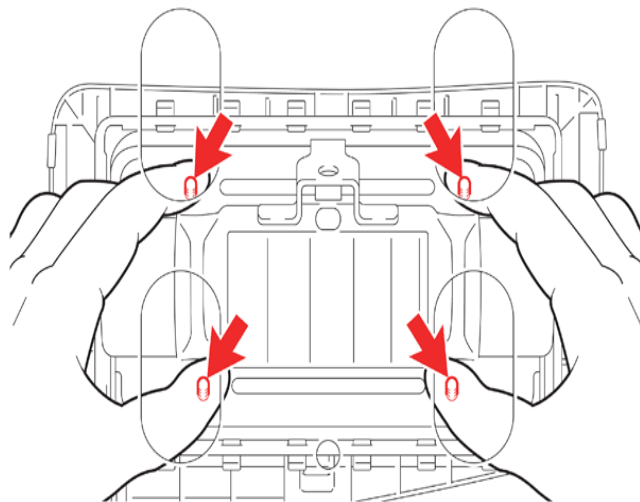
3607857

12. Gently push in the 4 studs to loosen the inflator for removal.

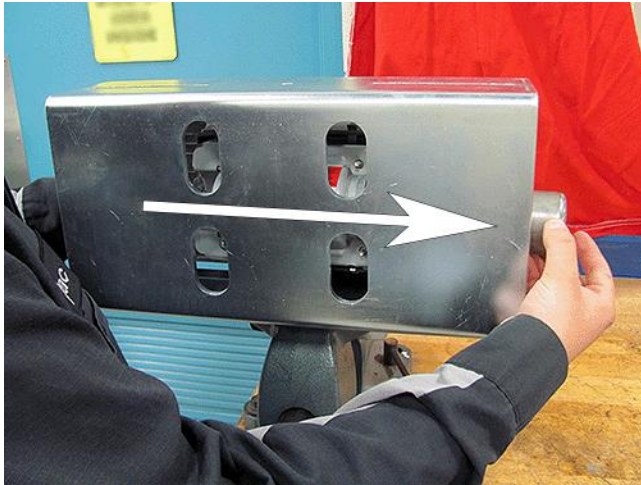
4664060

13. Remove the inflator from the housing, slide the inflator to the right.

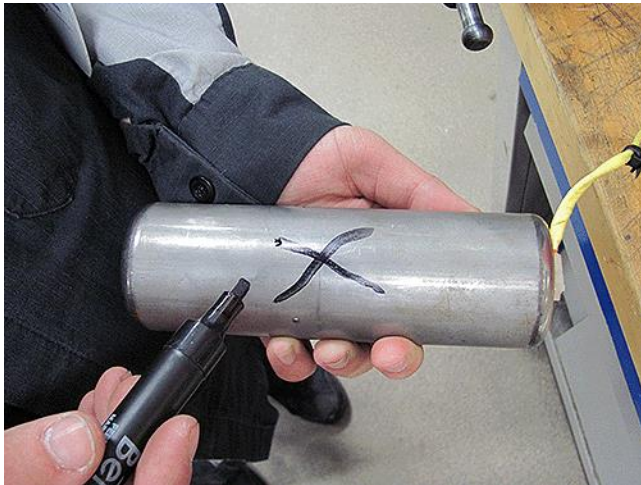
4664063

14. Put a mark on the removed inflator and store it in the provided replacement part box. Refer to the instructions that were included with the new inflator module kit.

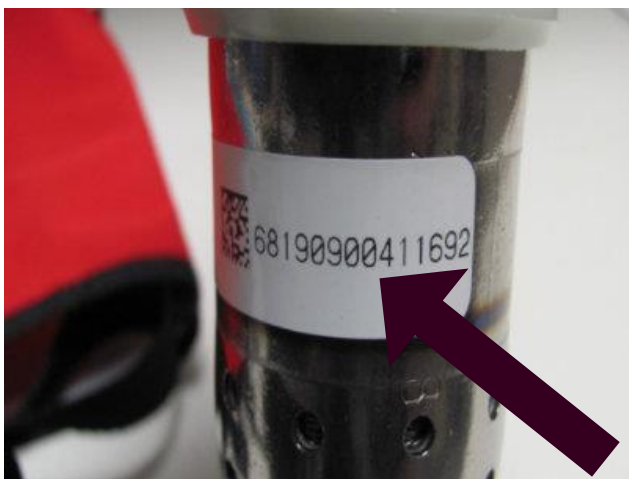
5838265

15. Record the serial number of the new (replacement) inflator from the service kit on the job card.

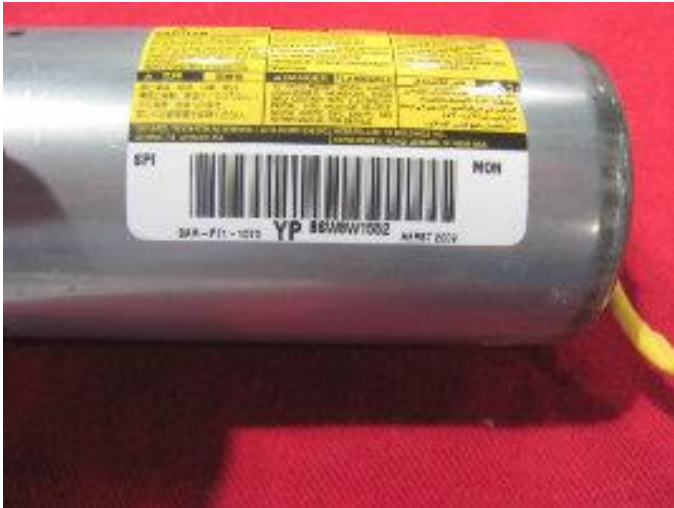
5844318

16. Record the serial number of the used inflator that is being returned on the job card.

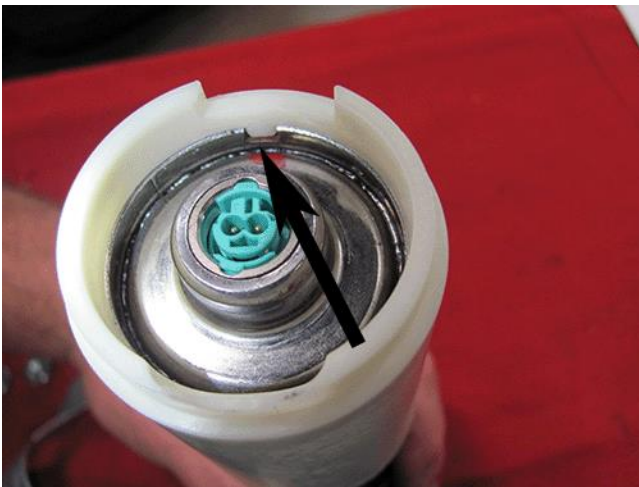
5680402

- Ensure the tab on the white end cap is aligned with the notch in the inflator.

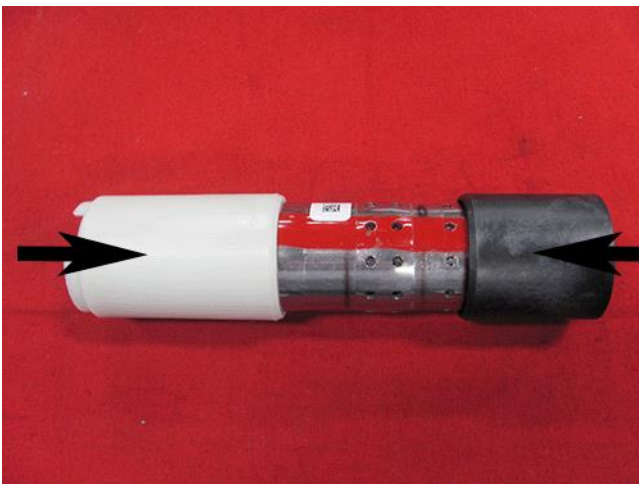
5680403

- Ensure both end caps are fully seated onto the inflator.

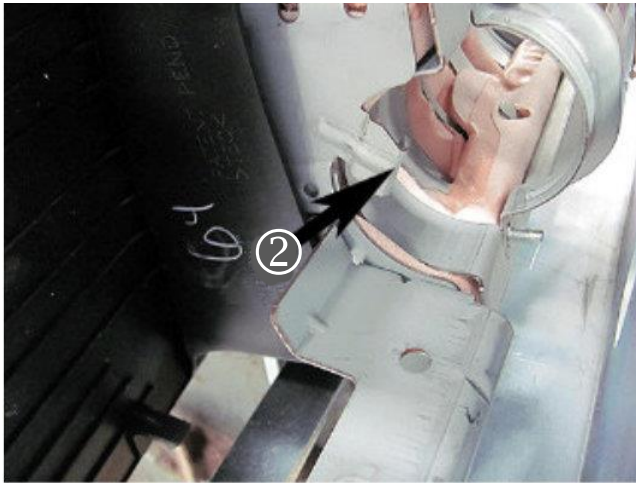
5735686

18. Using a small pair of slip joint pliers, bend the alignment tab on the airbag inward from a 90 Deg. angle (1) to a 45 Deg. angle (2).

Note: Only the small return tab should be bent. Take care to not bend any other portion of the orientation tab.

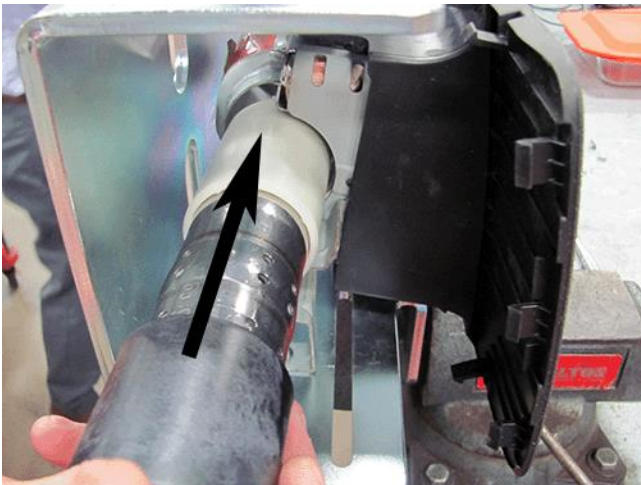
5680409

19. Slide the new inflator into the housing with the white end cap first.

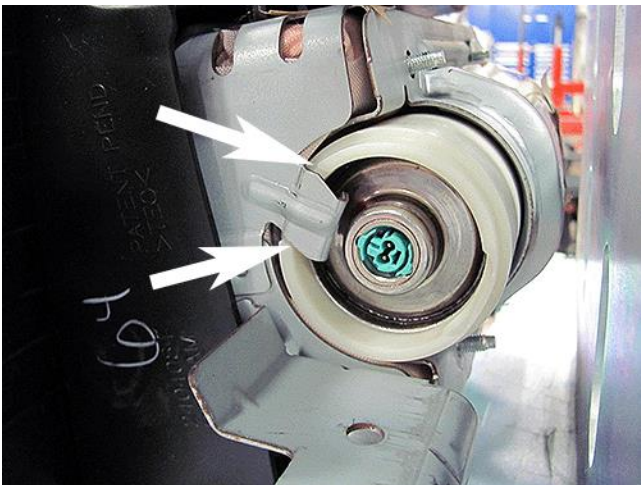
5680411

20. Rotate the inflator until the notch in the white end cap aligns with the alignment tab.

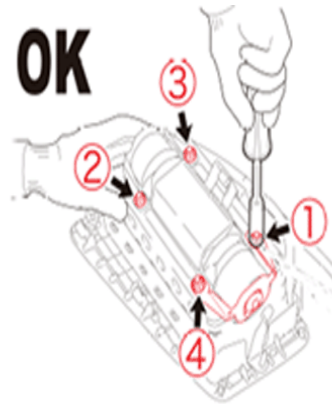
3610416

23. Tighten four (4) *NEW* plate nuts evenly in several increments in the order shown in the illustration using a 10-mm socket driver while pushing on the inflator against the alignment tab.

Note: The inflator should be netted out against the alignment tab prior to tightening the nuts. You will encounter some resistance during tightening because these nuts are self-locking nuts. **Torque Specification: 6.5 Nm 57 in-lb).**

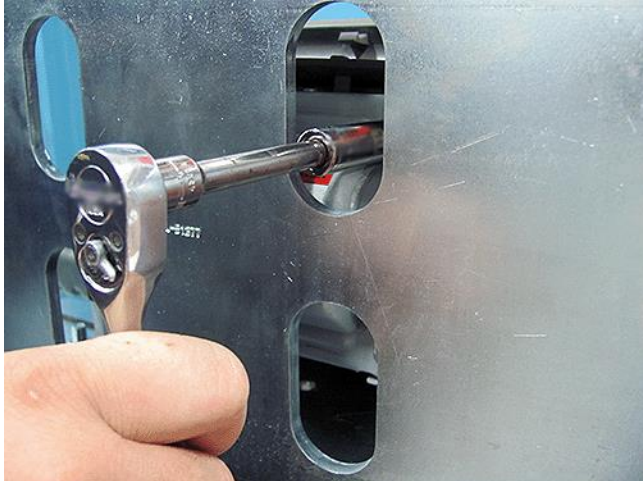
4664052

1. Use the access holes in the bracket to loosen and remove the four self-locking nuts, **do not use power tools to remove the nuts**. Discard the nuts, they will not be reused.

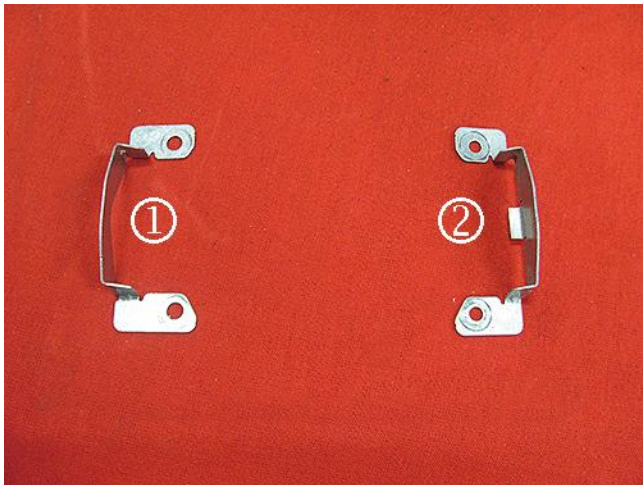
4664065

2. Remove the two stopper plates (1 and 2). Discard the stopper plates, they will not be reused.

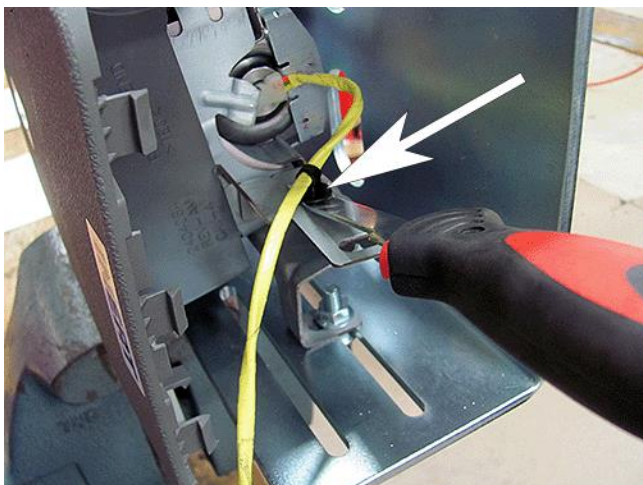
4664053

3. Disengage the wire harness locator from the housing.

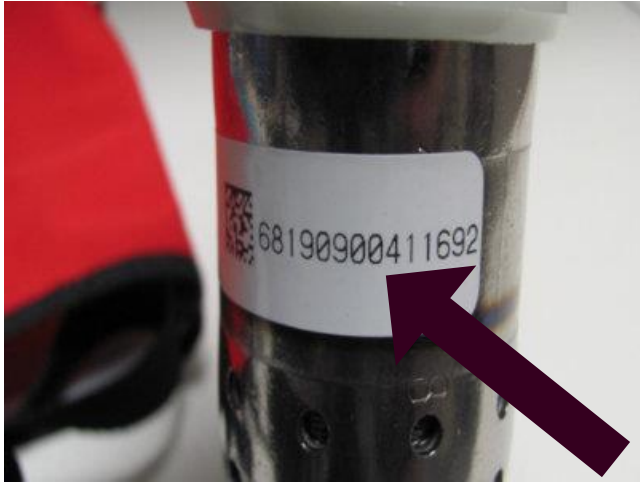
5838265

7. Record the serial number of the new (replacemet) inflator from the service kit on the job card.

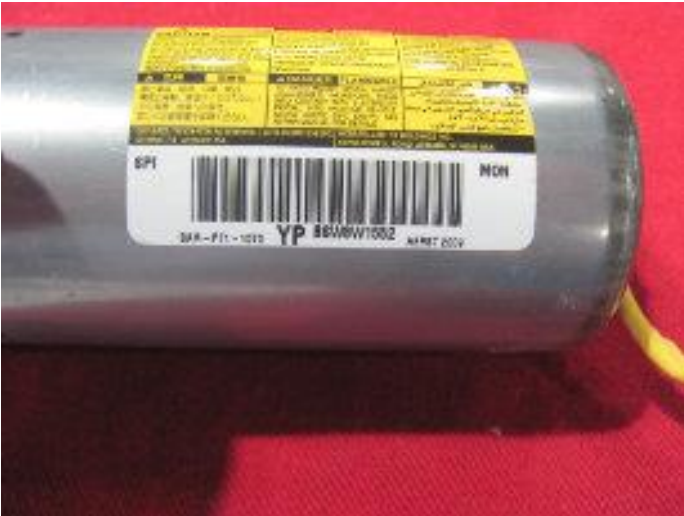
5844318

8. Record the serial number of the used inflator that is being returned on the job card.
9. Inspect the new inflator for the following two conditions:

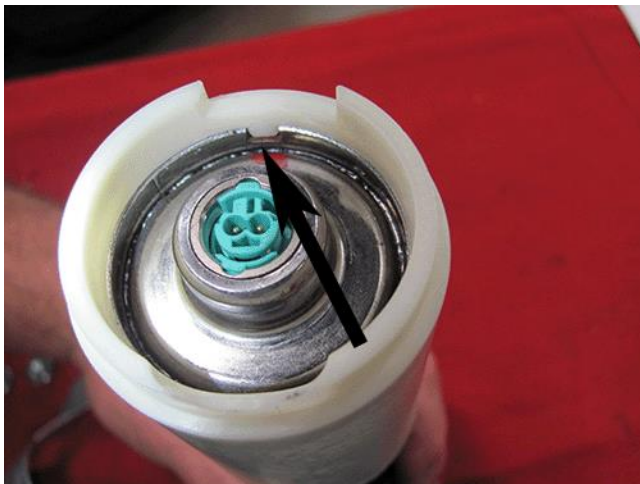
5680402

- Ensure the tab on the white end cap is aligned with the notch in the inflator.

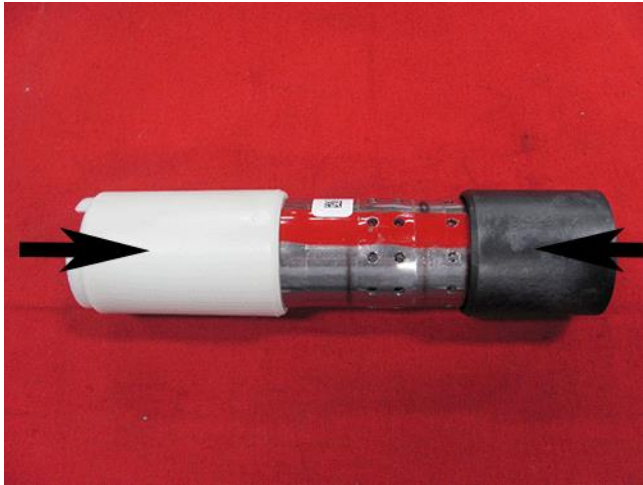
5680403

- Ensure both end caps are fully seated onto the inflator.

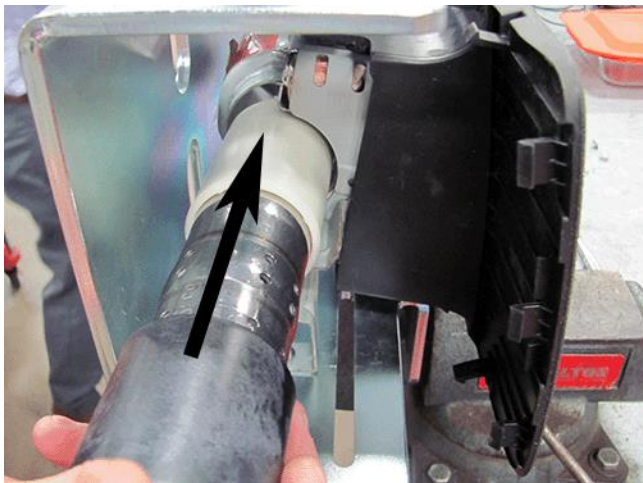
5680409

11. Carefully slide the new inflator into the airbag assembly. Ensure the inflator is installed with the harness (white end cap) end first.
