Product Safety Recall

N212328780 Front Passenger Airbag Takata Inflator

- Priority Group 8

Condition	TK Holdings Inc. ("Takata") has decided that a defect which relates to motor vehicle safety exists in the passenger-side frontal airbag inflators installed as original equipment in certain 2007-2014 model year Cadillac Escalade, Escalade ESV, Chevrolet Silverado 2500/3500, Suburban, and Tahoe, GMC Sierra 2500/3500, Yukon, and Yukon XL vehicles; certain 2007-2013 model year Cadillac Escalade EXT, Chevrolet Avalanche, Silverado 1500 and GMC Sierra 1500 vehicles. The determination was made that the propellant in these inflators may degrade after long-term exposure to high humidity and temperature cycling, which could cause the inflator to rupture during a deployment. An inflator rupture may cause metal fragments to pass through the airbag and into the vehicle interior at high speed, which may result in injury or death to vehicle occupants.
Correction	Dealers will replace the passenger-side frontal airbag inflator.

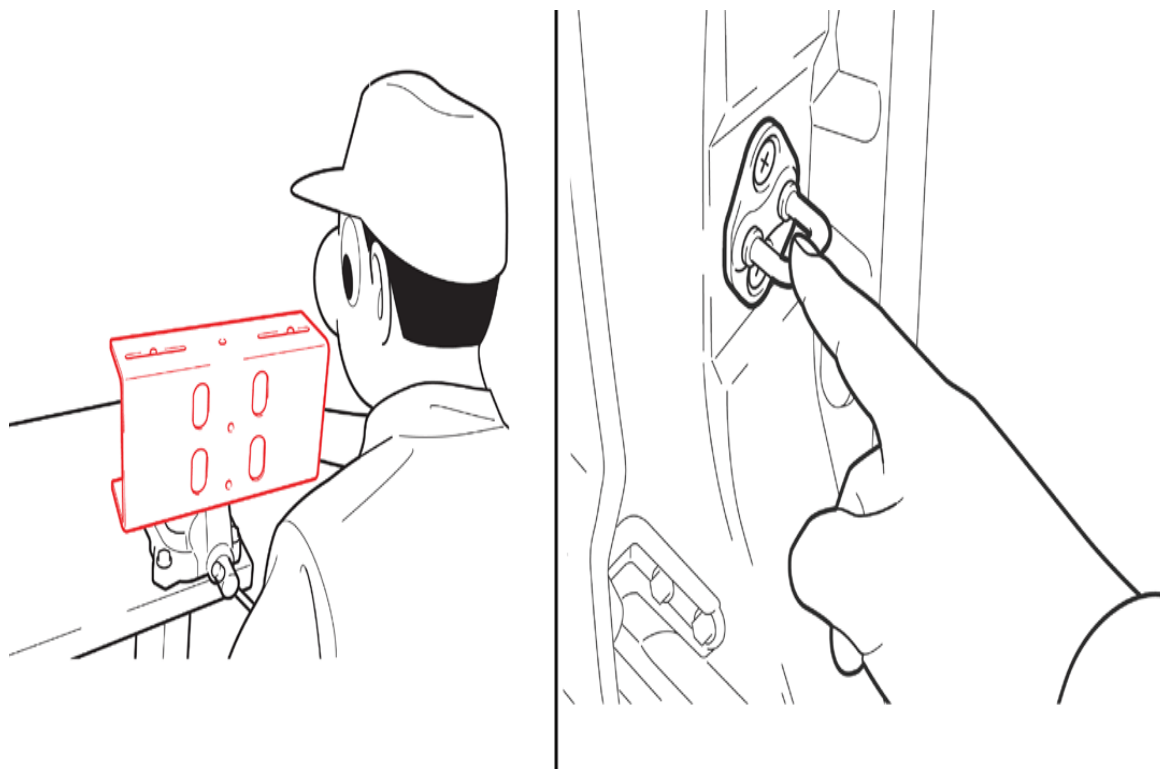
3607909

Danger: To avoid personal injury, **ALWAYS** keep as much of your body as possible in front of the bracket when working on the airbag assembly. Remember to periodically touch a metallic part of the vehicle or work bench to discharge static electricity in the body. **DO NOT** use power tools when performing the inflator removal/reinstallation steps.

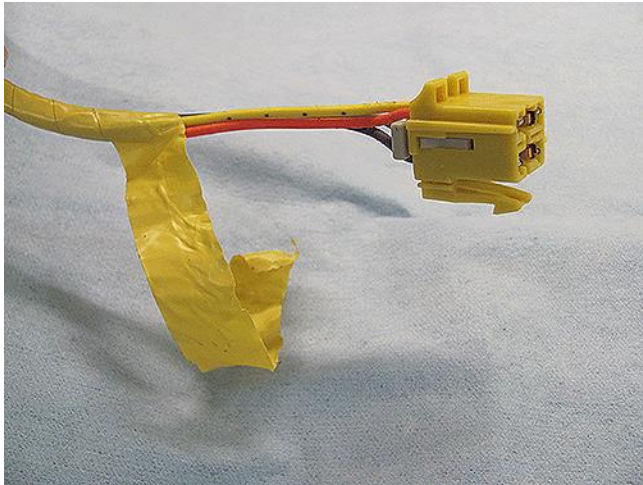
5680363

1. Peel the yellow tape off of the wire harness near the connector. **DO NOT** use a knife or sharp tool to remove the yellow tape.

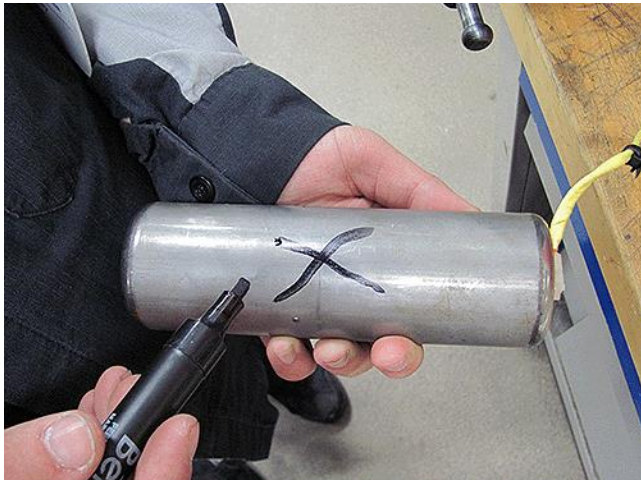
4664063

7. Put a mark on the removed inflator and store it in the replacement part box.
