# Product Safety Recall

## N212328780 Front Passenger Airbag Takata Inflator

### - Priority Group 8

**Release Date:** February 2021

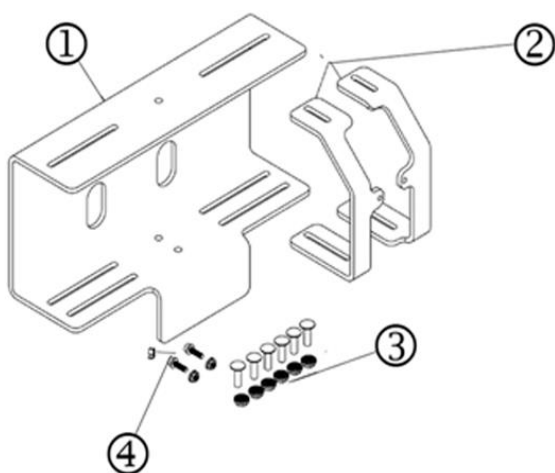
4006668

(1) Mounting Bracket (2) Support Bars (3) Support Bar Hardware (4) Airbag Mounting Hardware.

Dealers must use the airbag mounting bracket, shown below, to replace the front passenger airbag inflator. As of December 31, 2015, all U.S. dealers have been shipped the airbag mounting bracket at no charge through Bosch Automotive Service Solutions. The Bosch tool number is EL-51377. If your dealership does not have the airbag mounting bracket, do not attempt to perform this service procedure and immediately contact **1-800-GM-TOOLS** for assistance. Attempting to replace the front passenger airbag inflator without using the bracket may pose a safety risk for the technician and anyone else in the area.

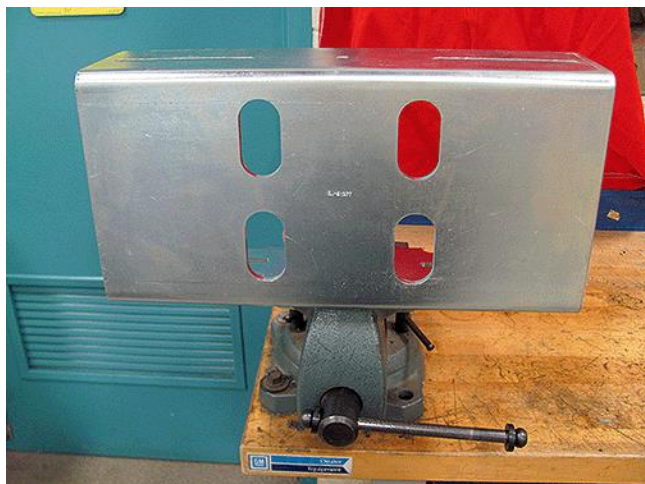
4664047

1. Mount the airbag module bracket securely in a vise.

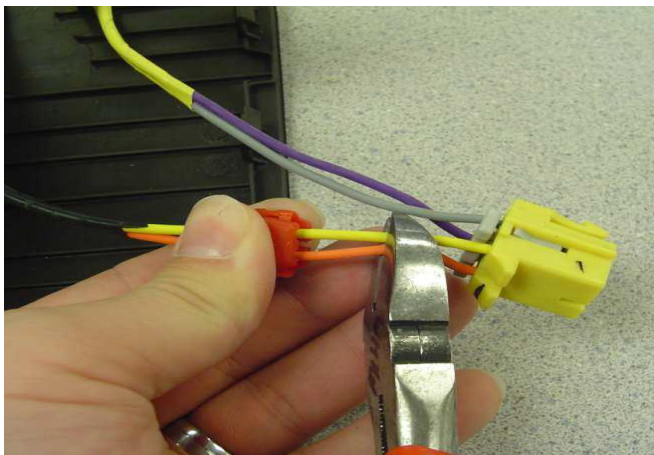
5680666

7. Place wire cutters on the connector side of the electro tap and cut the wires as shown.

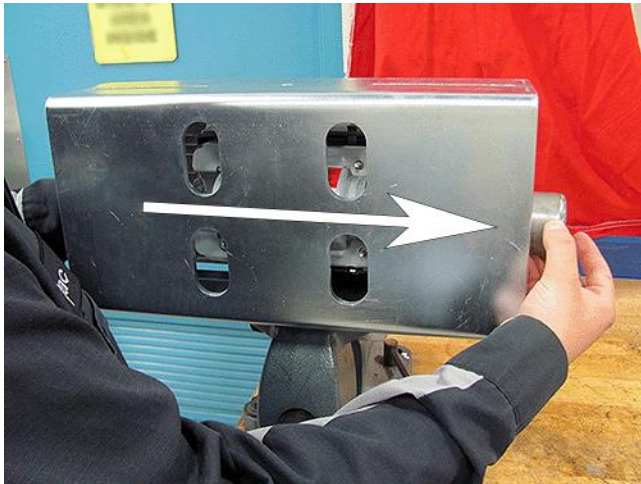
4664060

13. Remove the inflator from the housing, slide the inflator to the right.

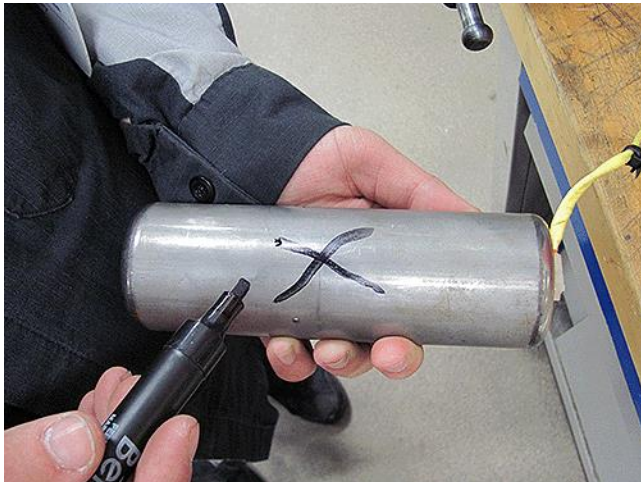
4664063

14. Put a mark on the removed inflator and store it in the provided replacement part box. Refer to the instructions that were included with the new inflator module kit.

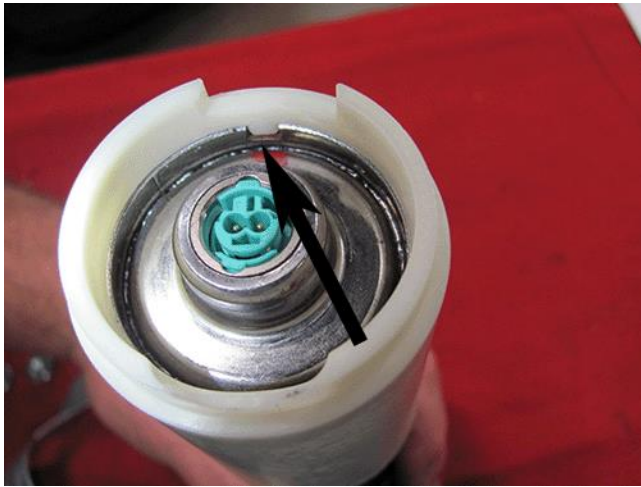
5680402

- Ensure the tab on the white end cap is aligned with the notch in the inflator.

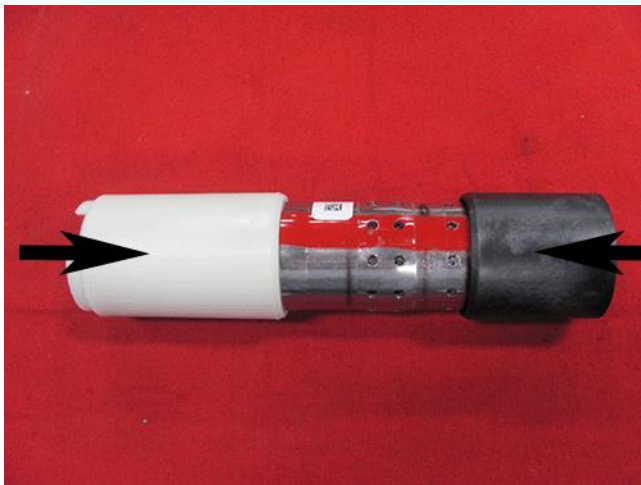
5680403

- Ensure both end caps are fully seated onto the inflator.

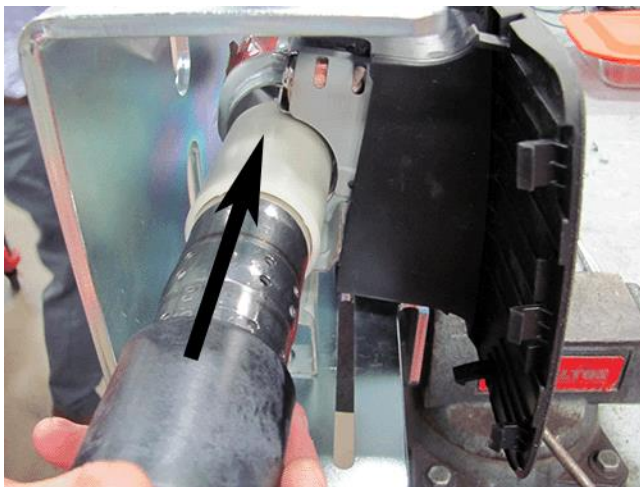
5680409

18. Slide the new inflator into the housing with the white end cap first.

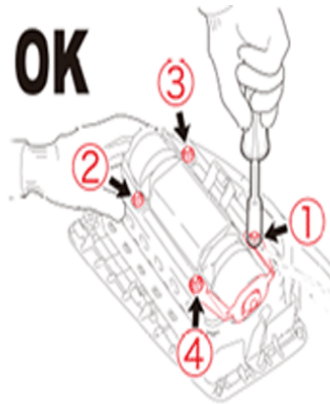
3610416

22. Tighten four (4) *NEW* plate nuts evenly in several increments in the order shown in the illustration using a 10-mm socket driver while pushing on the inflator against the alignment tab.

**Note:** The inflator should be netted out against the alignment tab prior to tightening the nuts. You will encounter some resistance during tightening because these nuts are self-locking nuts. **Torque Specification: 6.5 Nm (56 in-lb).**

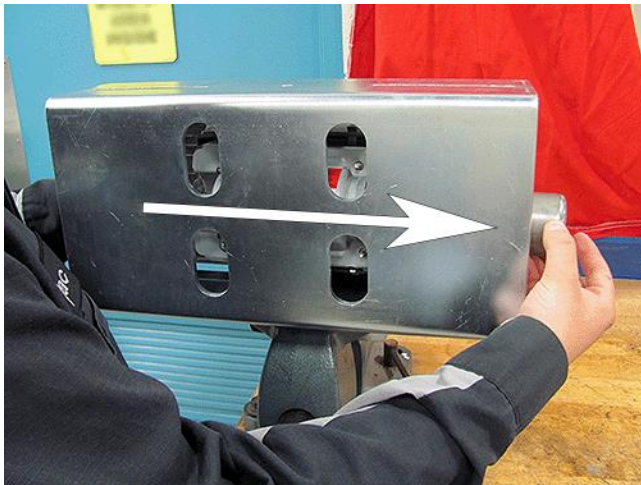
4664060

6. Remove the inflator from the housing, slide the inflator away from the harness side.

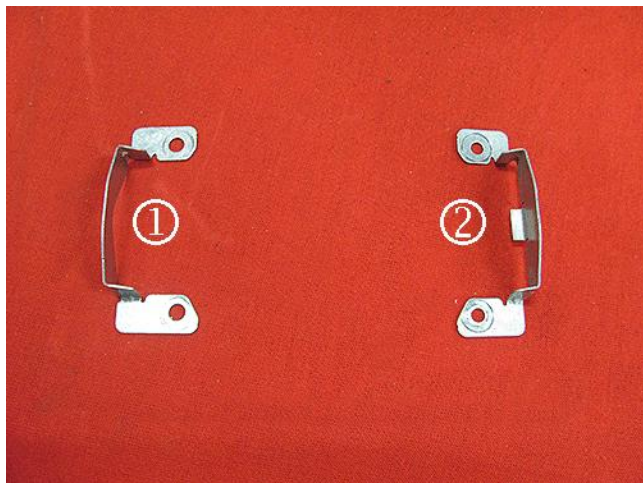
4664065

- Confirm the identification of the stopper and the position determining plate. *THEY ARE DIFFERENT.* Refer to the illustration: (1) Stopper Plate (2) Position Determining Plate.
- The Position Determining Plate goes on the harness end, the Stopper Plate goes on the opposite end.

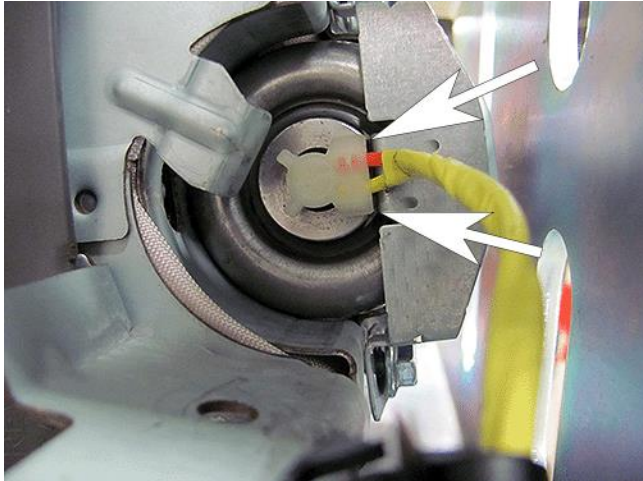
4664068

13. Rotate the inflator until the harness connector aligns with the Position Orientating Plate.

**Warning:** *DO NOT* pinch the harness between the inflator and the Position Orientating Plate.
