# Product Safety Recall

## N212328790 Front Passenger Airbag Takata Inflator

### – Priority Group 9

**Release Date:** February 2021

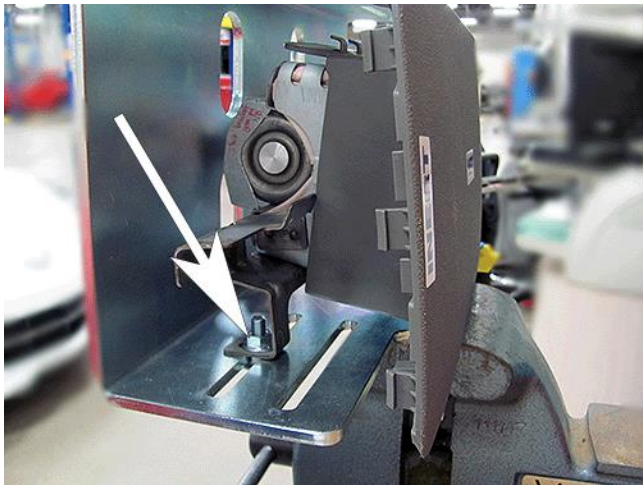
4664048

2. Using the hardware kit supplied with the module bracket, loosely mount the airbag assembly to the bracket using two nuts and bolts.

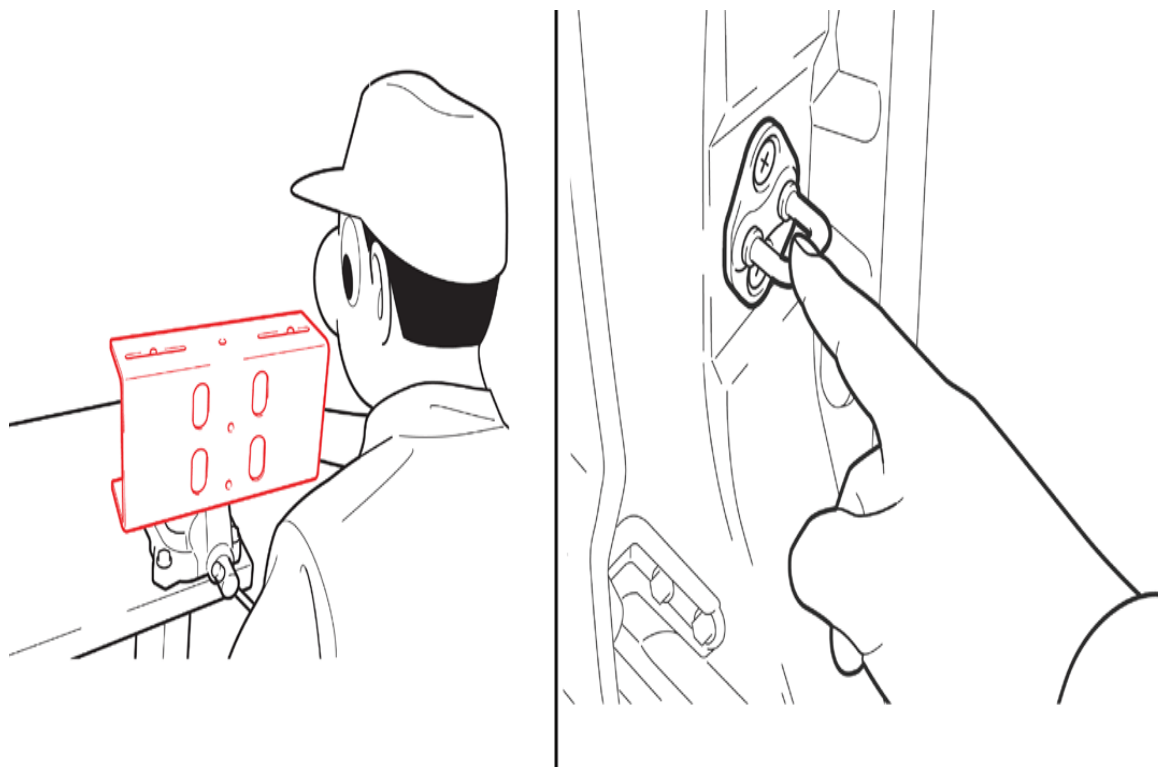
3607909

**Danger:** To avoid personal injury, *ALWAYS* keep as much of your body as possible in front of the bracket when working on the airbag assembly. Remember to periodically touch a metallic part of the vehicle or work bench to discharge static electricity in the body. **DO NOT** use power tools when performing the inflator removal/reinstallation steps.

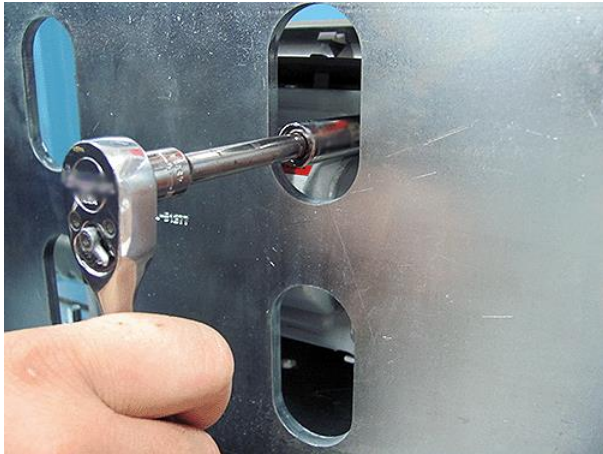
4664052

8. Use the access holes in the bracket to loosen and remove the four self-locking nuts, **do not use power tools to remove the nuts**. Discard the nuts, they will not be reused.

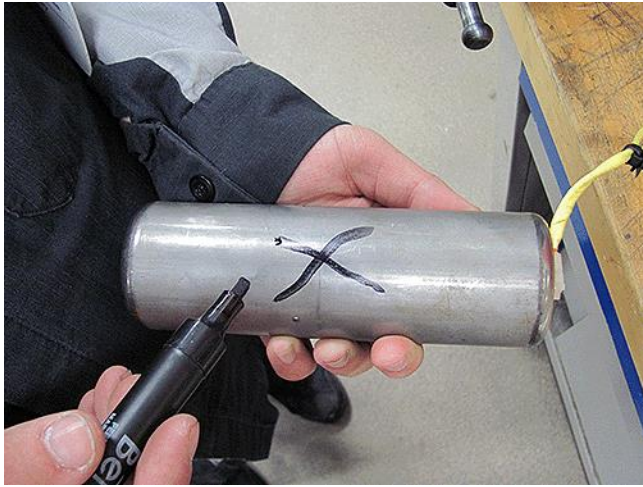
4664063

14. Put a mark on the removed inflator and store it in the provided replacement part box. Refer to the instructions that were included with the new inflator module kit.

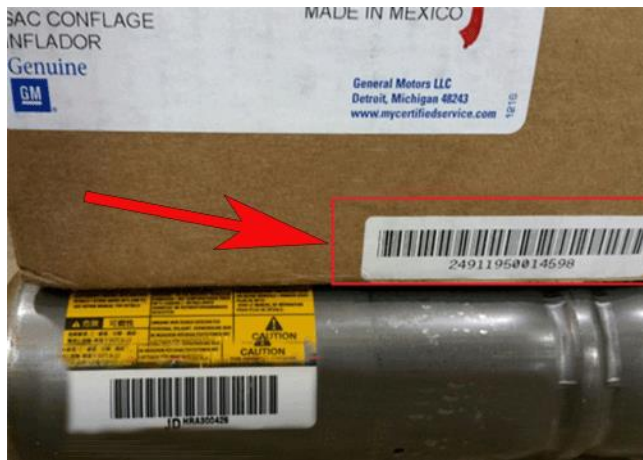
4664074

15. Record the serial number of the new inflator from the service kit on the job card. Also record the serial number of the used inflator that is being returned on the job card.
16. Inspect the new inflator for the following two conditions:

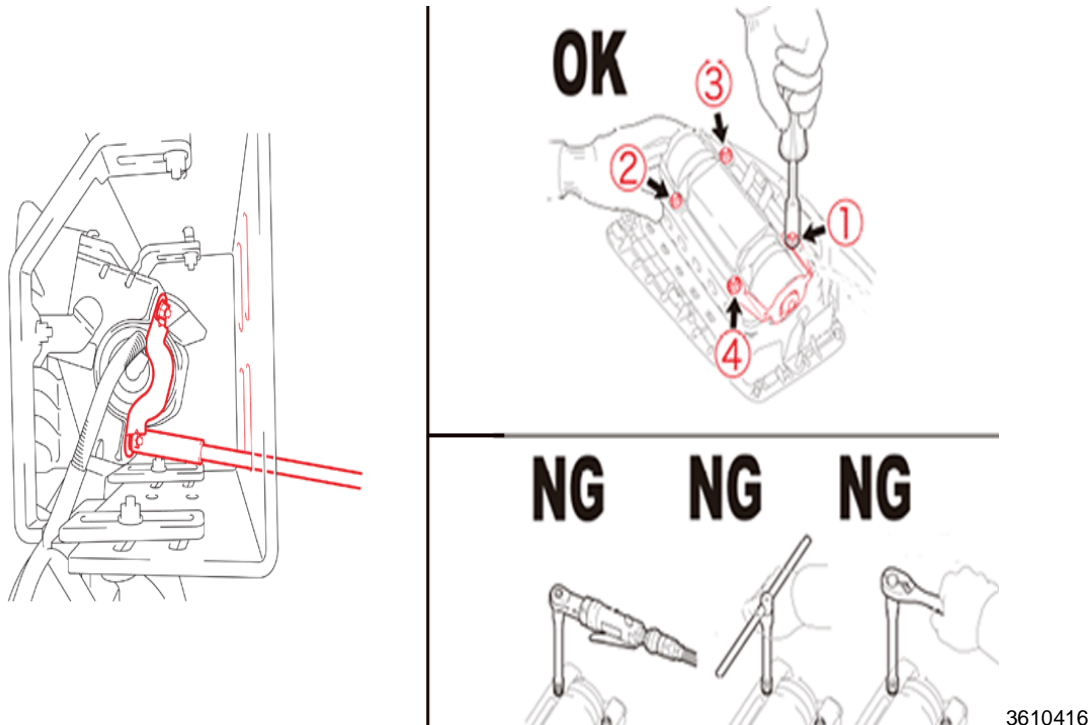
22. Tighten four (4) *NEW* plate nuts evenly in several increments in the order shown in the illustration using a 10-mm socket driver while pushing on the inflator against the alignment tab.

**Note:** The inflator should be netted out against the alignment tab prior to tightening the nuts. You will encounter some resistance during tightening because these nuts are self-locking nuts. **Torque Specification: 6.5 Nm (56 in-lb).**

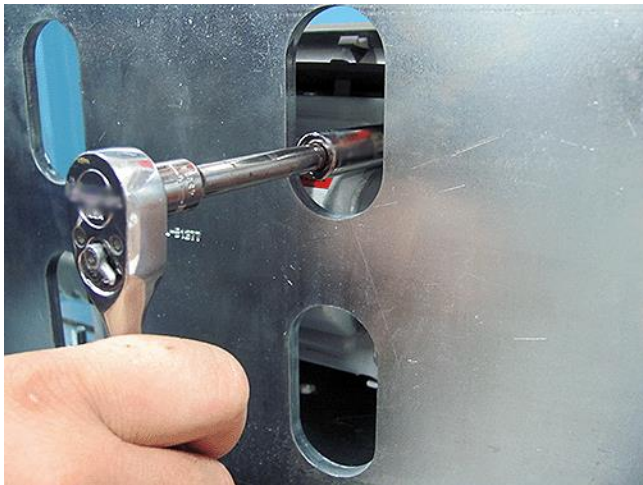
4664052

2. Use the access holes in the bracket to loosen and remove the four self-locking nuts. **Do not use power tools to remove the nuts.** Discard the nuts, they will not be reused.
3. Remove the two stopper plates.
