Product Safety Recall

N212328790 Front Passenger Airbag Takata Inflator

– Priority Group 9

Release Date: February 2021

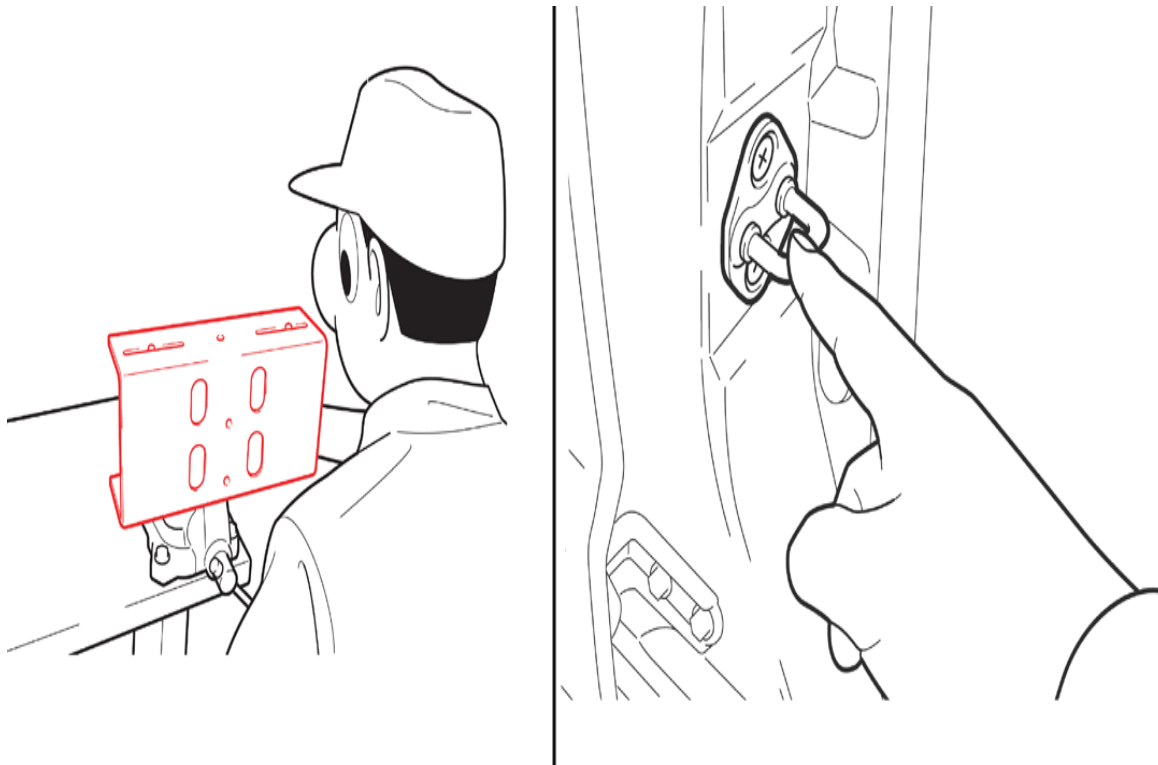
3607909

Danger: To avoid personal injury, *ALWAYS* keep as much of your body as possible in front of the bracket when working on the airbag assembly. Remember to periodically touch a metallic part of the vehicle or work bench to discharge static electricity in the body. **DO NOT** use power tools when performing the inflator removal/reinstallation steps.

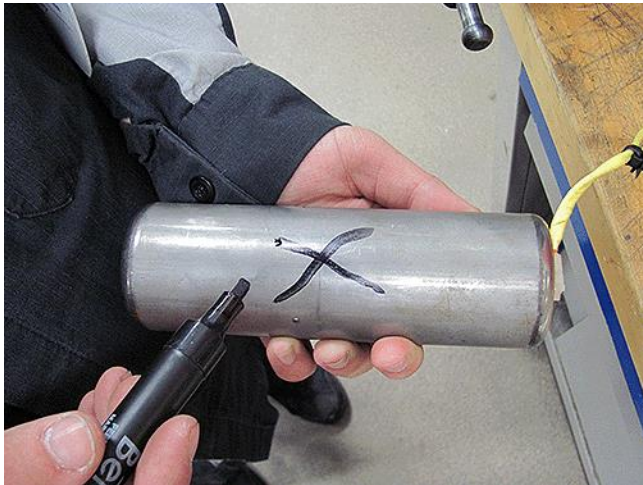
4664063

14. Put a mark on the removed inflator and store it in the provided replacement part box. Refer to the instructions that were included with the new inflator module kit.

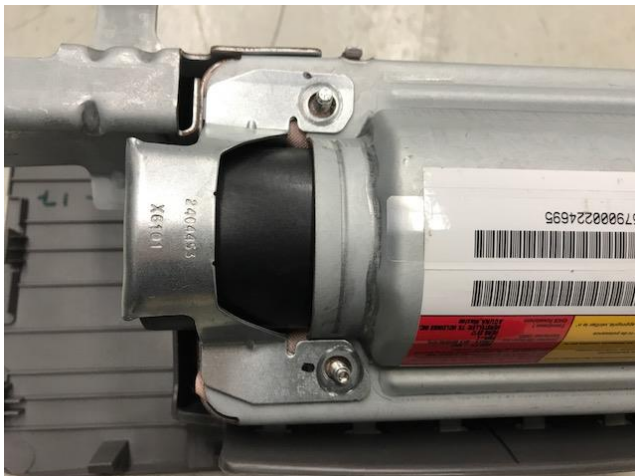
5680668

20. Place the stopper plate onto the studs as shown.

21. Place 4 new nuts on the studs.
