RECALL CAMPAIGN BULLETIN

Classification: FE21-002	Reference: NTB21-010	Date: February 11, 2021
-----------------------------	-------------------------	----------------------------

VOLUNTARY SAFETY/EMISSION RECALL CAMPAIGN 2021 ROGUE FUEL PUMP INSPECTION

CAMPAIGN ID #: PC791
APPLIED VEHICLES: 2021 Rogue (T33)

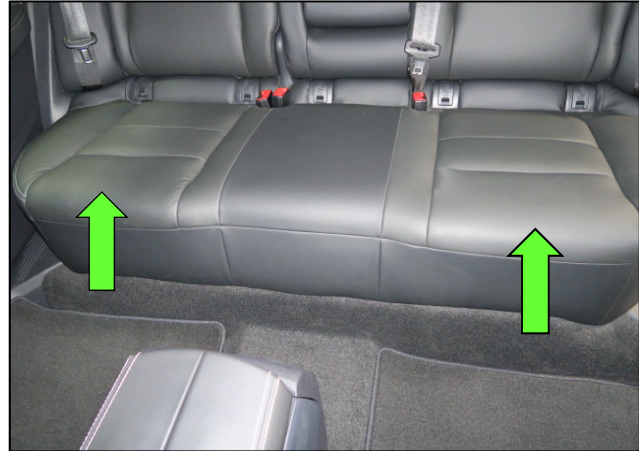
Figure 4

1. Open the LH and RH rear doors.
2. Lift upward, in the areas shown in Figure 4, to disengage the seat cushion hooks.
3. Lift the seat cushion up and pull it forward.
4. Disengage the seat belt buckles.

5. (If equipped) Lift the seat cushion up and disengage the rear heated seat harness connectors.
6. Remove the rear seat cushion and place it in a safe clean area, to prevent staining and damage to the seat cushion.
