Safety Recall Code: 44Q9

Subject	Wheel(s) – Lug Bolt Seat Machining					
Release Date	March 04, 2021					
Affected Vehicles	Country	Beginning Model Year	Ending Model Year	Vehicle	Vehicle Count	
	USA	2021	2021	ATLAS	106	
	USA	2021	2021	ATLAS CROSS SPORT	22	
	under this acti ✓ Can	on. ELSA is the <u>on</u> npaign status must .	<u>ly</u> valid campaign i show "open."	ay of repair to verify that a VIN inquiry & verification source. m your customer so that the w		
				in the workshop for this camp		
Problem Description	dimension. cause insuff result in failu	If this condition i icient thread eng	is present, the Jagement of the s, which may le	may not be machined to incorrect dimension of the wheel bolt to the wheel bo ad to separation of the wh	e lug bolt holes may earing hub. This may	
Corrective Action		bur wheels. Shou be replaced.	uld an affected v	wheel be found, the wheel	, lug bolts and wheel	
Code Visibility	On or about	March 04, 2021	, the campaign	code will be applied to aff	ected vehicles.

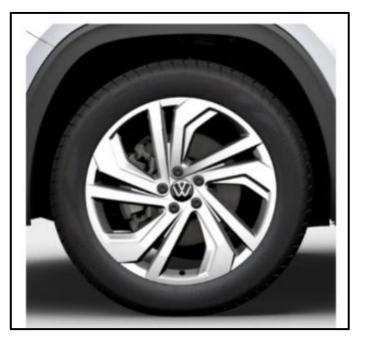
Repair Overview

- Inspect all four wheels.
- Replace wheel, lug bolts and wheel bearing if necessary.

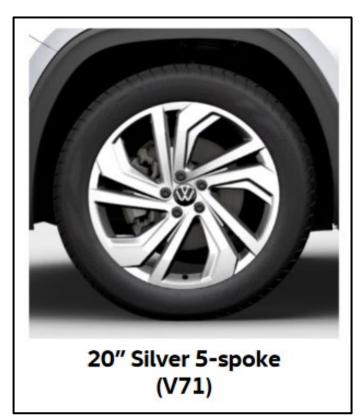
Inspect the wheel style:

- All four wheels must be inspected.
- The style of wheel potentially affected is the 20" silver 5-spoke wheel with PR Code V71 (as shown).
- If any other style of wheel is found AND the customer does not have a spare set of wheels that could match this style:
 - No further work is required.
 - Proceed to Section D.
- If the customer has a spare set of wheels, these also must be checked.
- If the wheels are the style shown:
 - The wheel supplier must be checked.
 - Proceed to the next step.

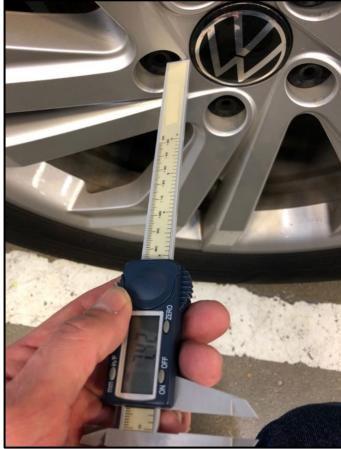
Inspecting lug bolt depth:

- ALL lug holes on ALL four wheels must be inspected.
- Ensure that each plastic wheel bolt cap is installed and fully seated on the wheel bolt. Lightly tap on the lug cap using a plastic mallet if necessary.
- Using a digital caliper or depth gauge, measure from the outer edge of the lug bolt hole at point <A> to the top of the lug bolt cap at point .
- Ensure the measuring device is perpendicular to the wheel face.

- If the measurement is greater than 6 mm:
 - The wheel(s) is/are OK.
- If the measurement is 6 mm or less:
 - The wheel(s) must be replaced.
 - The lug bolts for the affected wheel must be replaced.
 - The wheel bearing associated with the affected wheel must be replaced.
 - Proceed to Section C.
- If all four wheels are OK, or once all affected wheels, wheel bolts and wheel bearings have been replaced:
 - Proceed to Section D.

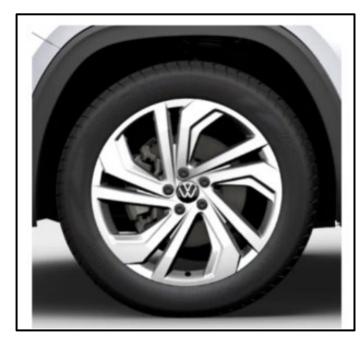
Replacing wheels:

- Indicate on the repair order the position of each wheel and wheel bearing which was replaced.
- Transfer the tire from the old wheel/tire assembly to the new wheel.
- Use a new valve stem.
- Balance wheel/tire assembly.
- Reinstall wheel and torque NEW wheel bolts to 120 Nm.

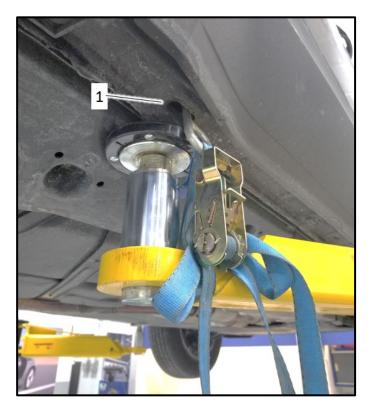
Secure vehicle on the hoist:

When suspension is lifted in curb weight position, the vehicle must be secured on the hoist to prevent it from tipping off the hoist.

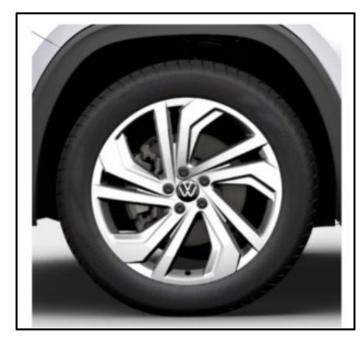
Replacing wheels:

- Indicate on the repair order the position of each wheel and wheel bearing which was replaced.
- Transfer the tire from the old wheel/tire assembly to the new wheel.
- Use a new valve stem.
- Balance wheel/tire assembly.
- Reinstall wheel and torque NEW wheel bolts to 120 Nm.

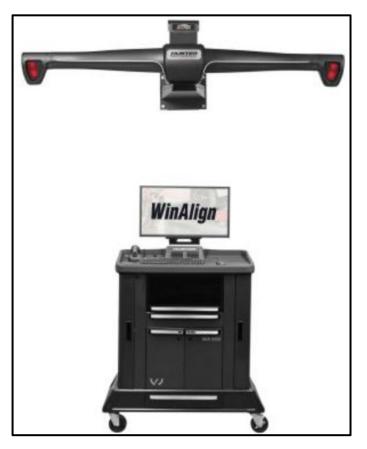
Perform four-wheel vehicle alignment:

An alignment is only required if a rear wheel bearing was replaced.

- Follow the ELSA Repair Manual and wheel • aligner equipment directions as needed.
- Was the rear axle toe adjusted?
 - If YES, proceed to the next step. 0
 - If NO and all affected wheels, wheel 0 bearings and wheel bolts have been replaced:, Proceed to Section D.
