RECALL 21V141. 2021-119 REMEDY INSTRUCTIONS

Make(s): Cardinal and Wildcat
Model(s): See below
Model Year(s): 2021

Concern: The furnace is not properly secured to the floor allowing movement of the furnace and platform, which could potentially misalign the intake tube and/or exhaust tube.

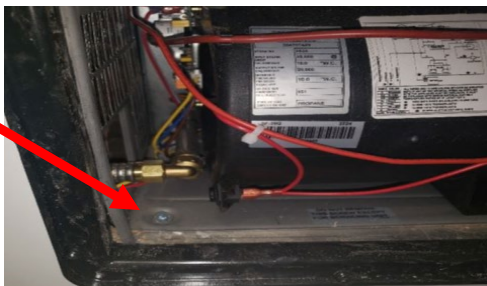
1. Locate the furnace access door and remove to gain access to the furnace.
2. Remove the two (2) corner screws and discard. See Figure 1 and Figure 2.

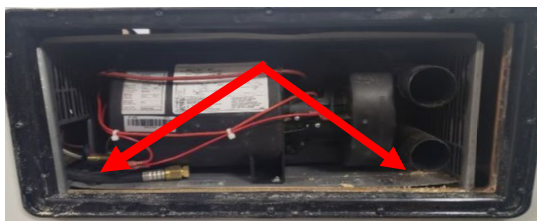
Figure 4

3. Install the # 8, 2 1/2" or 3" coarse-threaded washer head screws ensuring the screws go through the holes in the bottom of the furnace cabinet, into the platform and into the floor. Figure 4.

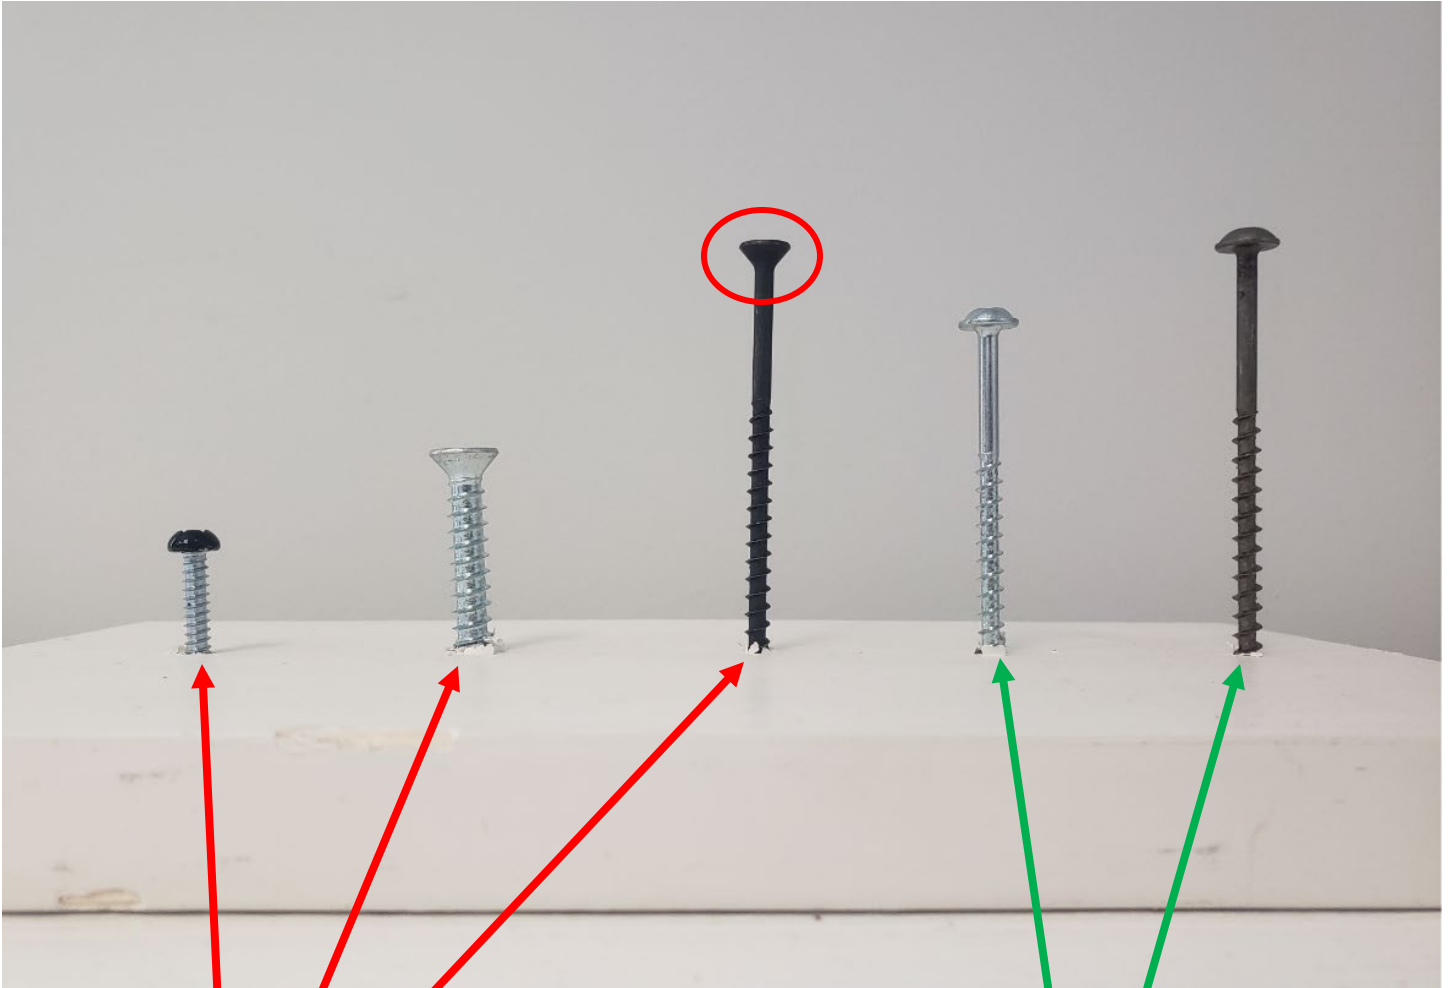
DO NOT USE THESE TYPE OF SCREWS

**CORRECT SCREWS: #8 2 1/2" OR #8 3"
COARSE-THREADED WASHER HEAD SCREWS**
