AMA3 - Reworking Various Threaded Connections on the Chassis (Recall Campaign)

Model line: **911 (992)**
718 (982)

Model Year: **As of 2020 up to 2021**

Concerns: **Hexagon clamping nut M12 x 1.5 on various threaded connections on the chassis**

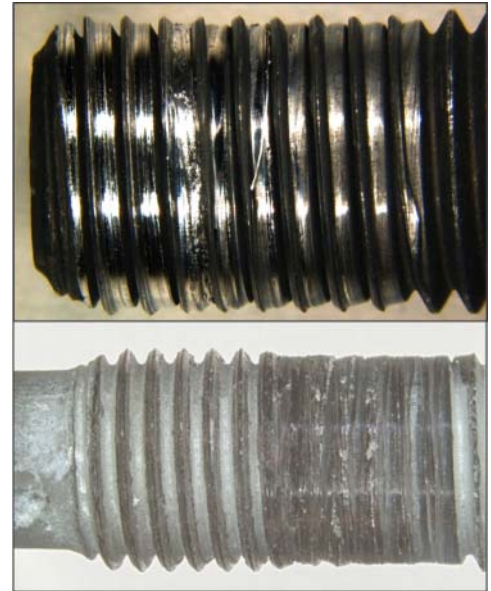
Example of a **damaged thread on the actuator**:
⇒ *Damaged thread on actuator*

Damaged thread on actuator

On vehicles on which **a component is screwed at the relevant screw point** (e.g. actuator or connecting link), depending on the assigned scope, the **thread on the relevant component must be checked** and the component may also have to be replaced, depending on the result of the check.

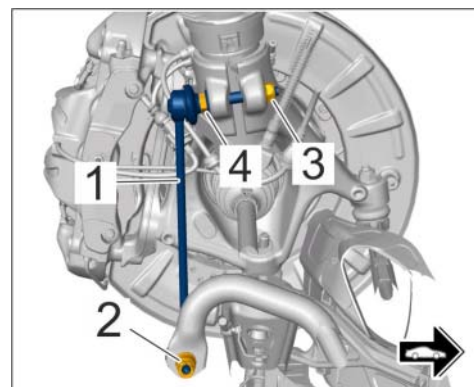
Spring strut to wheel bearing housing

3.2 Loosen and unscrew fastening nut ⇒ *Spring strut to wheel bearing housing -3-* on spring strut clamp.

For vehicles with a **conventional anti-roll bar**, counter at the flat surface ⇒ *Spring strut to wheel bearing housing -4-* of the connecting link ⇒ *Spring strut to wheel bearing housing -1-* while doing this.

Please note: The fastening nut ⇒ *Spring strut to wheel bearing housing -2-* is **not affected** and must not be loosened.

To do this, screw a nut (M12 x 1.5, e.g. square nut, Part No. WHT002305) fully onto the thread. If the nut can be **screwed on and off easily**, the connecting link does **not** have to be replaced.

If the **thread of the connecting link is damaged**, a new **connecting link** must be installed. For instructions, see:
