Mercedes-Benz

Campaign No. 2021040012, July 2021

SUBJECT: **Models C-Class, CLK-Class, E-Class, and CLS-Class (203, 209, 211, and 219 platform)**
Model Years 2001-2011
Sliding Roof Bonding

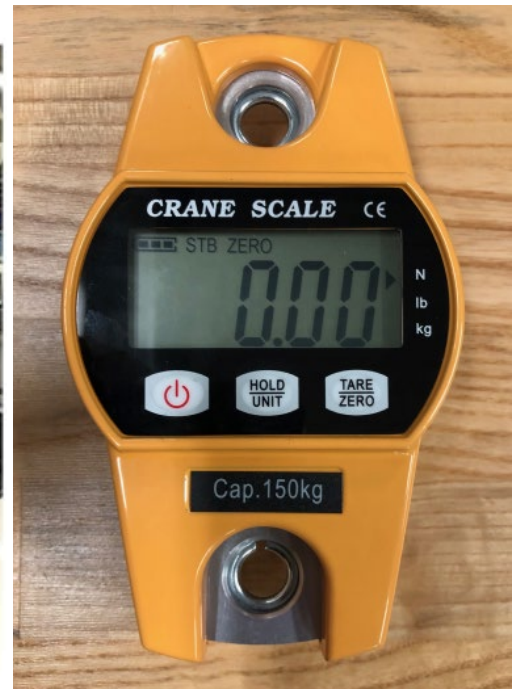
Figure 3 (Correct scale display)

i Before the start of the measurement, the "(auto) hold function" of the hanging scale **must** be deactivated and the measurement scale is set to N (see operator's manual). (**See figure 3**) for correct scale display.

No "hold function" may be activated so that the current pulling force is always displayed.

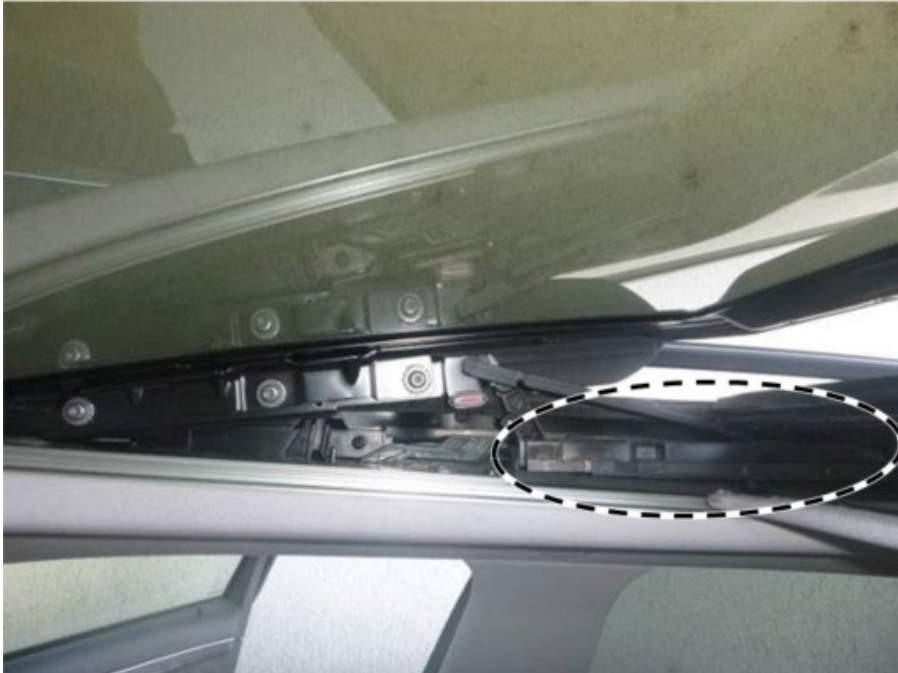
Figure7

i The accordion boot **need** not be removed completely. It is sufficient to slide it back (**figure 7**).

1. Replace sliding sunroof.
