Mercedes-Benz

Campaign No. 2021040012, April 2021

SUBJECT: **Models C-Class, CLK-Class, E-Class, and CLS-Class (203, 209, 211, and 219 platform)**
Model Years 2001-2011
Sliding Roof Bonding

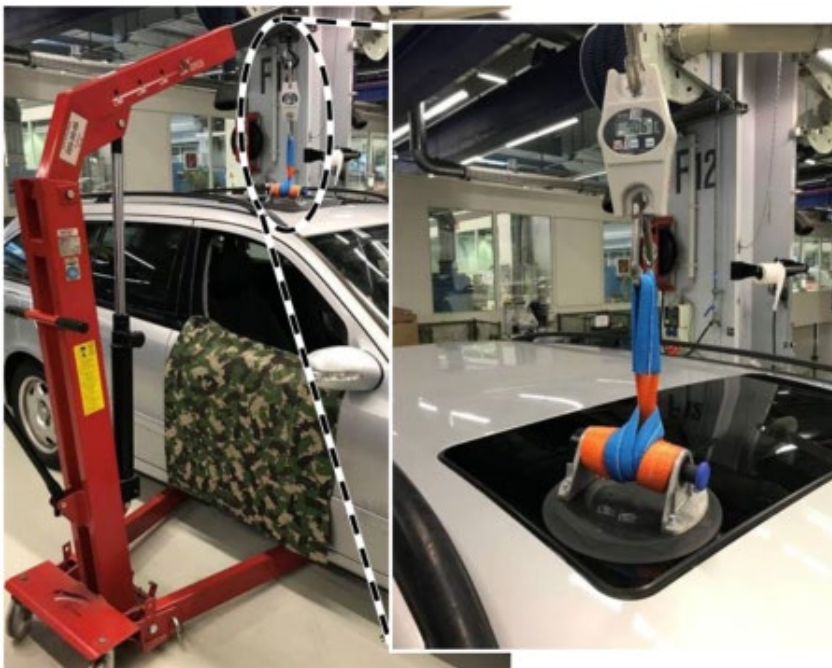
Figure 2

3. Position cup suction tool (**figure 2**) and pull as **vertically** as possible (tolerance of ± 10 degrees) using lifting tool (hoist/crane).

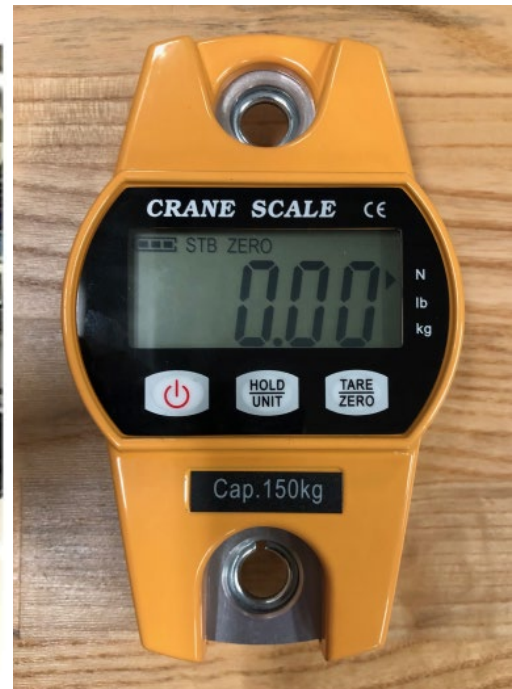
i Before the start of the measurement, the "(auto) hold function" of the hanging scale **must** be deactivated and the measurement scale is set to N (see operator's manual). **(See figure 3) for correct scale display.**

Figure 3 (Correct scale display)
