TO: Mercedes-Benz Dealer Principals, General Managers, Sales Managers, Service Managers, Parts Managers	FROM: Gregory Gunther, Department Manager, Vehicle Compliance and Analysis, Engineering Services
RE: <b>Recall Campaign Notification - Updated Work Instructions</b> <b>Replace Front Stationary Sunroof Panel</b> <b>MY14-20 117,156, 205, 222, and 253 (C-Class, CLA-Class, GLA-Class, GLC-Class, and S-Class)</b>	Date: August 20, 2021

Campaign No.2021070010, August 2021  
Revision A 09/03/2021

### **Replace Front Stationary Sunroof Panel**

### Check front fixed panel of the panoramic sliding sunroof, replace if necessary

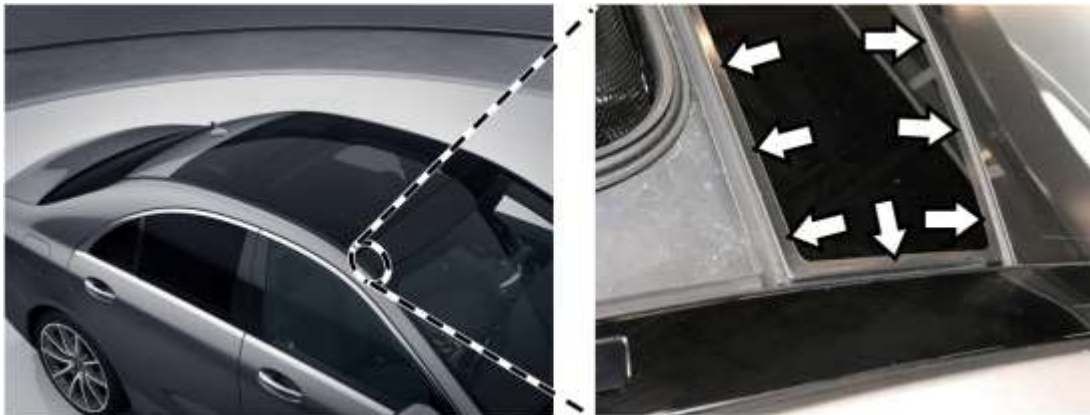
Figure 1

- i** Check/test procedure must ***only*** be performed for the **models 156 and 222**.
  - i** The material condition of the fixed panel must be checked.
1. Fixed panel (**Figure 1**) made from glass. ⇒ **no repair needed**
    - i** The fixed panel made from glass is foam-padded, the padding (**arrows, Figure 1**) is visible at the edge.

- a. The fixed panel is made from **polycarbonate**: Perform **work procedure**.
- b. The fixed panel is made from **glass**: **End measure**.

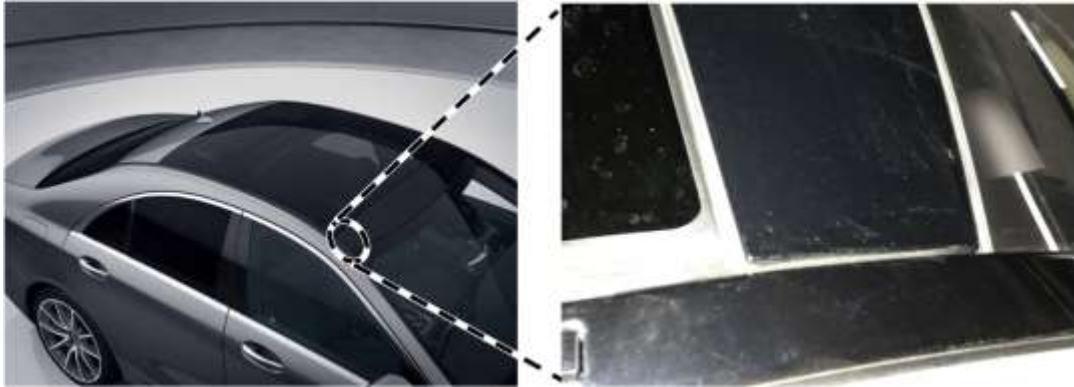
**Figure 2**

2. Fixed panel (**Figure 2**) made from polycarbonate (PC) ⇒ **repair is needed**

**i** The fixed panel made from polycarbonate is **not** foam-padded.

1. Replace front fixed panel of panoramic sliding sunroof.
