Mercedes-Benz

Campaign No. 2021040015, May 2021

SUBJECT: **Model GLB-Class vehicles (247 platform)**  
**Model Year 2020-2021**  
**Check Front Wheel Arch Cover**

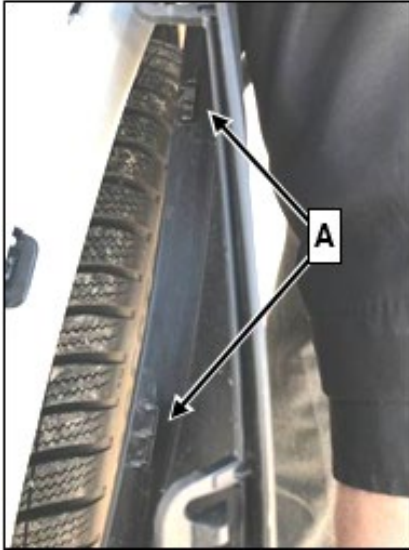
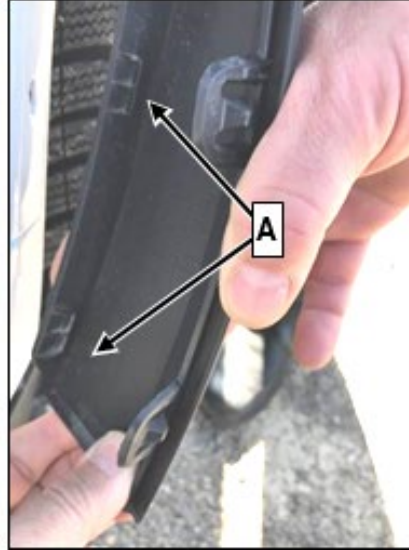
**2.1.** Engage the four outer engagements (**A, figures 4-5**) of the wheel arch liner around the bumper, starting from the top down (**figure 6**).

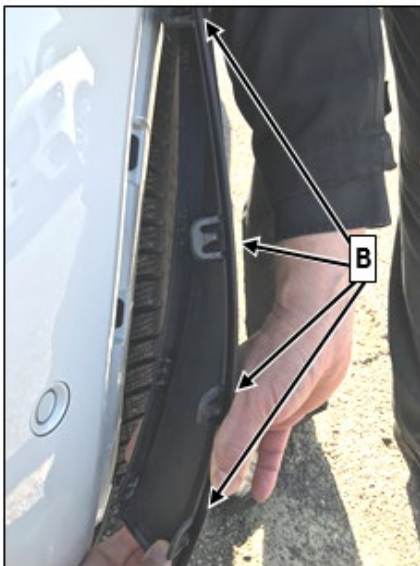
Figure 7

**2.2.** Engage the four inner engagements (**B, figure 7**) of the wheel arch liner in the bumper, starting from the top down (**figure 8**).

**i** After installation of wheel arch liner, check that firmly seated.
