# Keystone RV Company

## SAFETY ADVISORY # 21-405

### Passport Spare Tire Placement

**Models Included:** 2021 Passport Travel Trailers: 282QB

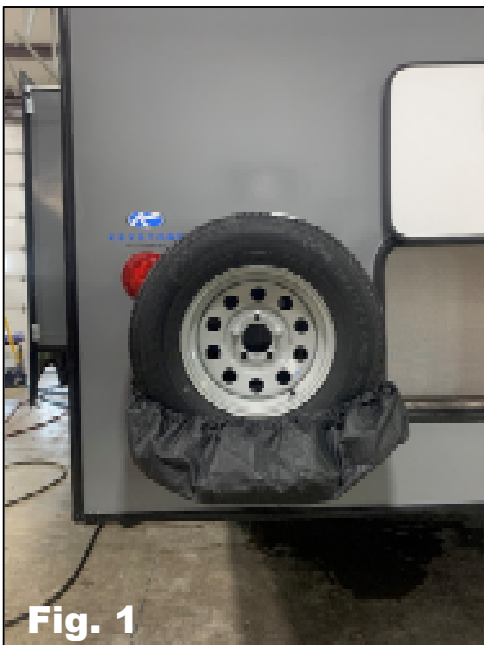
**Fig. 1**

Locate the spare tire and remove it. Figure 1.

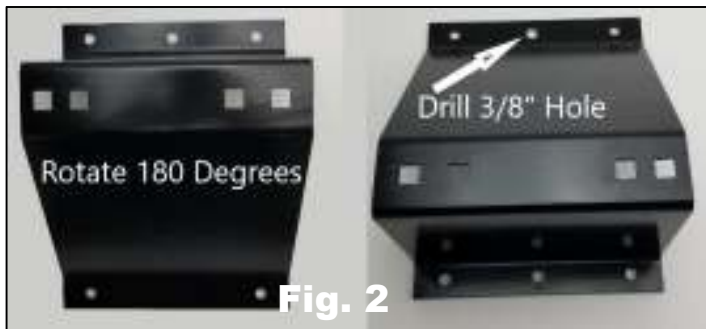
Fig. 2

Remove the spare tire carrier, turn it 180 degrees, add butyl tape as needed and remount it. Figure 2.

Drill a 3/8" hole in the top center directly between the two existing holes and install a 3/8" x 1" lag. Figure 2.

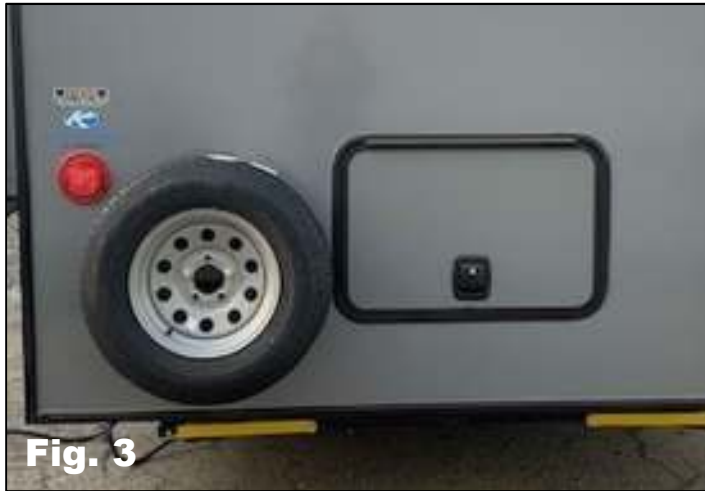
Fig. 3

Reinstall spare tire. Figure 3.
