## SAFETY ADVISORY # 21-407

### Bullet Egress Window Crank

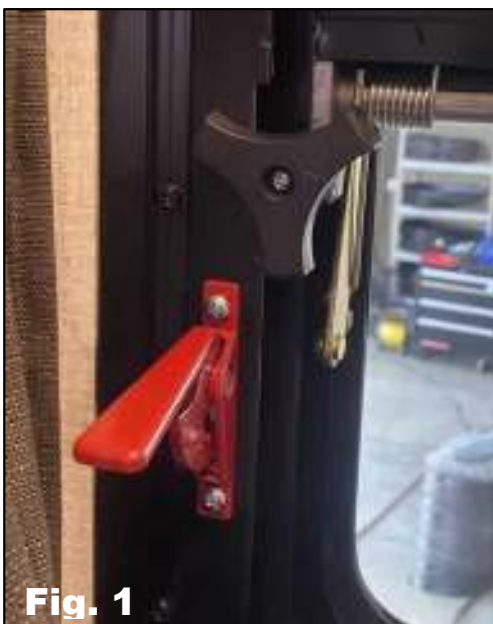
**Fig. 1**

Keystone is conducting a voluntary RECALL notification campaign in accordance with the National Highway Transportation and Safety Act. It has been decided that the vehicles in the recall population have an egress window installed in the bedroom and did not have the correct crank handle installed. If an emergency situation arises the emergency exit may be difficult to open as the current black round knob may impede the ability to open the window, which could result in an increased risk of personal injury.

Locate the bedroom egress window. Figure 1

The remedy is to replace the black round knob on the bedroom egress window with the narrow crank handle.
