**RECREATIONAL VEHICLE
SAFETY RECALL NOTICE**

Safety Recall: 21V-250
Safety Advisory: 21-407
#####, 2021

Bullet Egress Window Crank Instructions

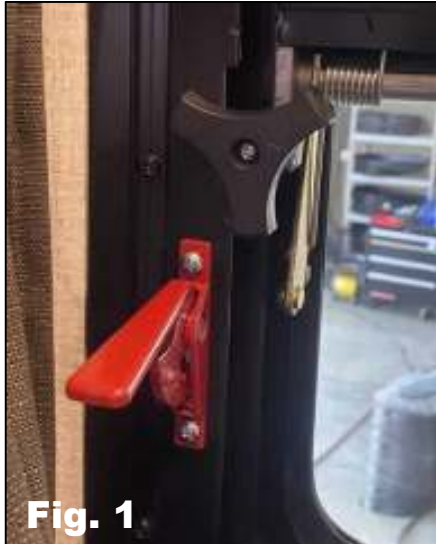
Fig. 1

Locate the bedroom egress window. Figure 1

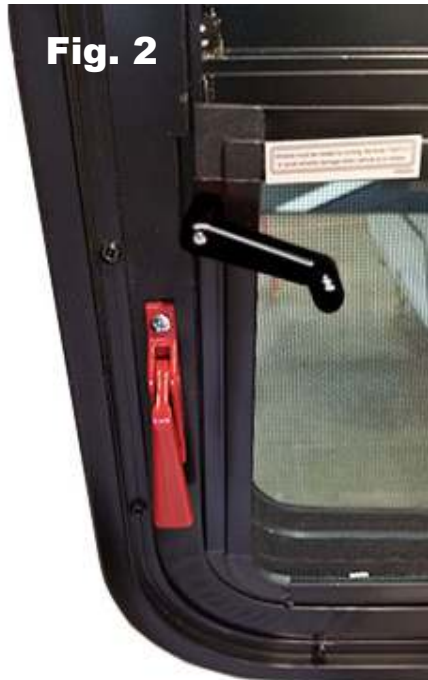
Fig. 2

It has been decided that the vehicles in the recall population have an egress window installed in the bedroom and did not have the correct crank handle installed. If an emergency situation arises the emergency exit may be difficult to open as the current black round knob may impede the ability to open the window, which could result in an increased risk of personal injury.

Remove the black round knob and install the narrow crank handle using KRV # 630481- Window - Crank - 3' - Black and an #8-32 x 2" screw. See Figure 2.
