# SERVICE BULLETIN

**FIELD CAMPAIGN SERVICE BULLETIN #:** SVC2021-103      **DATE:** 03 June 2021

**Interim Owner Notification:  
Trailer Frame Crack  
Inspection and Temporary  
Frame Repair Kit (IK00-4078)**

**IK00-4078: AX19 FRAME INSPECTION AND TEMPORARY REPAIRS  
FRAME LOCATION AND CRACK EXAMPLES**

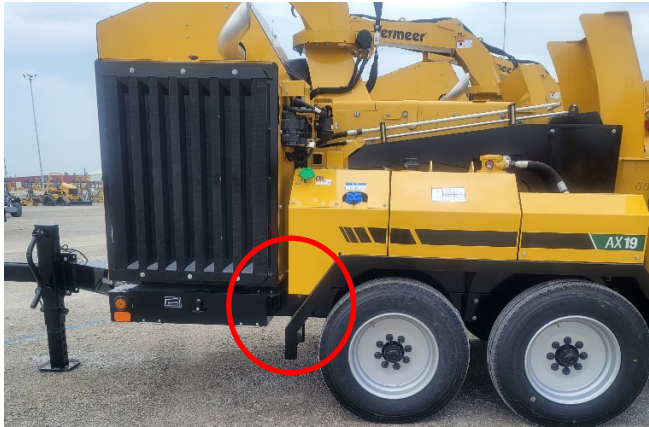
**Photo 1  
Potential crack location – left side**

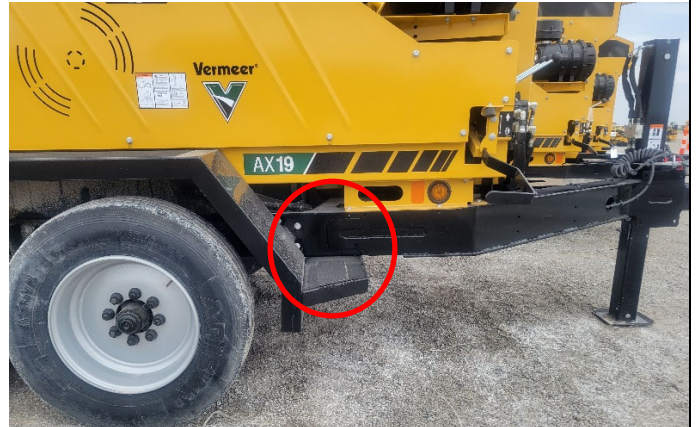
**Photo 2  
Potential crack location – right side**

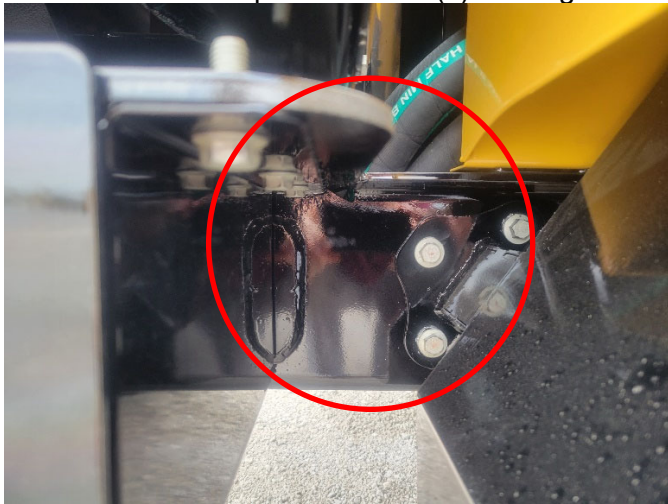
**Photo 3  
Potential crack location – left side  
(near V-cut out in frame)**  
Engineering analysis indicates the left side may be more susceptible to crack(s) forming.

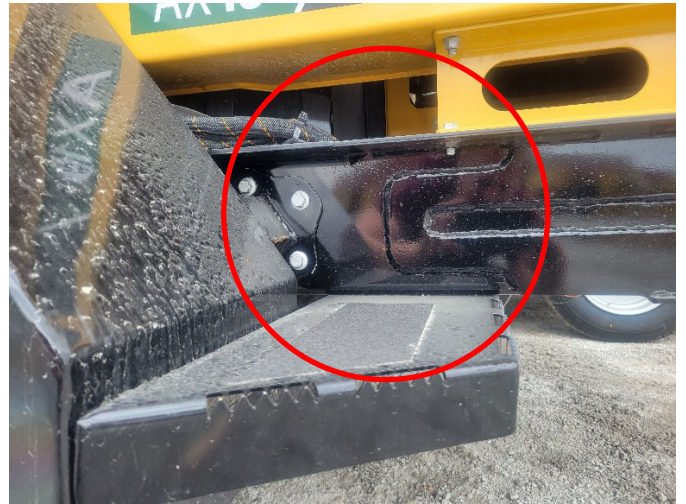
**Photo 4  
Potential crack location – right side**

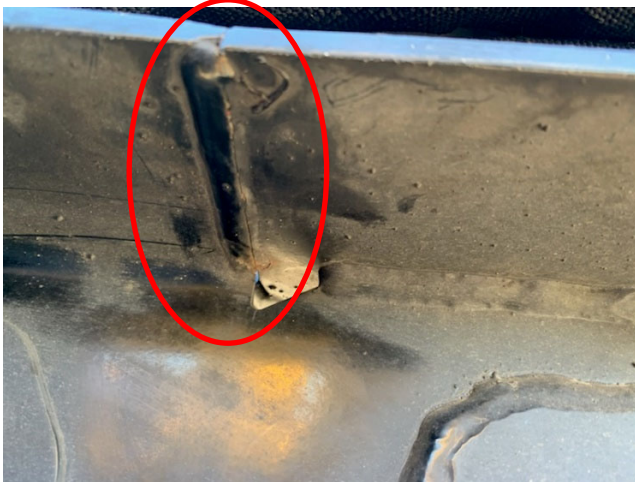
**Photo 5  
Crack example: frame horizontal top**

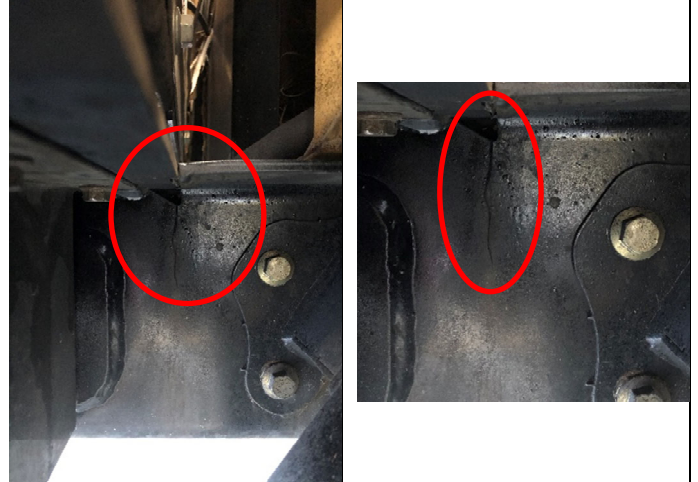
**Photo 6  
Crack example: frame vertical center**

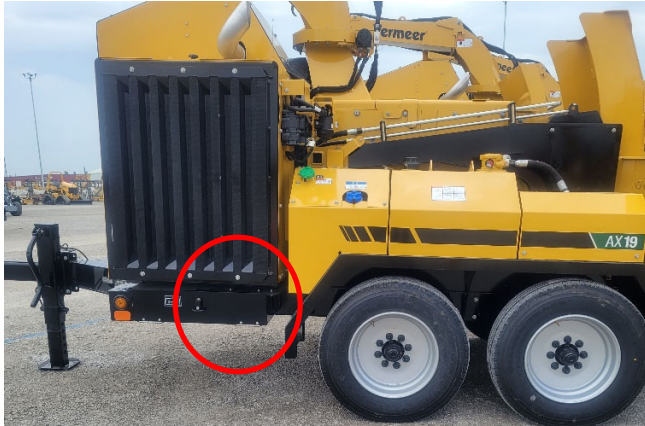
**Photo 1**  
**Potential crack location – left side**

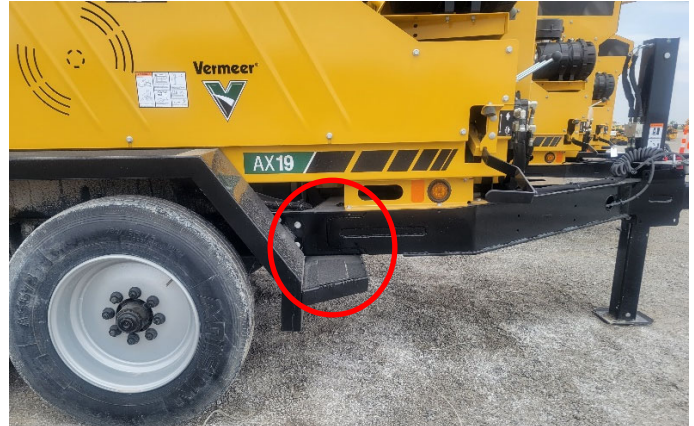
**Photo 2**  
**Potential crack location – right side**

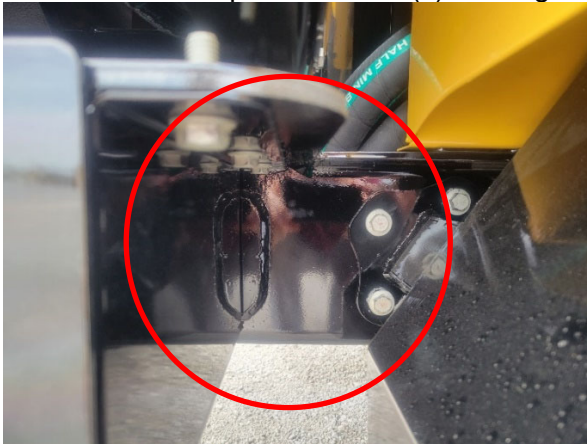
**Photo 3**  
**Potential crack location –left side (near V-cut out in frame)** Engineering analysis indicates the left side may be more susceptible to crack(s) forming.

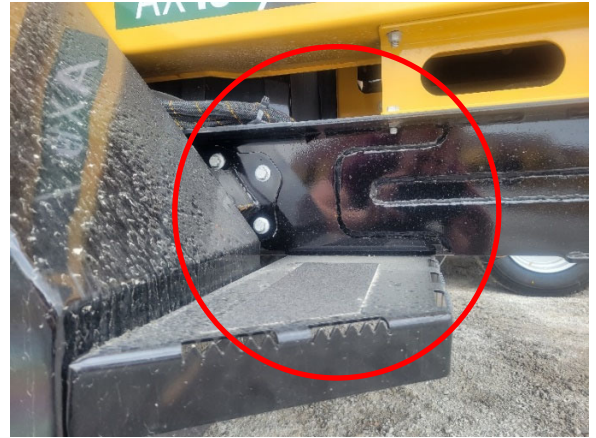
**Photo 4**  
**Potential crack location – right side**

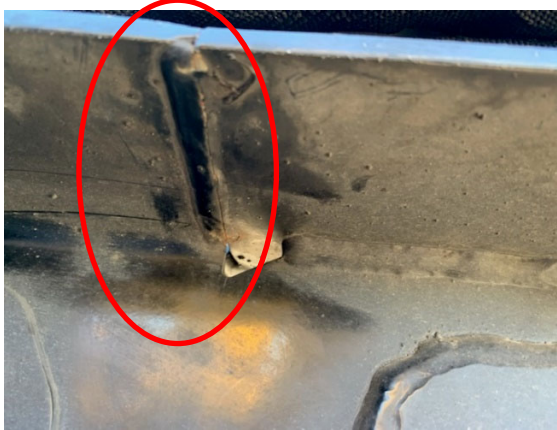
**Photo 5**  
**Crack example: frame horizontal top**

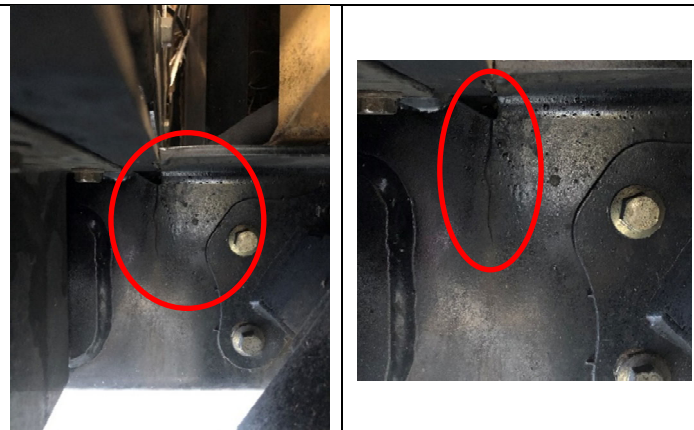
**Photo 6**  
**Crack example: frame vertical center**

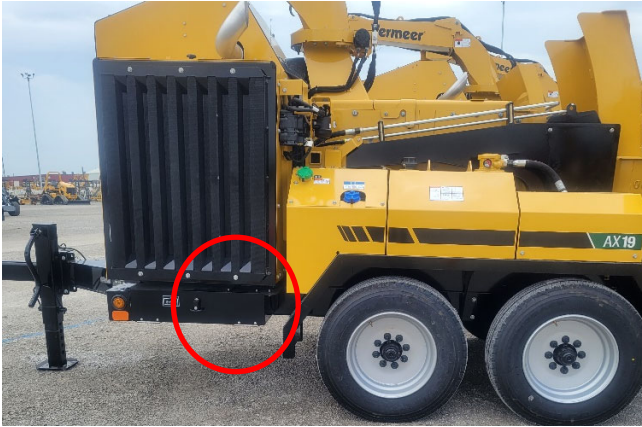
**Photo 1  
Potential crack location – left side**

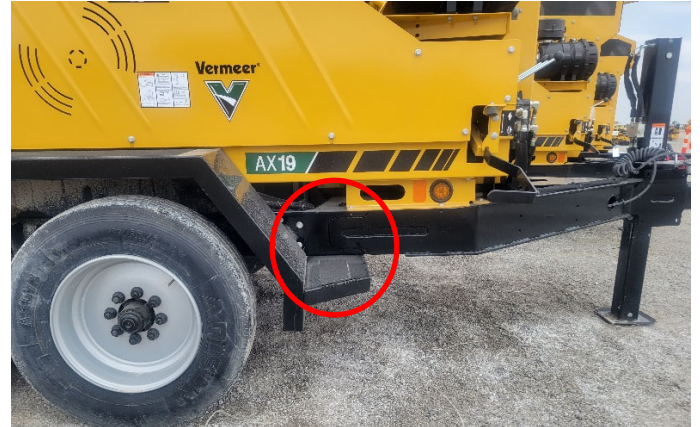
**Photo 2  
Potential crack location – right side**

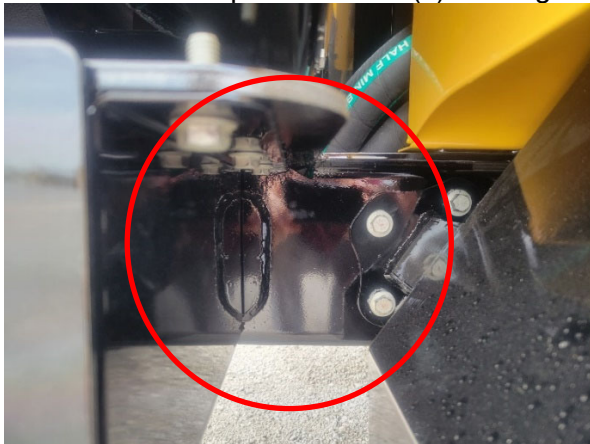
**Photo 3  
Potential crack location –left side (near V-cut out in frame) Engineering analysis indicates the left side may be more susceptible to crack(s) forming.**

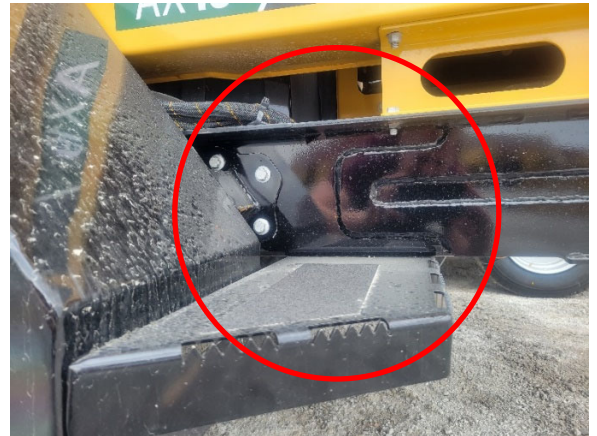
**Photo 4  
Potential crack location – right side**

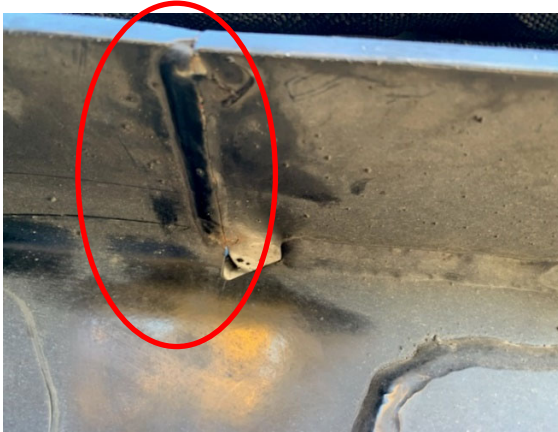
**Photo 5  
Crack example: frame horizontal top**

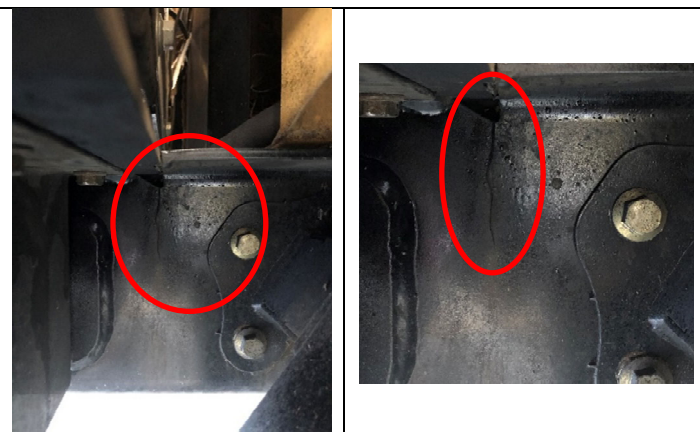
**Photo 6  
Crack example: frame vertical center**
