SuperSport Model Year 2017-2020 (USA-CAN only) Safety Recall Campaign SRV-RCL-21-006

Ongoing product quality testing and field reports have identified a potential for the rear brake application to soften over time as a consequence of use. To correct in cases of this occurrence, new rear brake hoses (ABS control unit to rear brake master cylinder—yellow, and ABS control unit to rear brake caliper-blue) will be installed for the above listed model. In addition to replacing the rear brake hoses, it is also necessary to apply the kit part no. 69929411A.

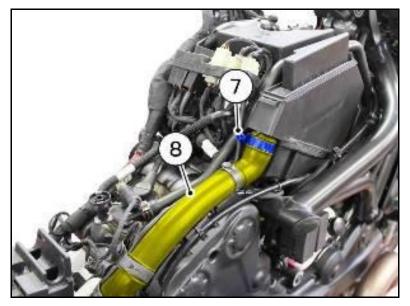
9. Loosen clamp (7) and disconnect Crankcase ventilation hose (8) from the Airbox.

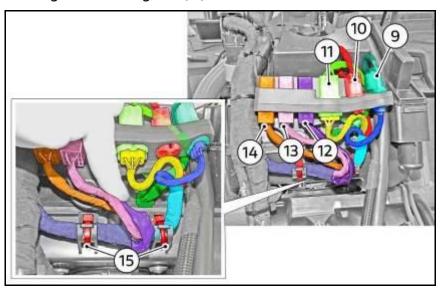
- **10.** Disconnect injector wiring **connector (9)**, vertical lambda sensor **connector (10)**, potentiometer wiring **connector (11)** and pull-out starter **relay (12)**, injection **relay (13)** and fuel pump **relay (14)**
- 11. Remove the 2 Large self-locking ties (15)

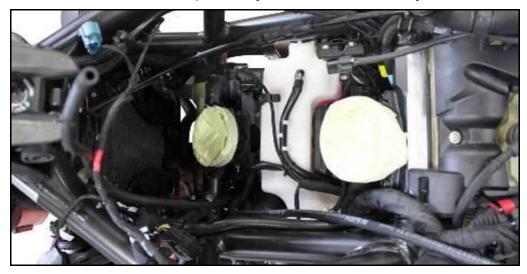
16. Protect the engine with a cloth near the ABS control unit and cover the intake manifolds as shown in the figure to avoid the possible penetration of brake fluid or impurities inside the manifolds.

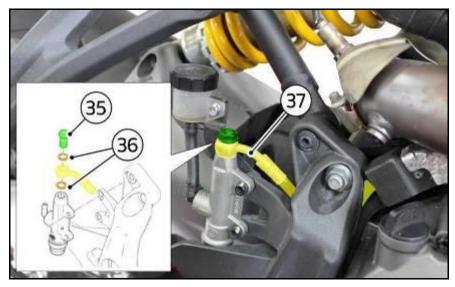
17. Remove the special screw (35) with the 2 copper washers (36) securing brake hose (37) to rear brake master cylinder

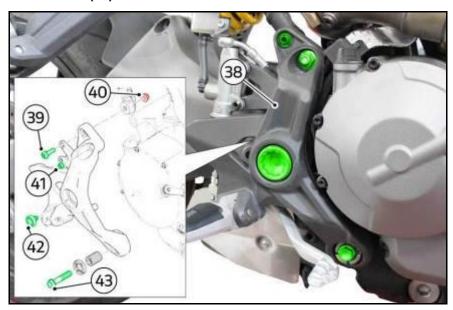
- 18. To pull out the RH front footpeg holder plate (38) assembly remove:
 - the special screw (39) while holding nut M8 (40)
 - the **nut (41)** while holding it on the opposite side
 - the special screw (42)
 - the screw M10x50 (43)

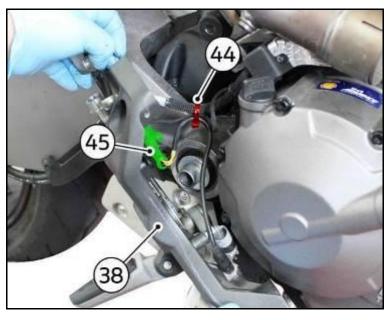
19. Pull out the RH front footpeg holder **plate (38)** by removing self-locking **tie (44)** and disconnect rear stop light **connector (45)**

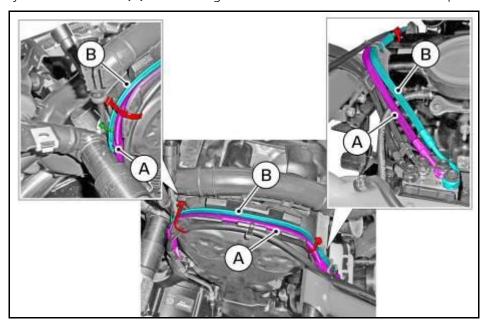
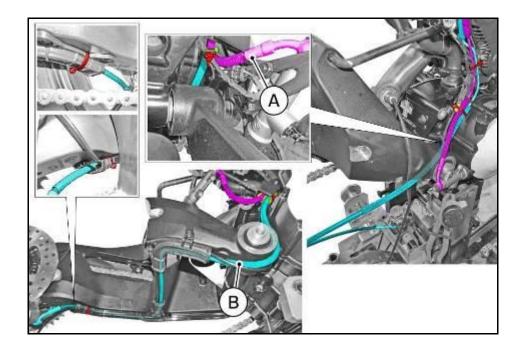
26. Remove any remaining ties from brake **hose (A)** connecting ABS control unit to rear brake master cylinder and **hose (B)** connecting ABS control unit to rear brake caliper

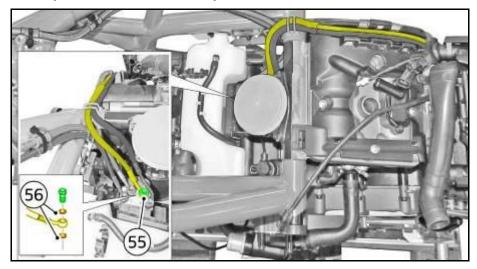
1. Working on ABS control unit, remove the special screw (55) with the 2 copper washers (56).

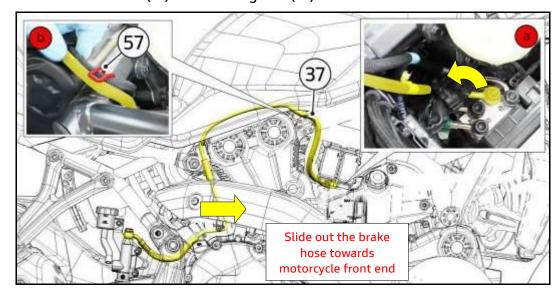
- 2. Remove the **brake hose (37)** towards the front end following the sequence indicated below:
 - 2 A. Route the ABS control unit fitting below the wiring support
 - 2 B. Release brake hose (37) from cable guide (57)

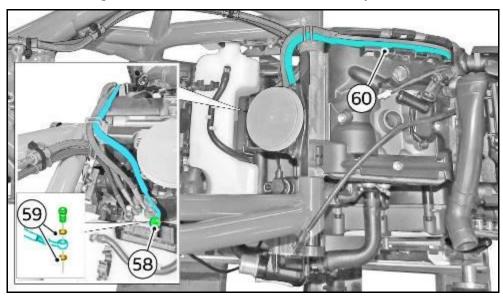
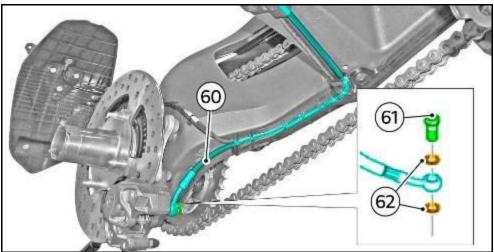
- 3. Working on the ABS control unit, remove the special screw (58) with the 2 copper washers (59) securing brake hose (60) to ABS control unit.
- 4. Working on the rear brake caliper, remove the **special screw (61)** with the **2 copper washers (62)** securing **brake hose (60)** to rear brake master cylinder

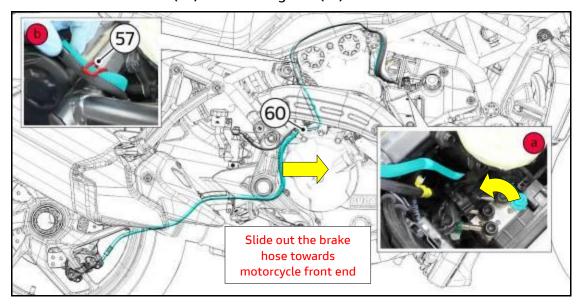
- **5.** Remove the **brake hose (60)** towards the front end following the sequence indicated below:
 - **5 A.** Route the ABS control unit fitting below the wiring support
 - 5 B. Release brake hose (60) from cable guide (57)

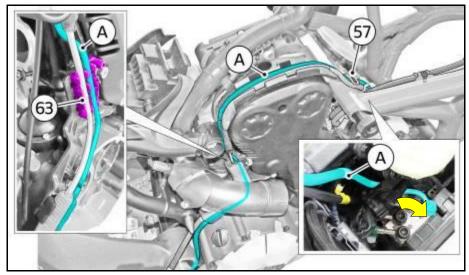
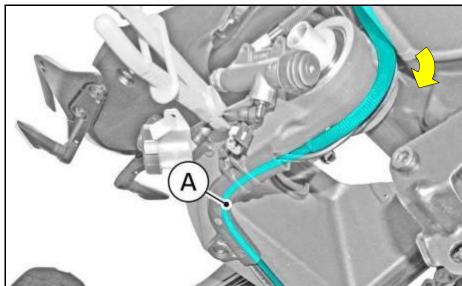
- 2. Install the new brake hose (A) connecting the ABS control unit to the rear brake caliper, as shown below:
 - 2 A. Route the ABS control unit fitting below the wiring support
 - 2 B. Position brake hose (A) inside cable guide (57)
 - 2 C. Position brake hose (A) inside cable guide (63), in the position shown in the figure
 - **2 D.** Route **brake hose (A)** between swinging arm and clutch cover.

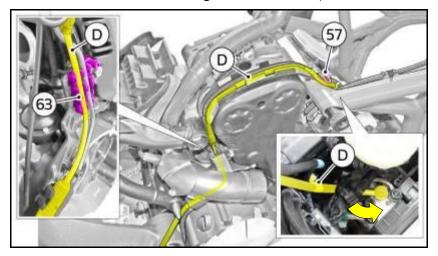
- 2. Install the new **brake hose (D)** connecting the ABS control unit to the rear brake master cylinder, as shown below:
 - 2 A. Route the ABS control unit fitting below the wiring support
 - 2 B. Position brake hose (D) inside cable guide (57), close to brake hose (A)
 - 2 C. Position brake hose (D) inside cable guide (63), in the position shown in the figure.

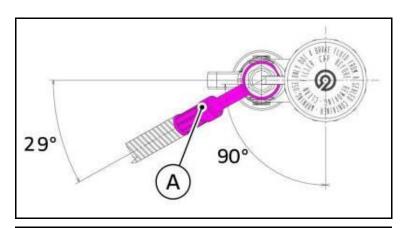
Ensure that brake hose (A) and brake hose (B) fittings are aimed on the ABS control unit as shown in the figure and check also that there are no interferences.

Ensure that brake hose (A) and brake hose (B) fittings are respectively aimed on the brake caliper and brake master cylinder as shown in the figure.

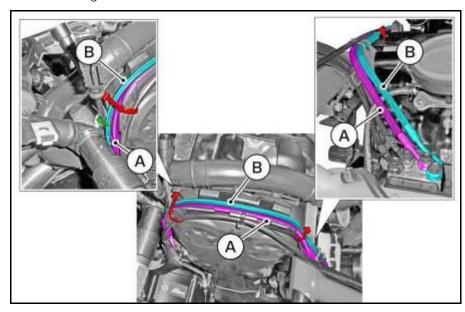
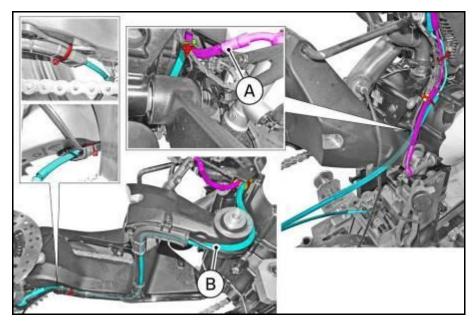
1. Fasten brake hose (A) connecting ABS control unit to rear brake master cylinder and hose (B) connecting ABS control unit to rear brake caliper using the self-locking ties at the points indicated in the figure.

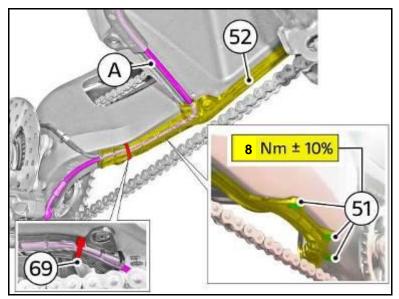
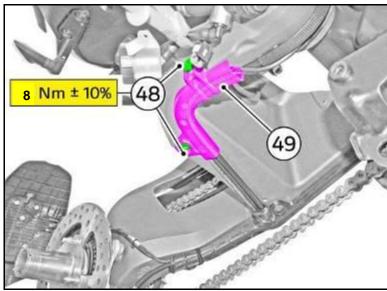
- 2. Position brake hose (A), speed sensor cable and number plate light cable along the swinging arm and fasten them with hose guide and chain sliding shoe (52).
- 3. Clean the 2 screws M5x12 (48) and 3 screws M5x12 (51) and remove any pre-applied threadlocker.
- 4. Tighten the 2 screws M5x12 (48) and 3 screws M5x12 (51) to 8 Nm ± 10% applying LOCTITE 243 on the threads.
- 5. Tie to the **chain sliding shoe (52)**, the **brake hose (A)**, the number plate light cable and the rear speed sensor cable with big self-locking **tie (69)**

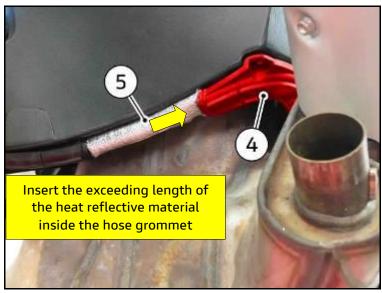
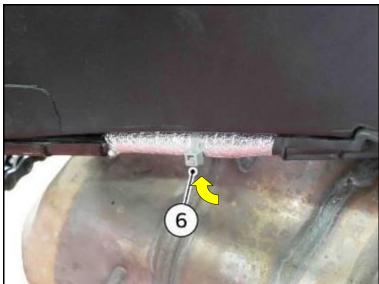
8. Fit nylon **tie (6)** in the middle of the heat reflective material, as shown in the figure; cut the exceeding length and turn tie end to position it under the swinging arm.

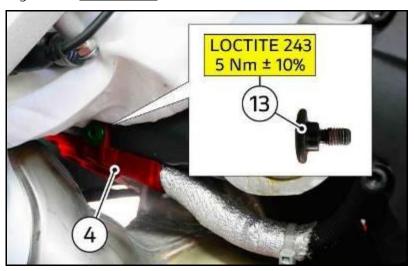
- 15. Clean the screw with collar M5x12 (13) and remove any pre-applied threadlocker.
- **16**. Apply LOCTITE 243 to the thread of the **M5x12 screw with collar (13)** and start it in the cable guide (4). Tighten to <u>5 Nm ± 10%</u>.

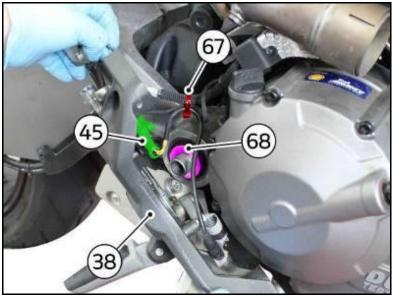
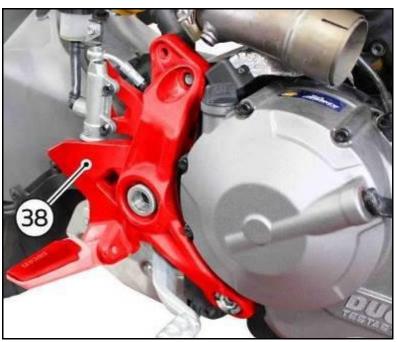
When fitting the RH front footpeg holder plate assembly, make sure that bushing (68) is present on swingarm shaft and take care not to damage the brake hose and wiring.

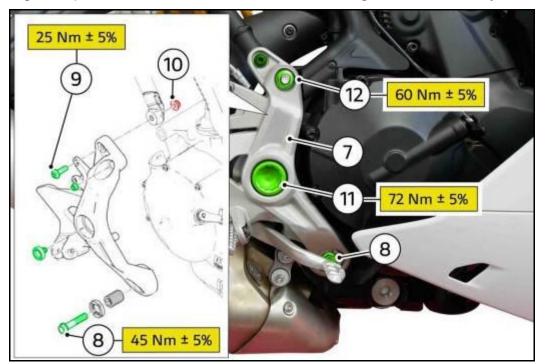
- **19**. Fasten the RH footpeg holder **plate (7)** following the sequence below:
 - **19 A**. Tighten **special screw (11)** to **72 Nm ± 5%** with grease GADUS S2 V220 AD 2 (Or equivalent) + certification
 - 19 B. Tighten nut (12) to 60 Nm ± 5% with grease GADUS S2 V220 AD 2 (Or equivalent) + certification while holding it from the opposite side
 - **19 C.** Tighten **screw M10x50 (8)** to **45 Nm ± 5%** with grease GADUS S2 V220 AD 2 (Or equivalent) + certification
 - 19 D. Tighten special screw (9) to 25 Nm ± 5% while holding nut (10) and certify

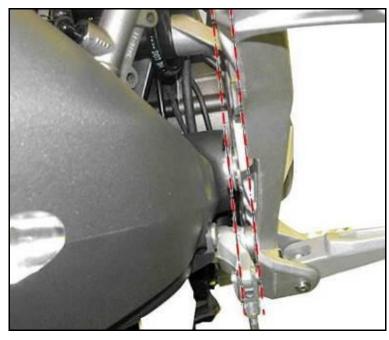
Check the correct alignment between the footpeg holder plate and the swinging arm.

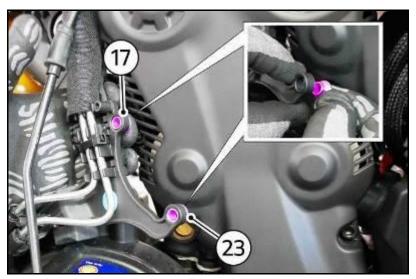
24. Position **spacers (17)** and **(23)** on ABS hose support inner side, aiming them as shown in the figure

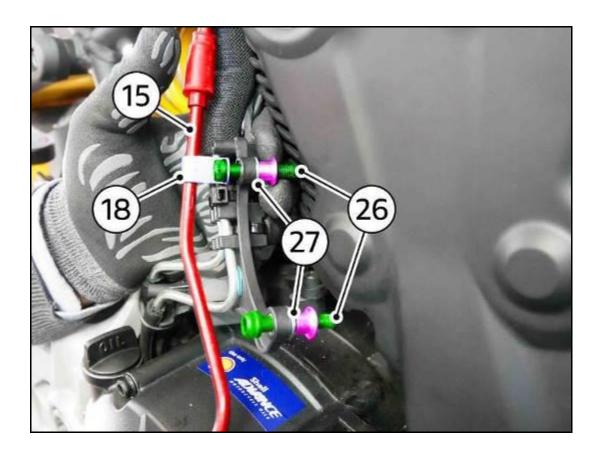
- 25. Take the 2 new screws M6X30 (26) and the 2 spacers (27) from kit Part no. 69929411A
- **26**. Follow the step sequence below to fasten the ABS hose support:
 - insert cable guide (18) on one of the two screws M6x30
 - insert screw M6X30 (26) with cable guide (18) inside the upper fastener
 - position clutch cable (15) inside cable guide (18)
 - insert the second M6X30 screw (26) in the lower fixing point
 - insert the **2 spacers (27)** on the **2 screws M6X30 (26)** aiming them as shown in the figure

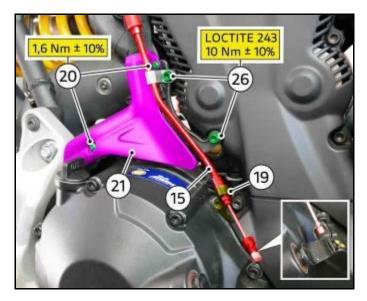
- 27. Apply LOCTITE 243 on the threads of the 2 screws M6x30 (26)
- 28. Tighten the 2 screws M6X30 (26) to a torque of 10 Nm ± 10%
- 29. Position clutch cable (15) inside cable guide (19) and fit the relevant pawl
- **30**. Fit ABS hose grommet **cover (21)** by tightening the **2 self-tapping screws (20)** to a torque of **1.6 Nm ± 10%**

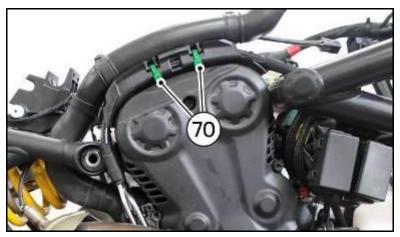
- 1. Install the rear wheel (See "Sec. 07 Chassis Rear wheel" of the Workshop Manual), the lower silencer cover and the lower silencer
- 2. Position the Crankcase ventilation hose on vertical cylinder head and secure it to head cover using the 2 large self-locking ties (70), aiming these latter as shown in the figure

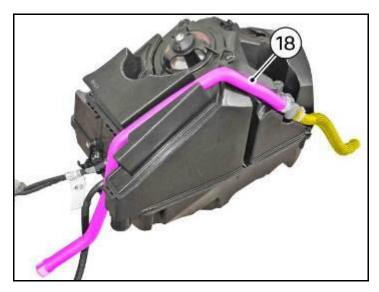
Make sure that secondary air **hose (18)** is correctly positioned on the Airbox.

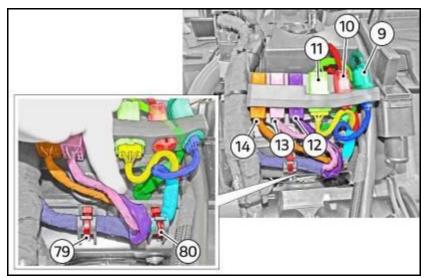
- 8. Connect injector wiring **connector** (9), vertical lambda sensor **connector** (10), potentiometer wiring **connector** (11) and insert starter **relay** (12), injection **relay** (13) and fuel pump **relay** (14) in the relevant support as shown in the figure
- **9.** Using the large self-locking **tie (79)** join the main wiring primary central branch to the airbox lower cover (aim it as shown in the figure)
- **10**. Using the large self-locking **tie (80)** join the main wiring secondary central branch to the airbox lower cover (aim it as shown in the figure)

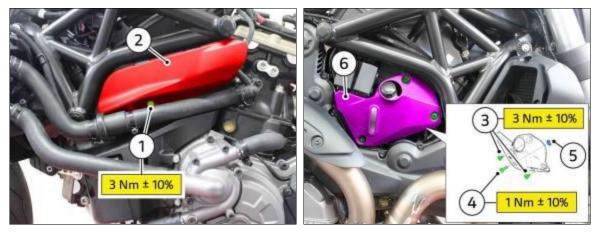
- 12. Working on the LH side, install cover (2) tightening screw M5x10 (1) to 3 Nm ±10%
- 13. Working on the RH side, install the coolant reservoir **cover (6)** and tighten the **2 screws M5x9 (3)** to <u>3 Nm ± 10%</u> and **screw M6x22 (4)** with relevant **spacer (5)** to <u>1 Nm ± 10%</u>

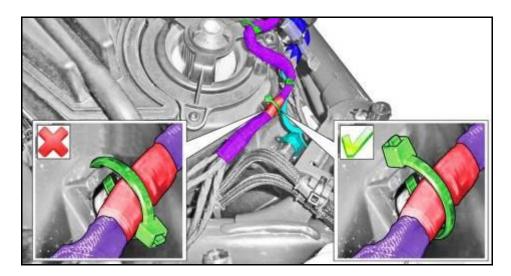
Check the correct positioning and orientation of the self-locking tie in correspondence of the red tape.

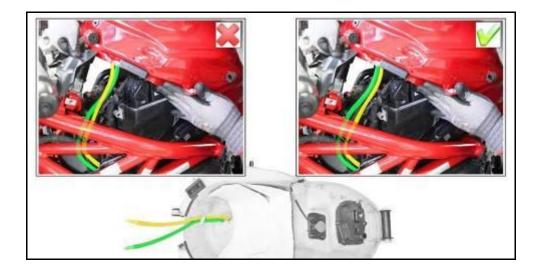
Check that the fuel tank breather tube and the canister filter breather tube are aimed as shown in the figure

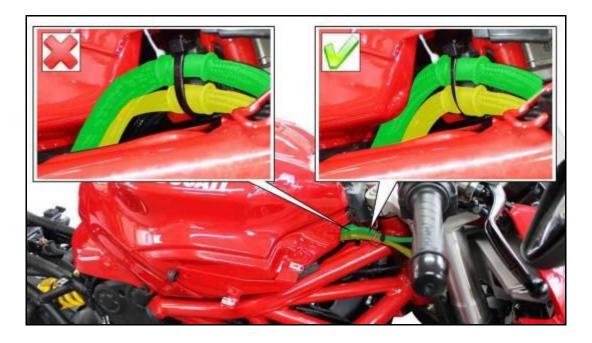
Check the correct ABS hoses orientation in the front RH area of the fuel tank.

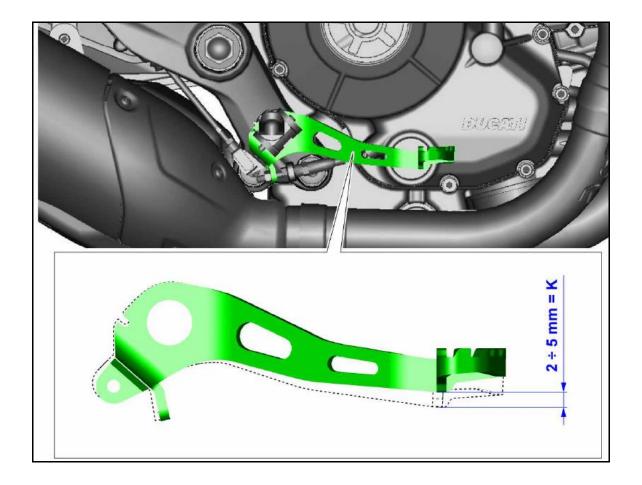
Before measuring the heights (A) and (B) for the brake pedal travel check, always check that the free play travel of the rear brake lever is correct (between 2 mm to 5 mm)

Remember that the idle stroke refers to the stroke performed by the brake cylinder control rod before operating the pump. If the idle stroke is outside the specified values, it must be adjusted again using the adjustment screw on the control rod

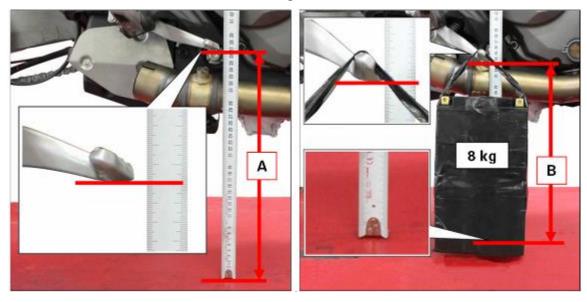
- **20**. Measure height **(A1)** between rear brake lever lower end and load-bearing surface; brake lever must be in rest position (upper limit stop)
- 21. Slowly position the 8 kg weight onto rear brake lever; then measure height (B1) between rear brake lever lower end and load-bearing surface

22. Note the difference between the measured heights (A1) and (B1)

Rear brake lever stroke 1 = (A1) - (B1)
